National Transportation Safety Board

Marine Accident Brief

Collision of Sand Barge *Weeks 207*, Pushed by Tugboat *Seeley*, with Sailboat *Sea Jay*

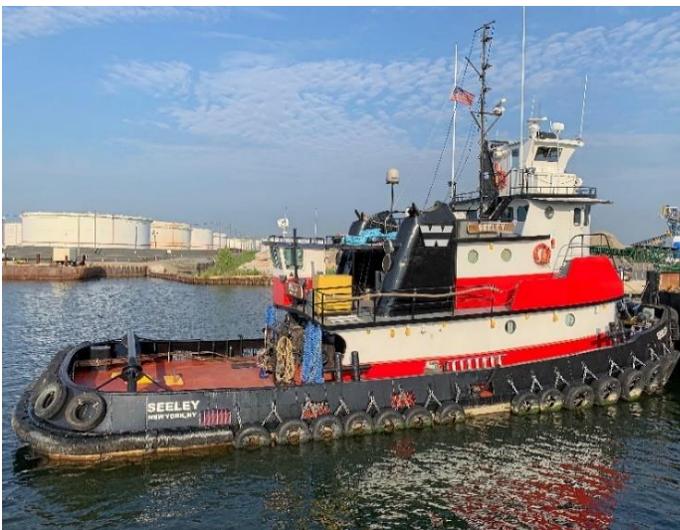
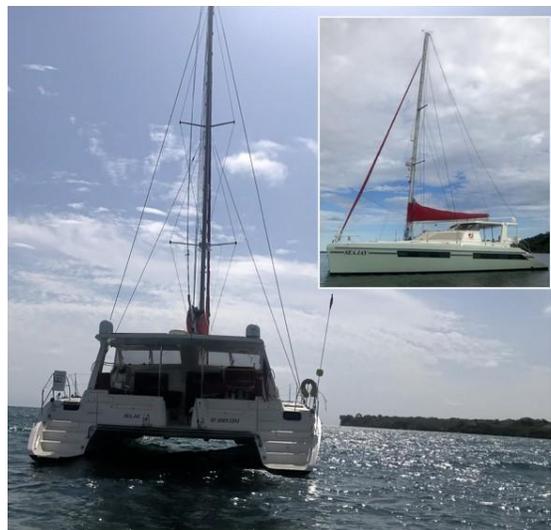
Left, tugboat *Seeley* before the accident. (Source: Weeks Marine) Right, sailboat *Sea Jay* anchored before the accident. (Source: Sea Jay)
