National Transportation Safety Board

Marine Accident Brief

Capsizing of the Towboat *Miss Roslyn*

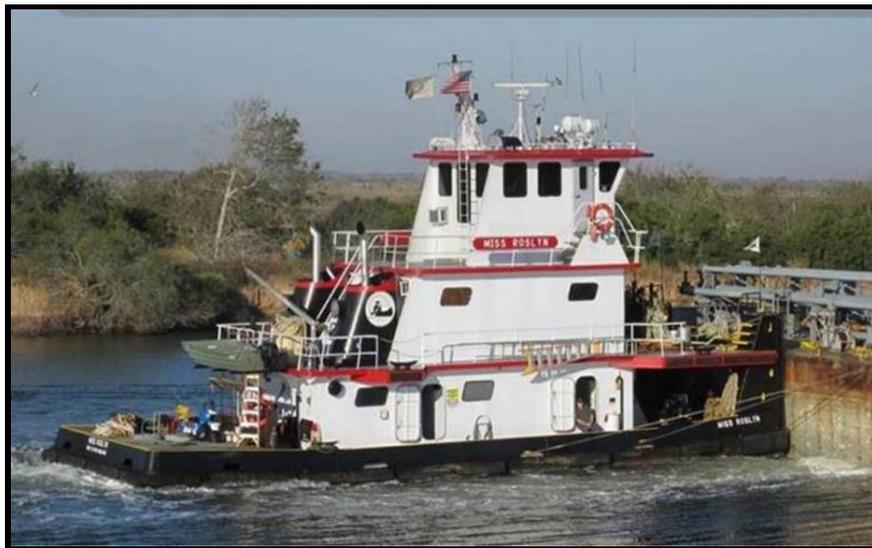
Preaccident image of the *Miss Roslyn*. (Source: Marquette Transportation Company Gulf-Inland)

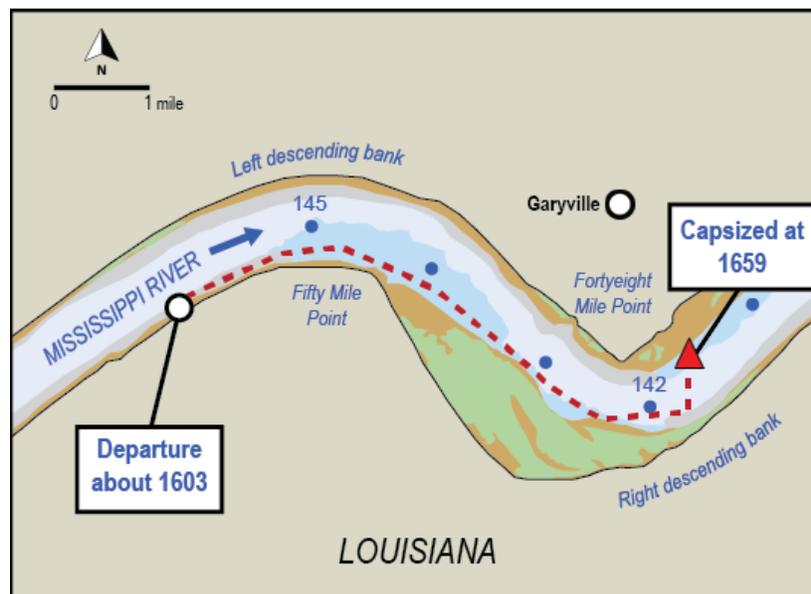
At 1639, the captain stopped at Fortyeight Mile Point (mile 142.4) to inspect the vessel himself. He noted that the engine room was dry, but on the main deck, starboard side aft, water was coming through the freeing ports (but not over the bulwark) and had covered the deck about one foot; he made a second call to the port captain to report his observations.⁵ The *Miss Roslyn*'s captain radioed a nearby tug for assistance, and according to the *Miss Roslyn*'s captain, the captain of the nearby Marquette towboat *Joanne Marie* stated that he did not think the *Miss Roslyn* would be able to safely return to the crew change dock at CCI Upper Reserve about 5 miles downstream. He also suggested that the *Miss Roslyn* cross the river (about 0.4 mile) to get to the shallower, slower-moving water on the other side. The captain of the *Miss Roslyn* stated he felt confident he could cross the river, and about 1650, the *Miss Roslyn* began crossing to the left descending (east) bank, with the Good Samaritan towboat *Kristy Dutsch* following behind.

Track line of the accident voyage. The *Miss Roslyn* capsized at mile 142 of the Lower Mississippi River, near Reserve, Louisiana.
