National Transportation Safety Board

Marine Accident Brief

Collision of Heavy Lift Vessel *Hawk* with Unnamed Barge and Destroyer *Delbert D Black*

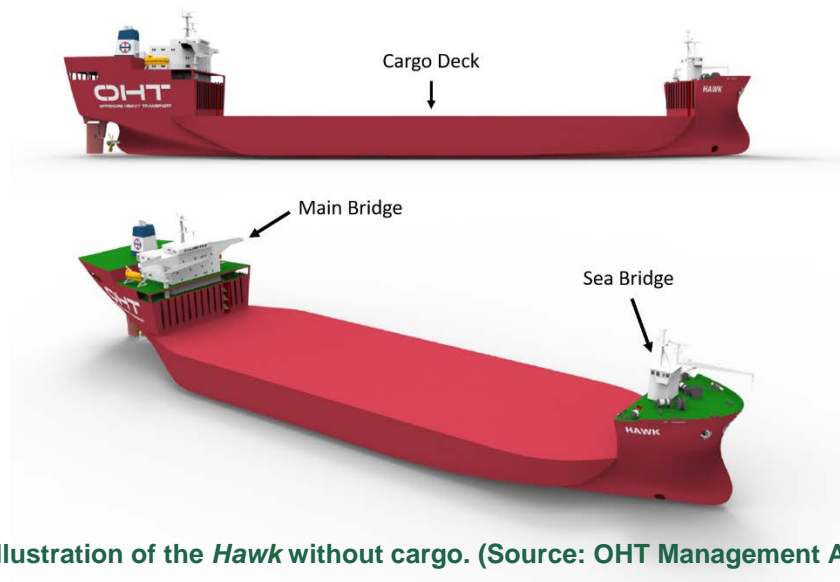
Illustration of the *Hawk* without cargo. (Source: OHT Management AS)

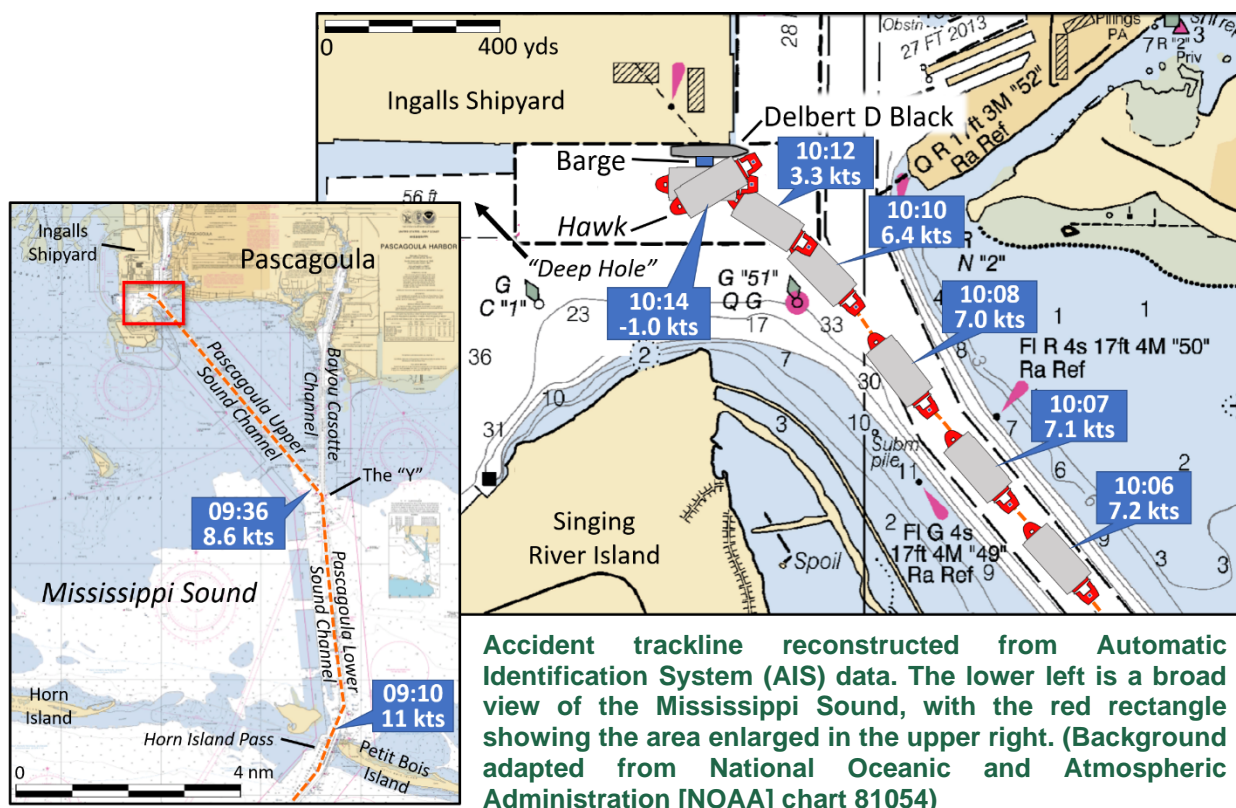
As the *Hawk* transited up the Pascagoula Lower Sound Channel, pilot 2 discussed with pilot 1 the need for a fourth tugboat to assist with positioning the vessel for anchoring when it arrived at the Deep Hole. Both agreed that the extra tugboat was needed, so pilot 2 made a call to order the tugboat. The pilots stated that the additional tugboat was needed only to assist with anchoring at the Deep Hole and was not intended to assist with maneuvering in the channel.
