National Transportation Safety Board

Marine Accident Brief

Contact of *Bettye M. Jenkins* Tow with Bunge Grain Facility

Accident type	Contact	No. DCA19FM018
Vessel names	<i>Bettye M. Jenkins</i> and barge <i>T9353</i>	
Location	Lower Mississippi River, mile 361, near Vidalia, Louisiana 31°32.95' N, 091°26.43' W	
Date	February 15, 2019	
Time	0130 central standard time (coordinated universal time – 6 hours)	
Injuries	None	
Property damage	\$3.3 million est.	
Environmental damage	None	
Weather	Visibility 10 miles, partly cloudy, winds south 4 knots, air temperature 60°F	
Waterway information	The Lower Mississippi River near mile marker 361 is 0.6 mile wide with a maintained channel depth of 9 feet. At the time of the accident, the river near mile marker 361 was at flood stage, and a high-water safety advisory was in effect. The river stage near Vidalia, at Natchez, Mississippi, was 49.1 feet.

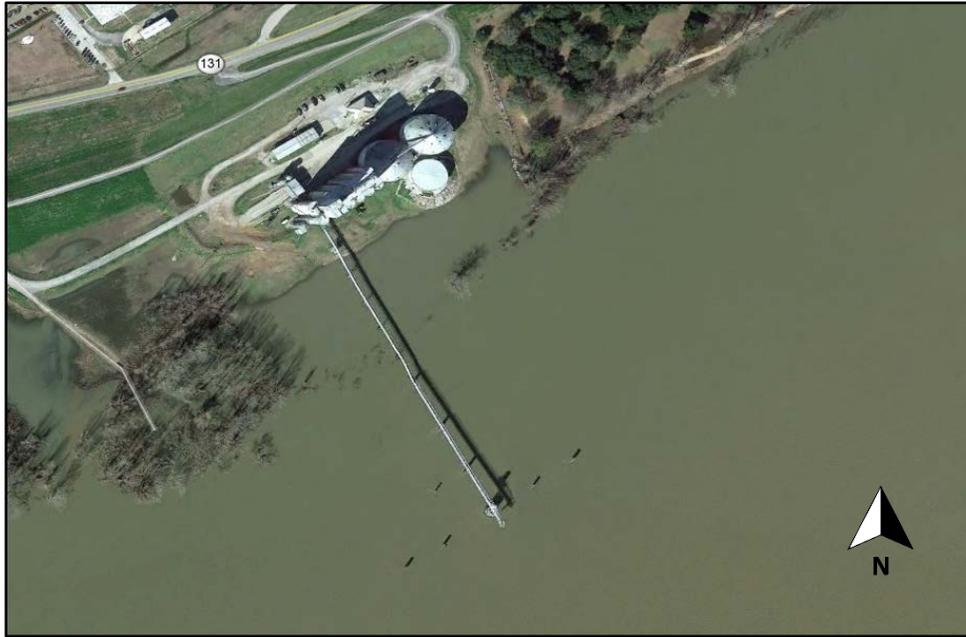
The Bunge facility, including silos, conveyor, and mooring pilings. (Source: Google Earth)

As a result of the contact, the two dolphins farthest from shore that supported the conveyor and trusses were deflected up to 15 feet. Three conveyor trusses were forced out of alignment as much as 3 feet. Bunge employees cut the conveyor belt to prevent the entire structure from being damaged. Due to the damage, Bunge had to transport cargo 7.4 miles across the river to the Adams County Port for loading on barges until repairs were completed on August 20, 2019.
