SAFETY INVESTIGATION REPORT

REPORT NO.: 01/2020

MV Guro*n*i
Main engine failure
in position 57° 44.4' N 010° 08.0' E
08 January 2019

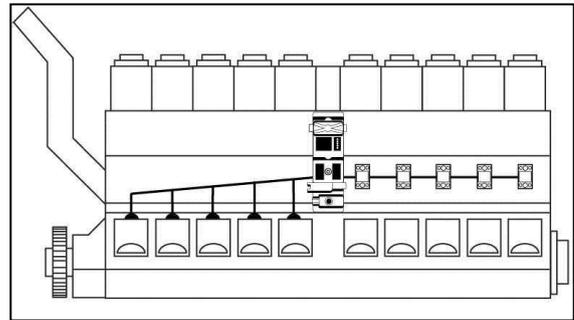
Figure 7: Position of the oil mist detector

The type of oil mist detector fitted on board *Guroni* indicated the detection of high oil mist level, in general, and was typically positioned at mid-length of the main engine as shown in Figure 7.

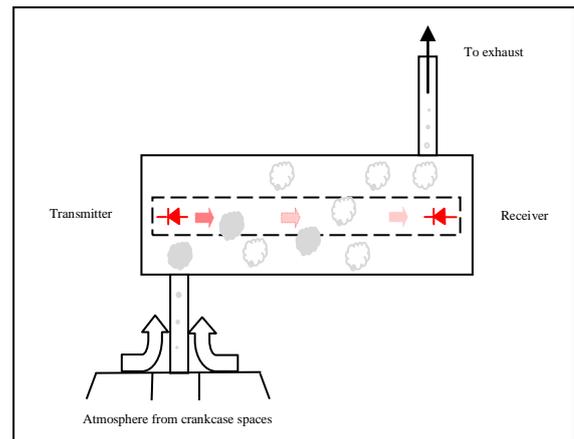
Figure 8: Working of the oil mist detector

This detector was designed to continuously and simultaneously sample the atmosphere from each crankcase compartment between two main bearings. As indicated in Figure 8, the sample mixture is then passed through an optical turbid channel, within the detector, and the turbidity of the crankcase atmosphere would be measured by optical absorption.
