## Collision between the bulk carrier *Gülnak* and the moored bulk carrier *Cape Mathilde* River Tees, England on 18 April 2019

### SUMMARY

On 18 April 2019, the Turkey registered bulk carrier *Gülnak* collided with the Panama registered bulk carrier *Cape Mathilde*, which was moored alongside the Redcar bulk terminal, Teesport, England. Both vessels were damaged but there were no injuries and there was no pollution.

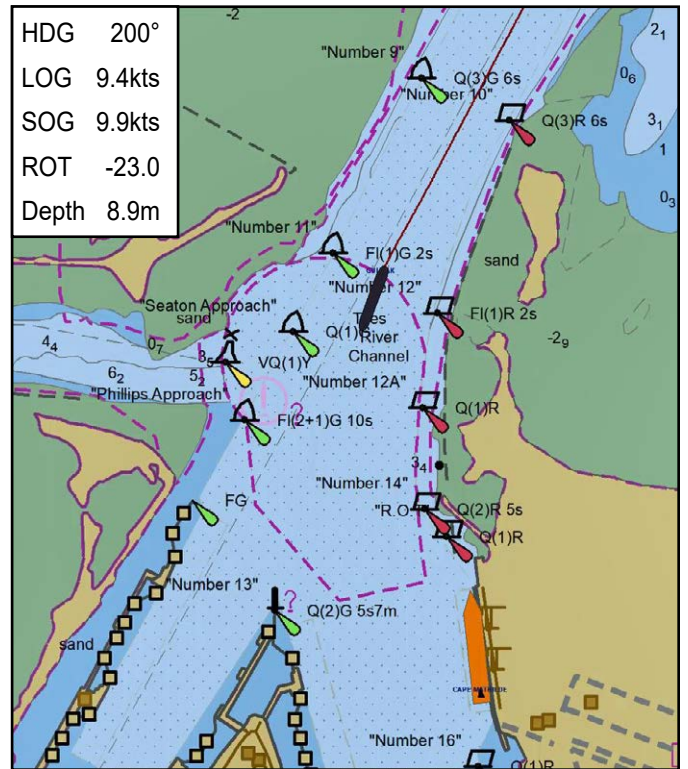
**Figure 3b:** Position at 0321:01 when rudder put to midships

As *Gülnak* approached No 11 buoy (**Figure 3a**), the pilot ordered 'port 10', to start to turn the vessel towards a heading of about 170°, keeping towards the centre of the main channel. Within 1 minute, *Gülnak* was turning towards the south at a rate of 23°/minute (min) (**Figure 3b**) and the pilot ordered 'slow ahead' (64rpm – 7kts). The order of 'midships' soon followed in order to reduce the rate of turn. At 0321:17, *Gülnak*'s heading was passing through 190° at about 28°/min (**Figure 3c**), which was quicker than the pilot expected. The pilot ordered 'starboard 20°' quickly followed by 'hard-a-starboard'.

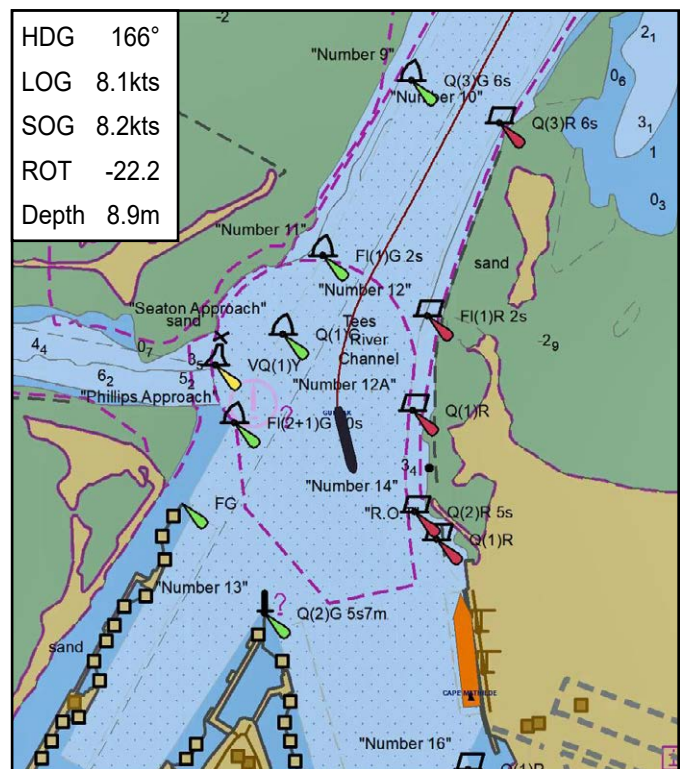
**Figure 3d:** Position at 0322:22 when engine put to 'full ahead'

*Gülnak*'s master was standing by the engine telegraph and saw that the rate of turn was not decreasing. He suggested an increase in engine speed "to stop the vessel turning". The pilot agreed, and ordered 'half ahead'. Accordingly, the master moved the engine telegraph. However, the vessel's heading was now passing 166° with a rate of turn to port of 22°/min (**Figure 3d**) and the master increased the engine speed to 'full ahead'. Soon after, the pilot requested 'full ahead' to which the master replied "full now".
