## Grounding of the ro-ro freight ferry *Seatruck Performance* in Carlingford Lough, Northern Ireland 8 May 2019

### SUMMARY

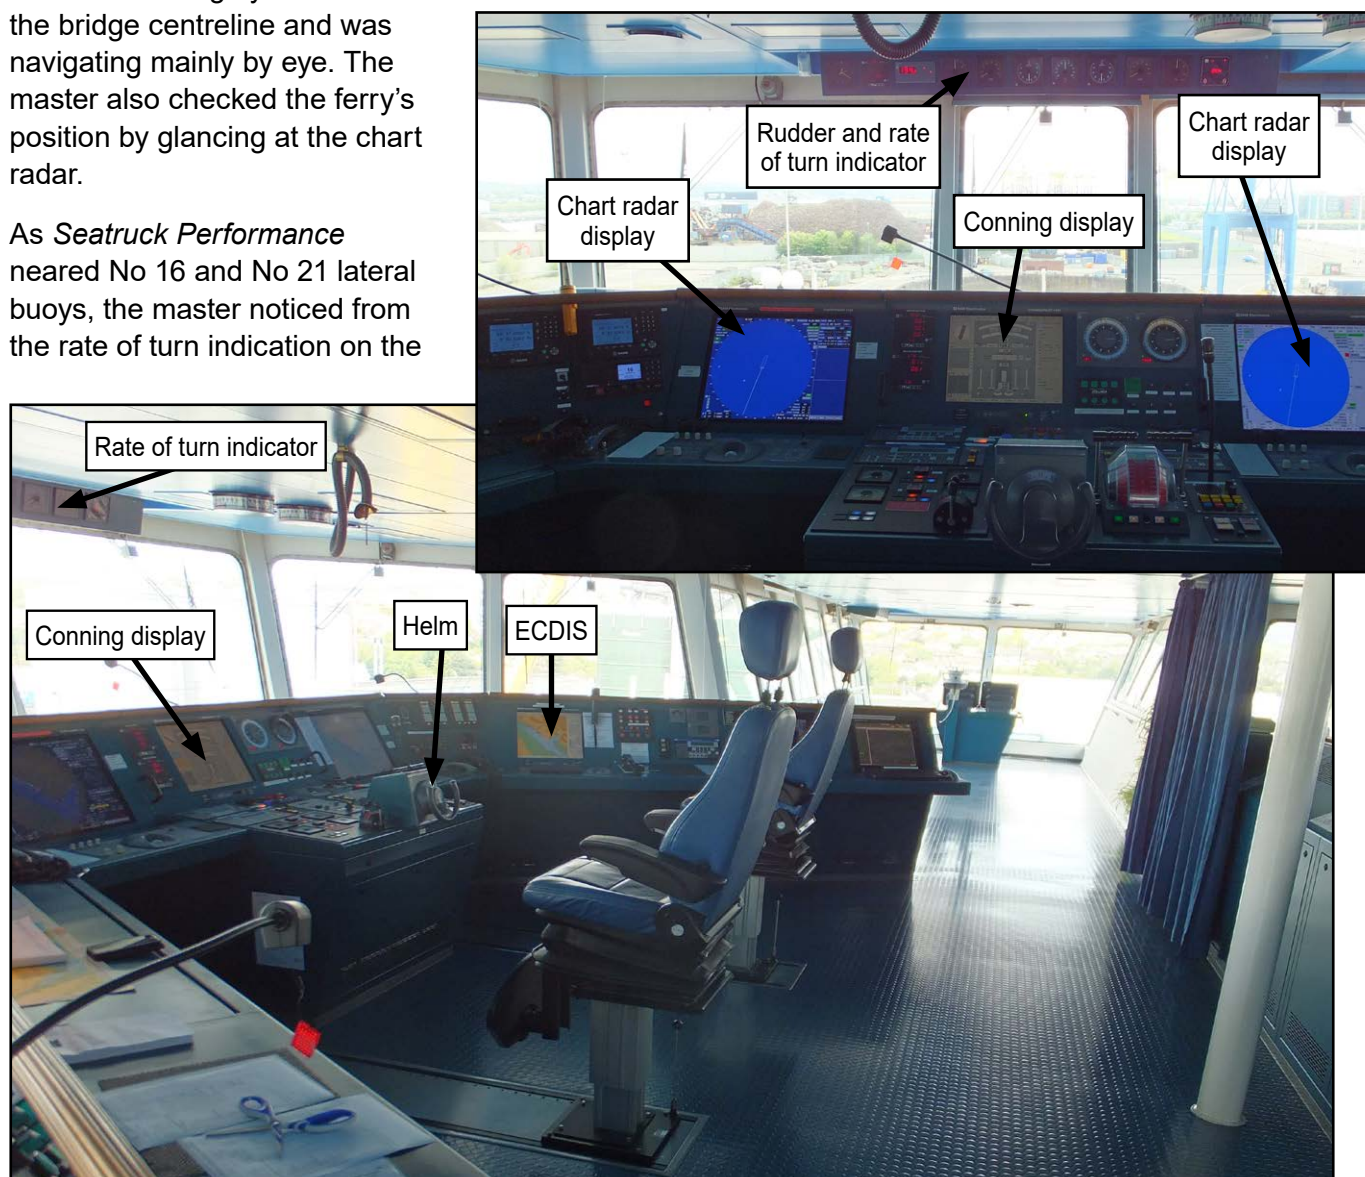
**Figure 2:** *Seatruck Performance* bridge (inset: Bridge looking forward)

As *Seatruck Performance* approached the critical course alteration between No 16 and No 21 buoys, the master's preference to steer the ferry himself inevitably reduced his ability to effectively monitor either the chart radar or ECDIS displays due to their distance and oblique angle when viewed from the helm position (**Figure 2**). Although steering by hand was a common practice among other *Seatruck* masters
