SAFETY INVESTIGATION REPORT

REPORT NO.: 04/2020

MV BOSTON TRADER **Serious injury while lashing containers on deck, in the port of Oran, Algeria 14 March 2019**

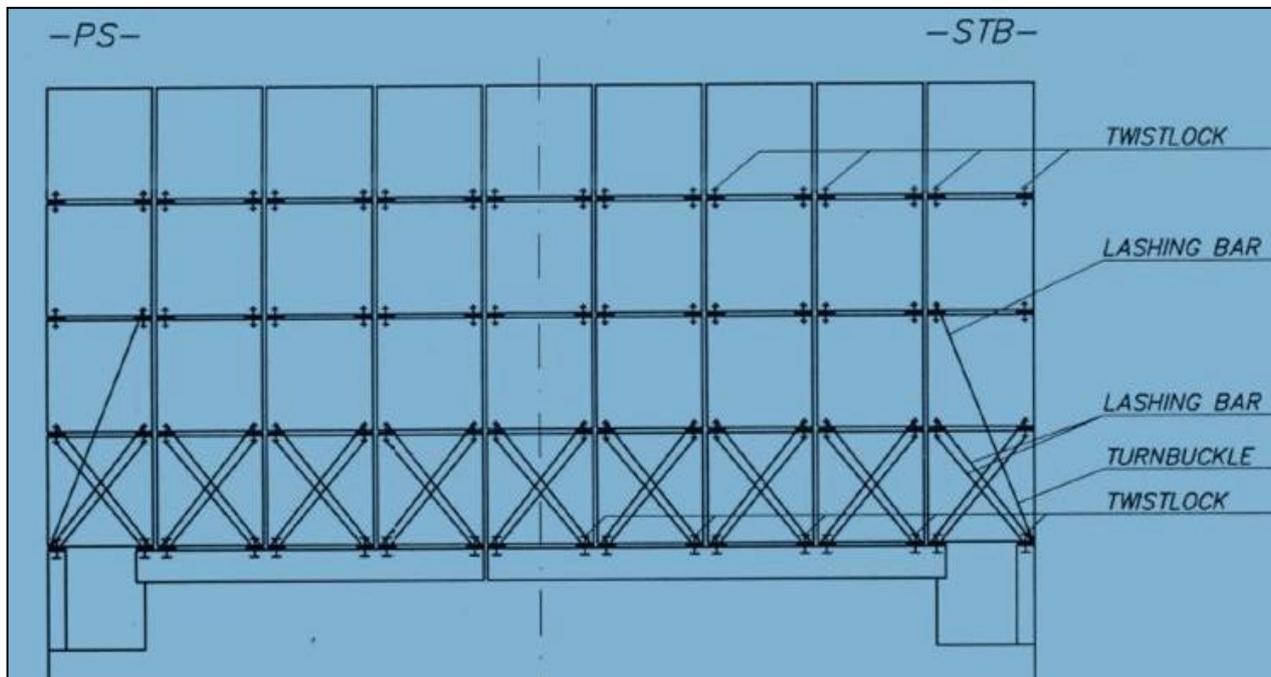
Figure 1: Container stowage and lashing plan – Bay 06

The containers loaded on deck were secured in accordance with the Cargo Securing Manual, which required the containers stowed on Bay 06, in the vicinity of where the accident occurred, to be secured as shown in Figure 1.

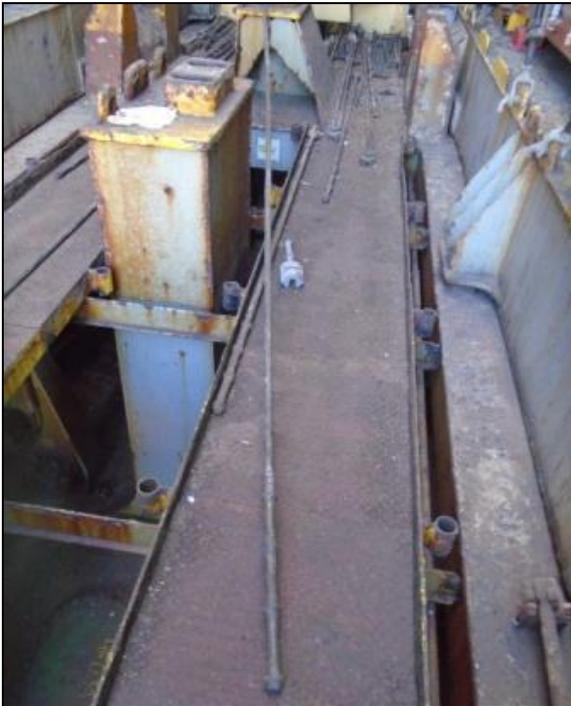
Figure 2: Long lashing bar used for securing

The containers loaded on the third tier of the outboard ends had to be secured using a long lashing bar (Figure 2), and tightened with a turnbuckle connected to it.

The height of the long lashing bar was 5.07 m and it was said to weigh more than 20 kg.

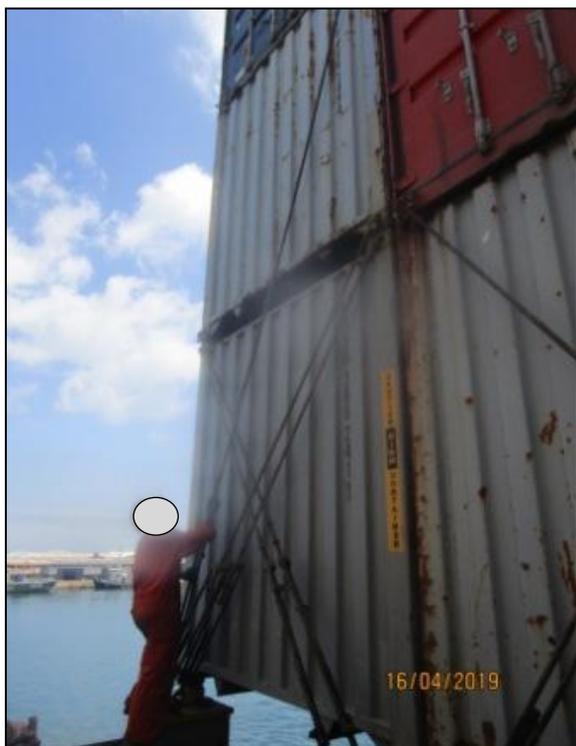
Figure 5: Connecting a lashing bar to a turnbuckle

Once hooked, the lashing bar would have to be brought diagonally across to be connected to the turnbuckle, which would then be screwed down to tighten the securing arrangement (Figures 5 and 6).
