National Transportation Safety Board

Marine Accident Brief

Collision of Towing Vessel *St. Rita* and Tow with Moored Barges, and Subsequent Sinking

Accident type	Collision	No. DCA19FM022
Vessel name	<i>St. Rita</i>	
Location	Lower Mississippi River, mile 132, near New Orleans, Louisiana 30°02.0' N, 090°28.4' W	
Date	March 7, 2019	
Time	1430 central standard time (coordinated universal time – 6 hours)	
Injuries	Minor	
Property damage	\$1.5 million est.	
Environmental damage	No environmental damage reported	
Weather	Partly cloudy, visibility 10 miles, winds south 13 knots, small chop, current 5-6 knots, air temperature 73°F, water temperature 47°F	
Waterway information	The Mississippi River at the La Place fleeting area was at flood stage with an estimated current of 5-6 knots.

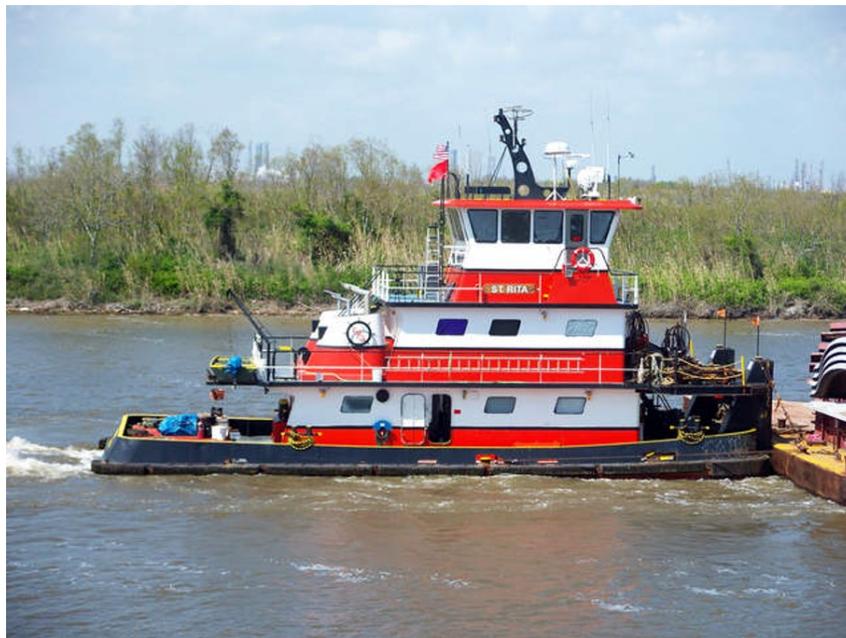
The *St. Rita* under way before the accident. (Source: M. Haury)

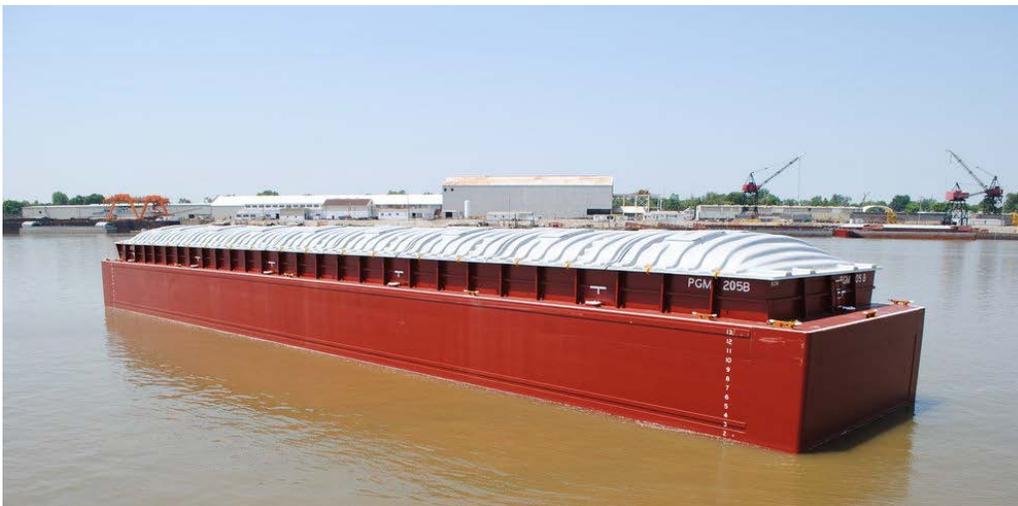
Picture of a barge similar to the *LTD 14161*. (Source: Cooper Consolidated, LLC)

The *LTD 14161* was located on the head of Block 2, which was the row of barges on the upriver part of the block, facing the current. The *LTD 14161* had another barge on its starboard side and a barge tied up astern of it. There was no barge on its port side.
