Report on the investigation of
the man overboard from the dredger

Cherry Sand

resulting in one fatality

in the non-tidal basin at Port Babcock Rosyth,

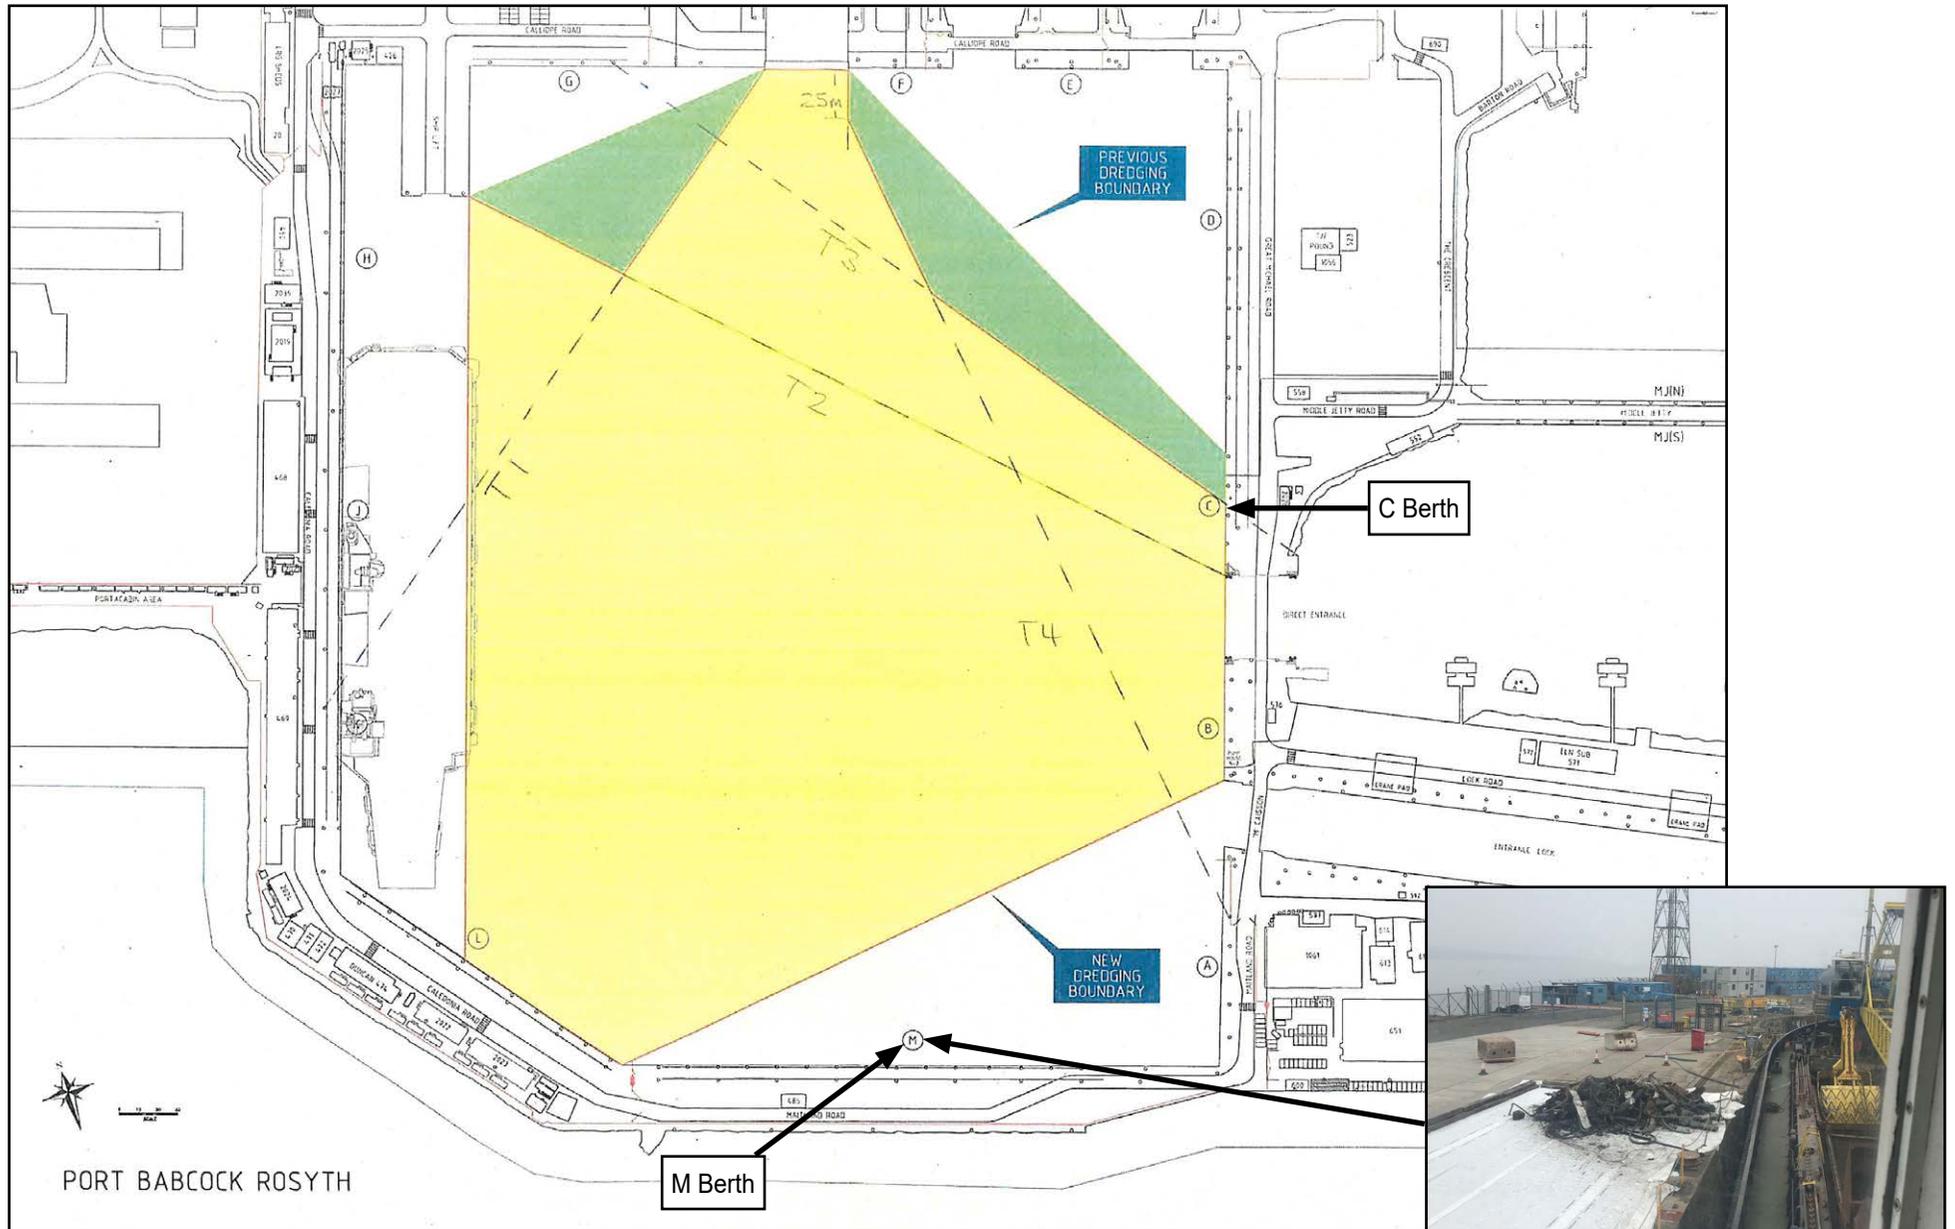
Figure 1: Plan of the non-tidal basin at Port Babcock Rosyth

On the morning of 27 February, *Cherry Sand* dredged area T3 before returning to C berth (**Figure 1**) at 1006. The dredger then remained alongside until 1600. During this time, *Cherry Sand*'s 'B' watch crew joined the vessel at various times relieving all of 'A' watch, except for the master, who remained on board with the operations manager. After the crew change had been completed, *Cherry Sand* was moved to M berth (**Figure 1**) to discharge debris² ashore, before continuing to dredge in area T3 and returning to C berth for the night.

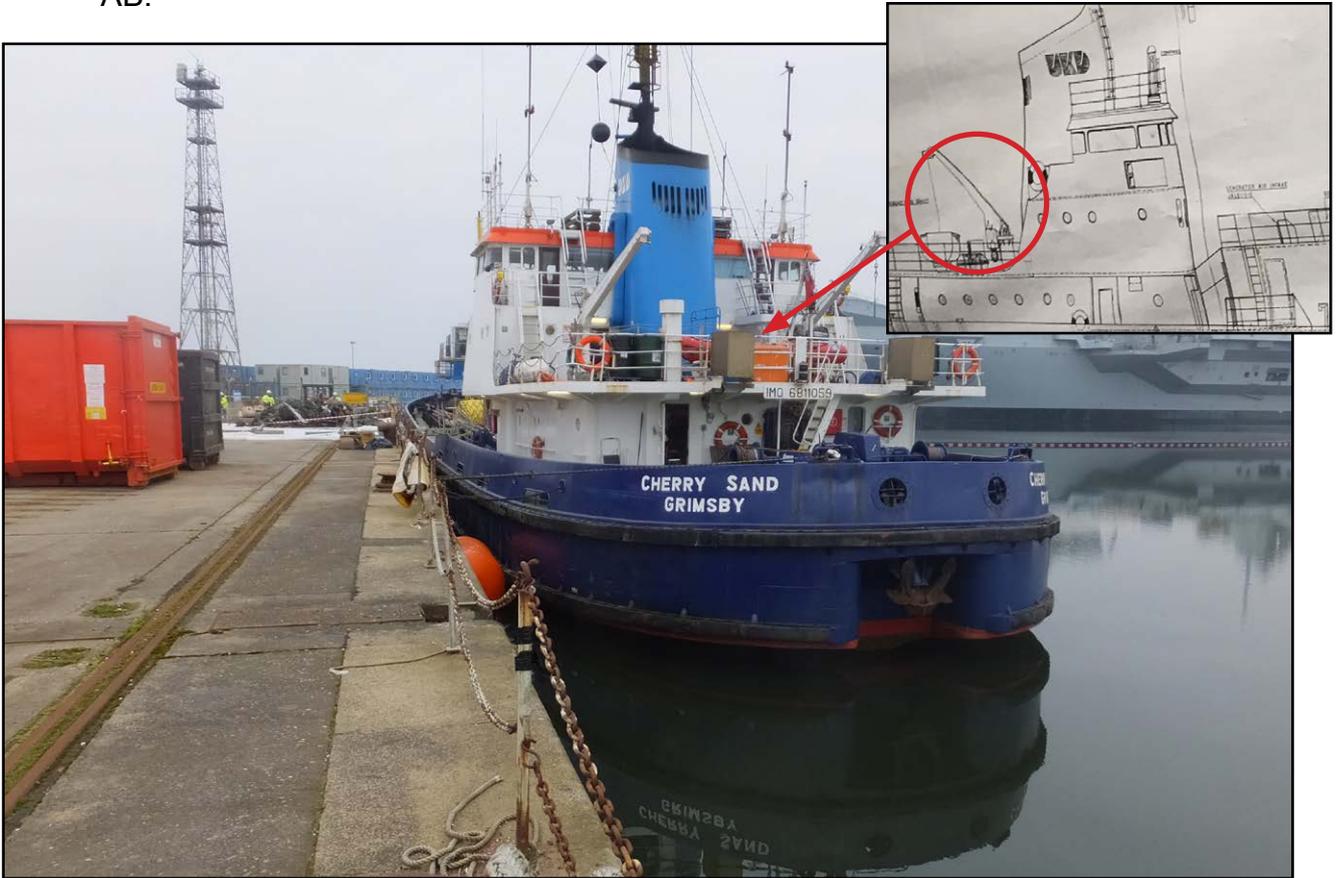
Figure 8: Stowage position of rescue boat

Cherry Sand's lifesaving equipment included a rescue boat that was stowed aft of the accommodation (**Figure 8**). The boat had its own davit and was capable of being launched quickly. The rescue boat was usually crewed by the chief officer and an AB.
