2 Synopsys

On Sunday, November 10th 2019, around 15:30, the fv Z.15 – ZILVERMEEUW moored at Milford Docks, Wales, UK. An additional crewmember was to embark and the catch was to be landed. The crew also wanted to take advantage of the time in port to carry out some repairs to the fishing gear.

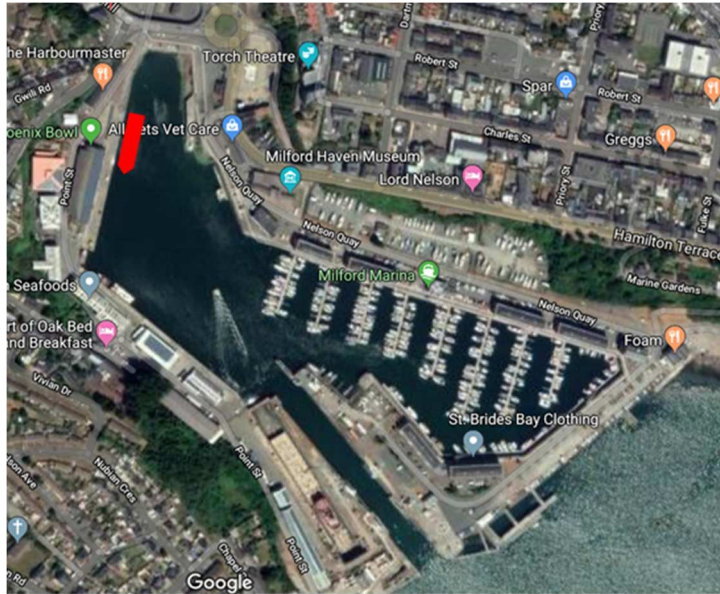
Figure 2 - Z.15 ZILVERMEEUW berth

Milford Docks is located near the centre of Milford Haven. The fv Z.15 – ZILVERMEEUW berthed SB side at the K Wall, as indicated in Figure 2.

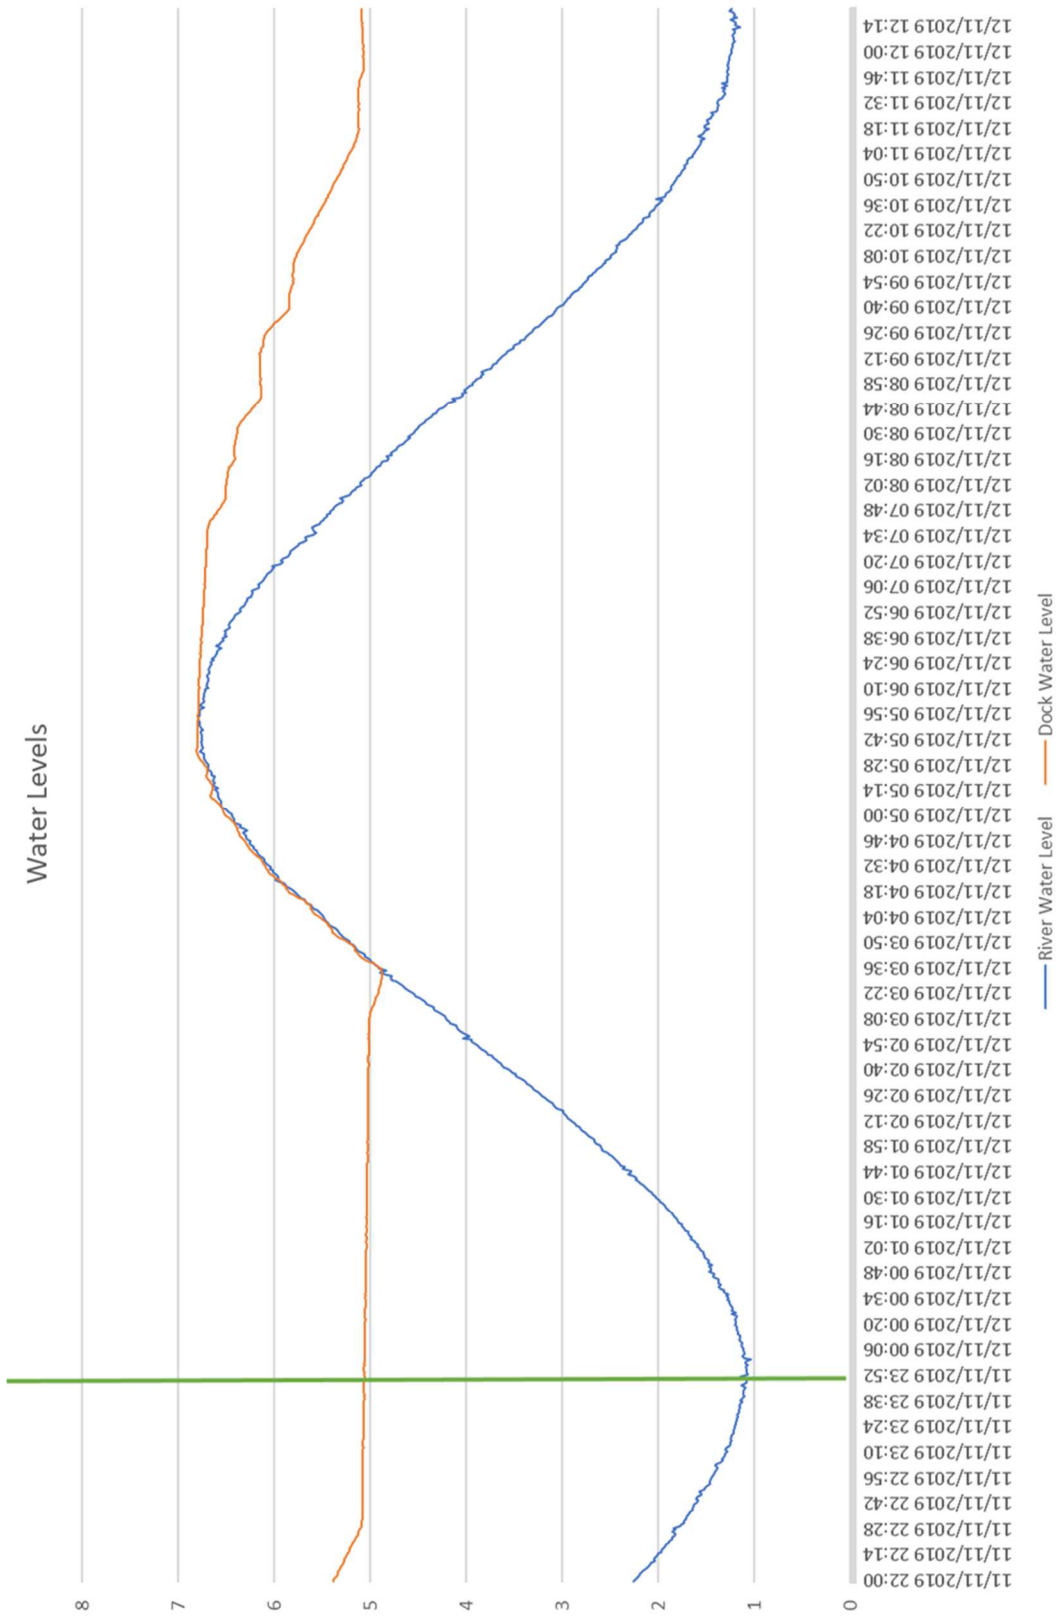
Figure 3 - Water level in Milford Haven

The port entrance is protected by a lock, reducing the interval between high and low water inside the port. As shown in Figure 3, there was a tidal range of approximately 2 metres.

Fv Z.15 – ZILVERMEEUW was berthed inside the docks. The orange line indicates the water level inside the docks. The green line indicates the time the crewmember fell into the water.

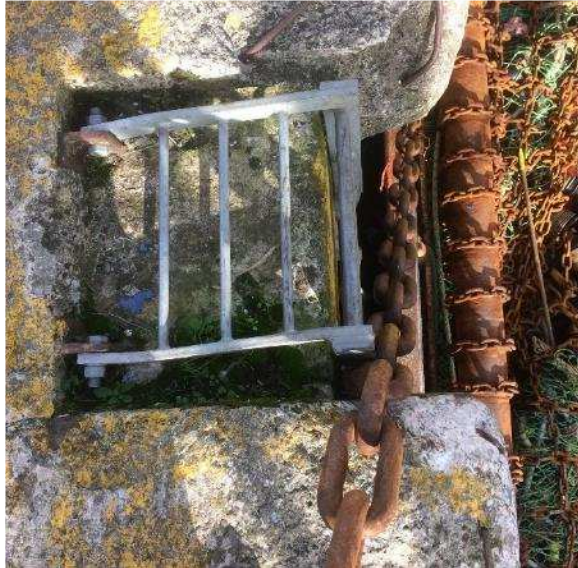
Figure 5 - Quay side ladder- top view from jetty

Even in ideal conditions, the quay side ladder was awkward to climb, and its design did not encourage use:

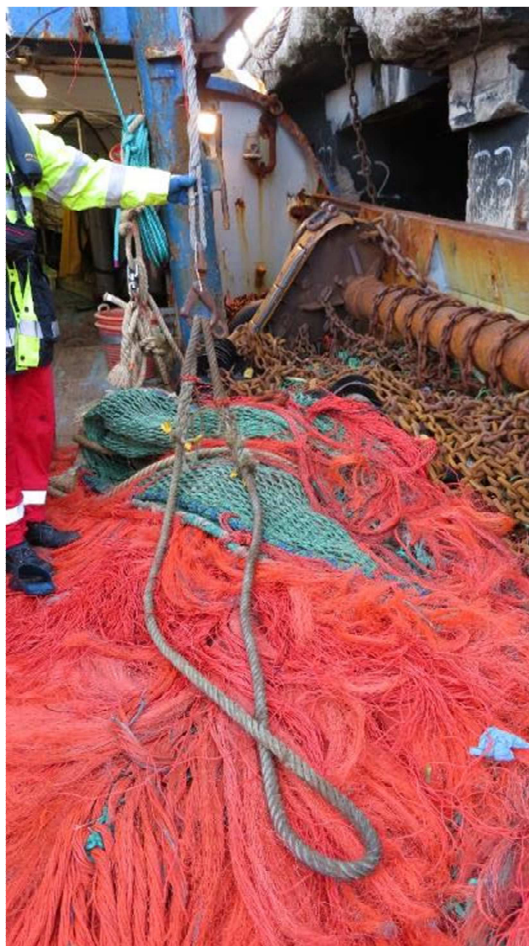
Figure 7 - Strop used to lift the victim out of the water

The crew decided to use the winch wire to lift the victim out of the water. The crewmember who had already been in the water jumped back into it to fit a strop under the victim's arms and subsequently returned back on board by using the quay side ladder.
