National Transportation Safety Board

Marine Accident Brief

Contact of *Mary Lucy Lane* Tow with Markland Locks and Workboat *Gibson*

Accident type	Contact	No. DCA19PM011
Vessel names	Towing vessel <i>Mary Lucy Lane</i> and workboat <i>Gibson</i>	
Location	Ohio River, mile 531.5, Markland Locks & Dam, Warsaw, Kentucky (about 30 miles southwest of Cincinnati, Ohio) 38°46.44' N, 084°57.34' W	
Date	December 18, 2018	
Time	1555 eastern standard time (coordinated universal time – 5 hours)	
Injuries	0	
Property damage	\$2.1 million est.	
Environmental damage	None	
Weather	Visibility 10 miles, sunny skies, south winds at 8 mph, air temperature 52°F, water temperature 45°F	
Waterway information	The navigable Ohio River is 981 miles long, starting at mile 0 in Pittsburgh, Pennsylvania, and ending at mile 981 in Cairo, Illinois, where it flows into the Upper Mississippi River. ¹ The Markland Locks & Dam has an upper pool and a lower pool used to maintain the navigable channel.

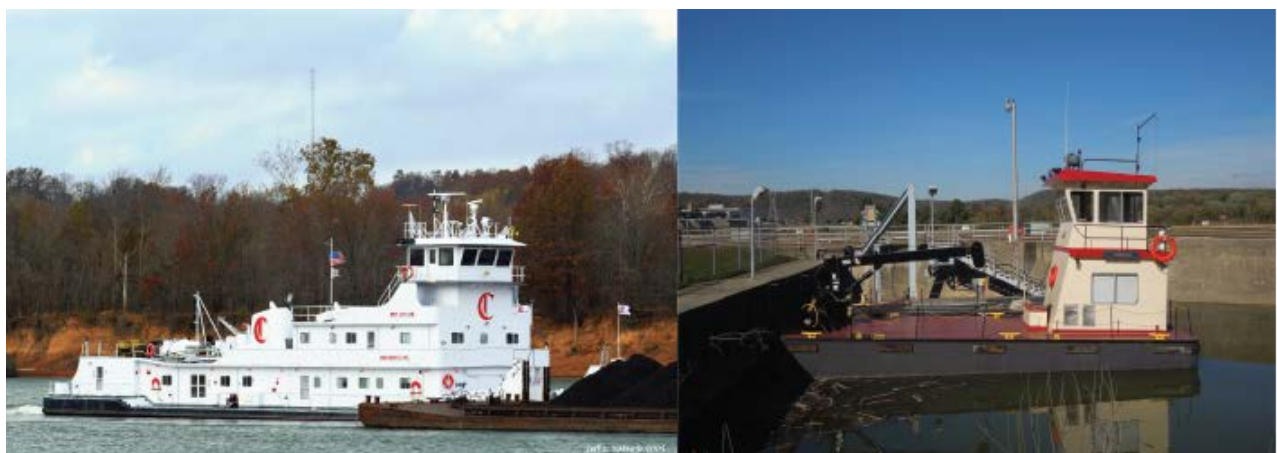
Left: Towing vessel *Mary Lucy Lane*. (Source: © Photo by Jeff L. Yates) Right: Corps of Engineers workboat *Gibson*. (Source: US Coast Guard)

Damage. A damage survey of the *Mary Lucy Lane* and its tow was conducted on December 20, 2018. Four of the vessel's winches were damaged, and the starboard string of barges that struck the guard wall's protective bullnose—the *CBC92*, *CBC1341*, and the *CS1319*—had minor scraping damage.⁸ The *ART 36109*, which struck the *Gibson*, had estimated damages of \$6,500. The *WCAO 116*, which was impaled on the guide wall bullnose, sustained a 5-foot-wide-by-10-foot-high hole in the bow rake.

The guide wall's bullnose armor steel plate edge broke off, and the underlying 17-foot-long-by-24-feet-thick concrete was damaged up to a depth of 6 inches. A 2-foot-thick-by-5-foot-long section of the concrete cap of the wall extending shoreward broke off and fell into the harbor pool. The *Gibson's* pilothouse and deckhouse were crushed, and portions of the aft deck were buckled by the impact with the *ART 36109*; the Corps of Engineers estimated the cost to replace the *Gibson* at \$1.8 million. The total estimated damages for the *Mary Lucy Lane*, the barges, and the dam were \$321,943.
