SAFETY INVESTIGATION REPORT

REPORT NO.: 11/2020

May 2020

MT ALYARMOUK **Damage to equipment, leading to a fall from a height on deck,** **in position 06° 20' N 079° 34' W** **10 May 2019**

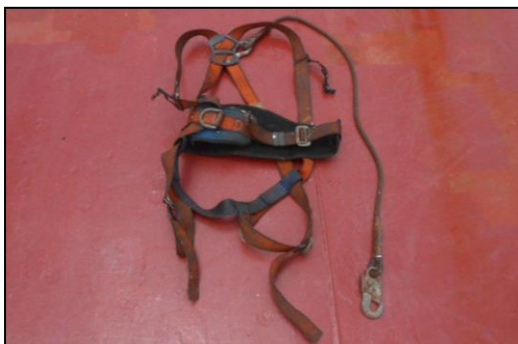
Figure 3: The safety harness

The task was planned to be carried out using a bosun's chair¹ (Figure 2) suspended by a rope (rope 'A'); while the seafarer would be perched on the chair, wearing a safety harness (Figure 3) secured to another rope (rope 'B').

The safety harness was reportedly inspected for fraying, discolouration and damages, the buckles and their connections were inspected, and the lanyard was checked for fuzzy, worn, broken or cut fibres.

At the time of the accident, the injured seafarer was wearing the appropriate PPE required for the task *i.e.*, a hard hat with a chin-strap, overalls, safety gloves and safety shoes. In addition, as mentioned earlier, he had worn a safety harness, which was secured to rope ‘B’.

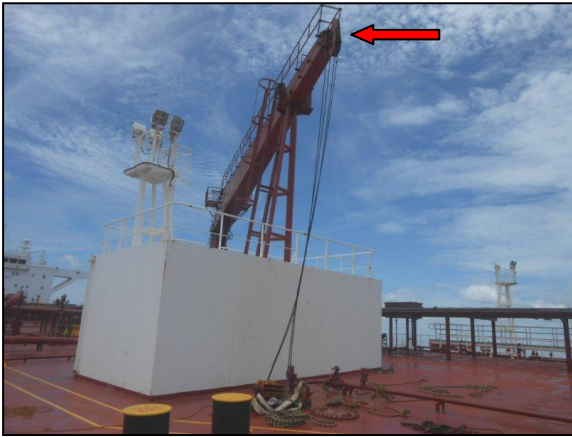
Figure 11: The hose handling crane

A twist in the runner wire of the crane, which was noticed earlier, was also planned to be rectified during the maintenance. The rectification of the twist required disconnection of the end of the wire which was secured to the head of the jib (marked with the red arrow in Figure 11) and would, therefore, require work to be carried out while being suspended from a height.

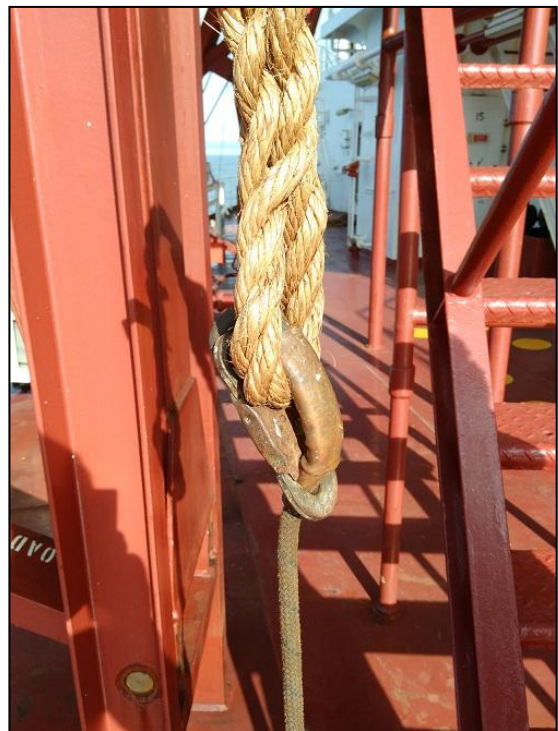
Figure 12: Simulation of safety harness secured to rope B during maintenance.

The equipment was rigged (Figure 6) following which, the bosun, who was the assigned team leader, conducted the final checks of the work area and of the PPE. At 1035, the bosun descended onto the bosun's chair, wearing a safety harness secured to rope 'B' (Figure 12). In order to enable access to the secured end of the crane's wire,
