SAFETY INVESTIGATION REPORT

REPORT NO.: 10/2020

FV ZAIRA

Foundering in Marsascala Bay

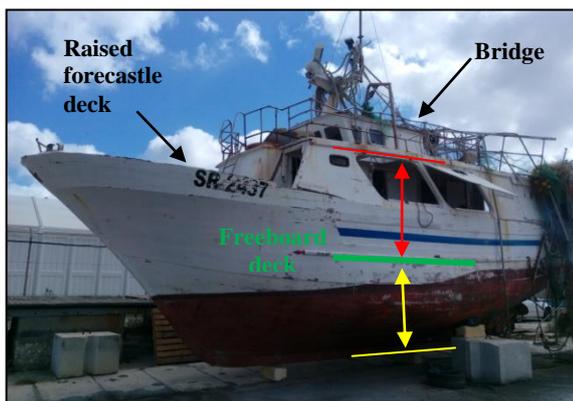
Zaira had a length overall of 14.25 m, a moulded depth of 1.78 m and a moulded breadth of 4.18 m. The vessel was of a wooden construction, having a freeboard deck, a raised forecastle deck, a bridge and a sheltered deck (Figures 1 and 2). The bulwark was estimated to be two metres high on either side, having large openings on her port side and small side scuttles on her starboard side.

Figure 1: *Zaira*, from her port side. The moulded depth is indicated in yellow, and the bulwark is marked in red

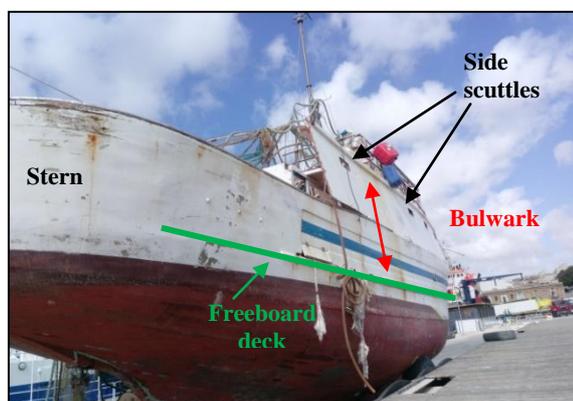
Figure 2: *Zaira*, from her starboard quarter

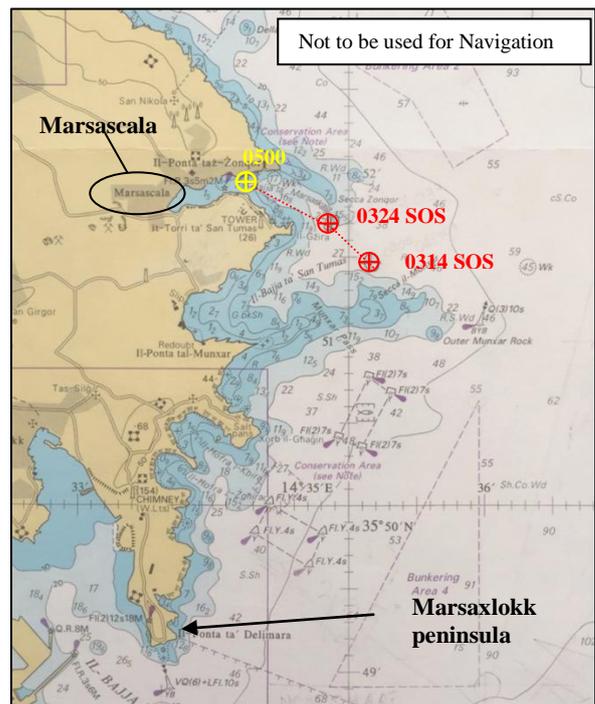
At 0314, the Italian authorities received the first SOS⁹ from *Zaira*. At that time, she was approximately 0.5 nm from the nearest land and moving in a Northwesterly direction (Figure 5). The skipper, seeing the distressing situation that the vessel was in, pressed the emergency button on the vessel monitoring system for 12 times in a time span of 10 minutes. The mechanic, who was on the bridge at the time, was reportedly seen by the skipper to jump overboard as soon as it was apparent that the vessel was sinking. Eventually, the skipper was forced to leave the bridge, due to the rising waters.

Figure 5: The first SOS position recorded at 0314 and the last SOS position recorded at 0324. Position at 0500 shows the final position of *Zaira* as it rested on the bottom of Marsascala Bay

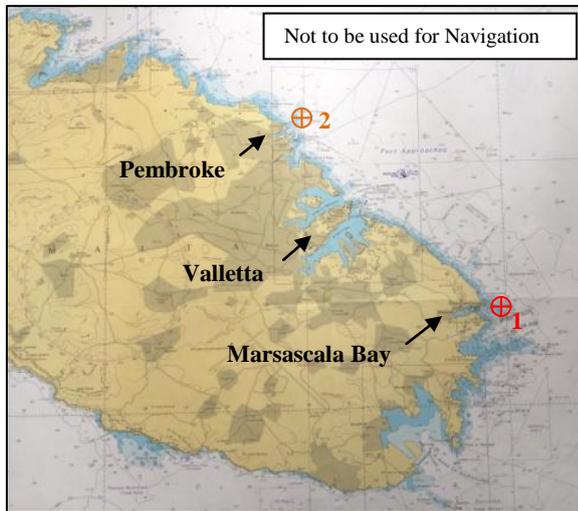
The search and rescue for the Italian mechanic remained active by sea, land and by air for almost 15 hours, until he was located at 1911, approximately eight nm from the accident location. He was confirmed dead soon after recovery.

Figure 6: Position 1: location of first SOS and approximate position 2: location where the body of the mechanic was found

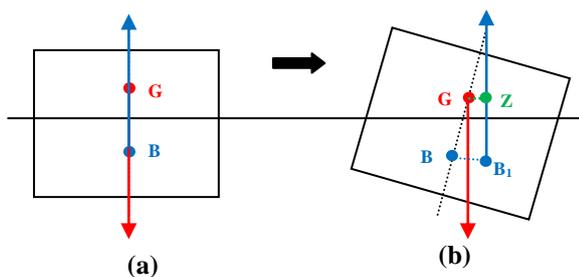
When a vessel is floating upright in still water, the centre of buoyancy (B) and the centre of gravity (G) will be on the same vertical (imaginary) line, acting in opposing direction (Figure 18a). When a vessel is heeled by an external force, such as waves, the shape of the underwater section of the vessel would change, causing the centre of buoyancy (B) to shift in the direction of the heel, to a new position (B₁). With the centre of gravity (G) acting downwards and the centre of buoyancy (B₁) acting upwards, this will create a righting lever (GZ) which will try to bring back the vessel to the upright position (Figure 18b).

Figure 18: (a) the vessel in an upright position and (b) the vessel heeled to one side with B₁ indicating the shift in the centre of buoyancy

However, when there is a loss of buoyancy, such as when compartments have been flooded, the righting lever would be insufficient to bring the vessel back to the upright. Generally, smaller vessels are unable to cope with large waves.
