National Transportation Safety Board

Marine Accident Brief

Collision Between Fishing Vessels *American Eagle* and *Koorale*

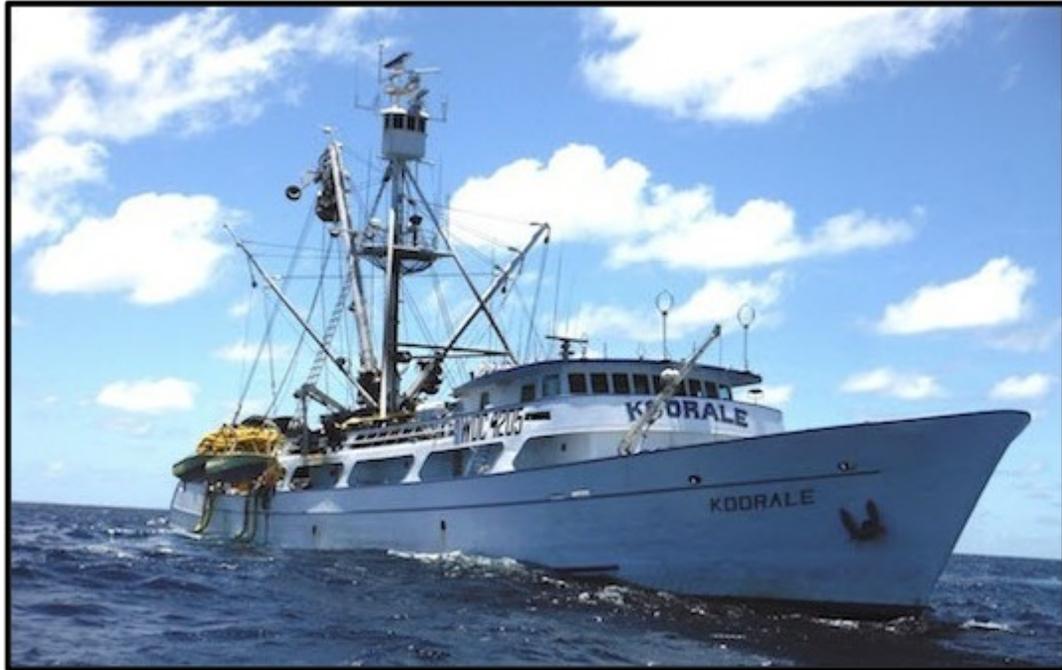
Koorale under way prior to collision. (Source: sdtunaboats.com)

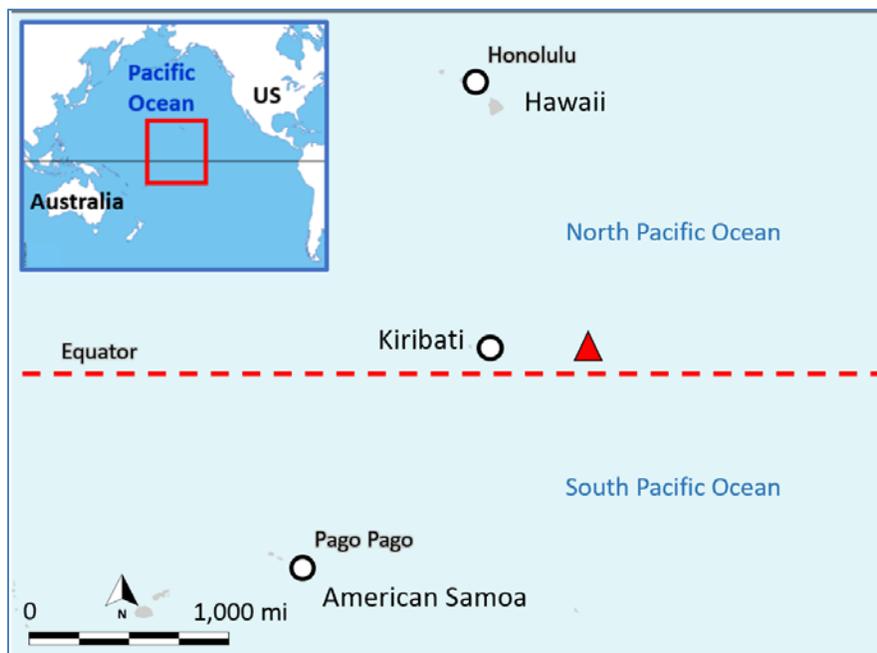
Area of accident where the *American Eagle* and *Koorale* collided, as indicated by the red triangle. (Background source: Google Maps)
