**REPORT INTO AN INCIDENT
INVOLVING THE
'FV DILLON OWEN'
OFF ARDGLASS HARBOUR
23rd OCTOBER 2019**

**REPORT NO. MCIB/295
(No.5 OF 2020)**

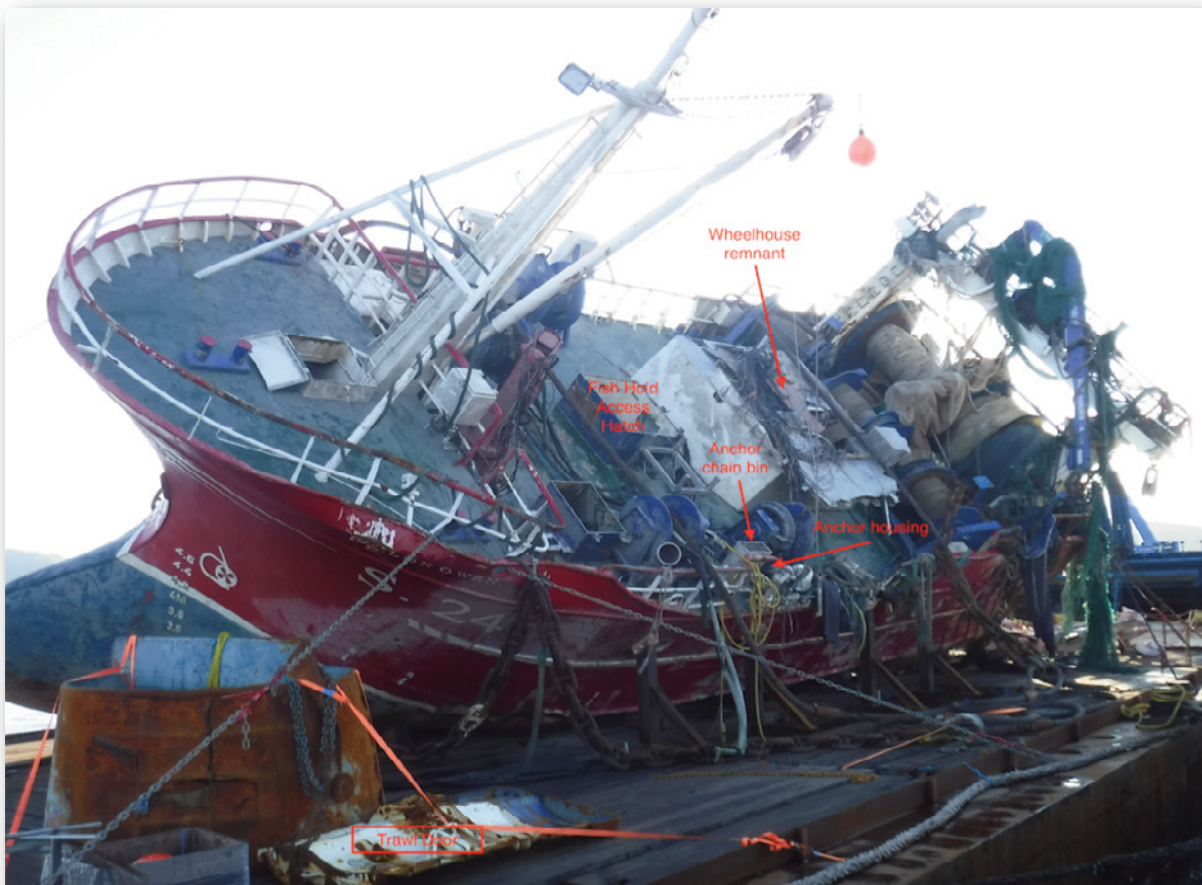
(see Appendix 7.1 '*FV Dillon Owen*' Photograph No.2).

Photograph No.2 - 'FV Dillon Owen' wreck as lifted off the seabed.

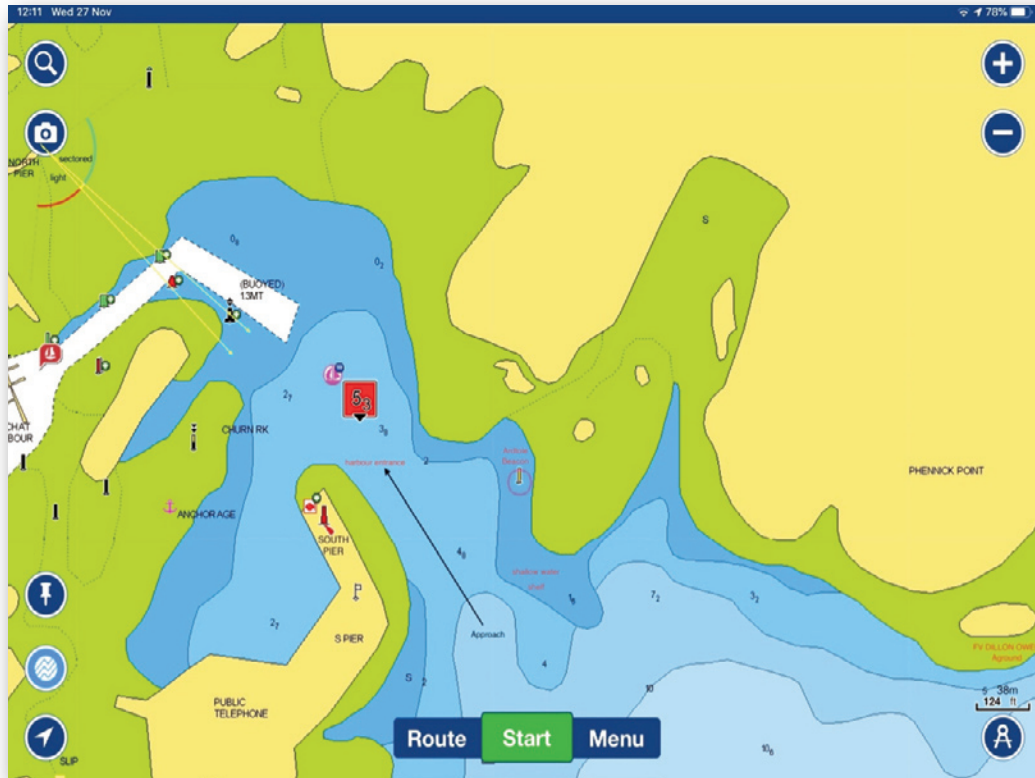
(see Appendix 7.3. Fig.4 Ardglass Harbour and Approaches (chart) and Fig.5 '*FV Dillon Owen*' - AIS track.)

Fig.4. Ardglass Harbour and Approaches (chart).
