National Transportation Safety Board

Marine Accident Brief

Fire at Jackson County Park Marina

Accident type	Fire/Explosion	No.	DCA20FM013
Vessel/Marina name	<i>Dixie Delight</i> /Jackson County Park Marina, Dock B		
Location	Lake Guntersville/Tennessee River, Scottsboro, Alabama 34°38.24' N, 086°00.82' W		
Date	January 27, 2020		
Time	0035 central standard time (CST) (coordinated universal time - 6 hours)		
Injuries	8 deaths, 1 serious injury		
Property damage	>\$500,000 est.		
Environmental damage	An estimated 4,000 gallons of fuel and lube oil were released and consumed during the fire.		
Weather	Visibility 3 miles, overcast, calm; air temperature 41°F, water temperature 41°F; morning twilight 0619, sunrise 0645, evening twilight 1734, evening sunset 1707		
Waterway information	A dam on the Tennessee River at mile 349 creates 75-mile-long Lake Guntersville in northern Alabama. The water depth reported around the marina was 8-10 feet.

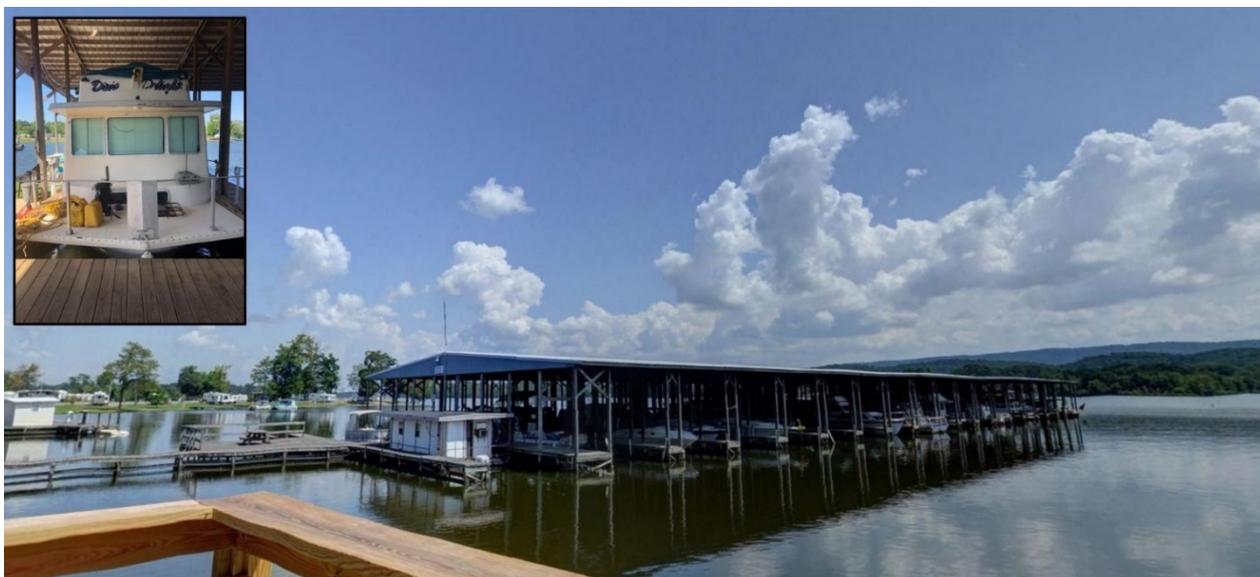
Jackson County Park Marina Dock B (Source: Google Maps). An inset of the *Dixie Delight* in the upper left (Source: A. Utech, via Facebook).

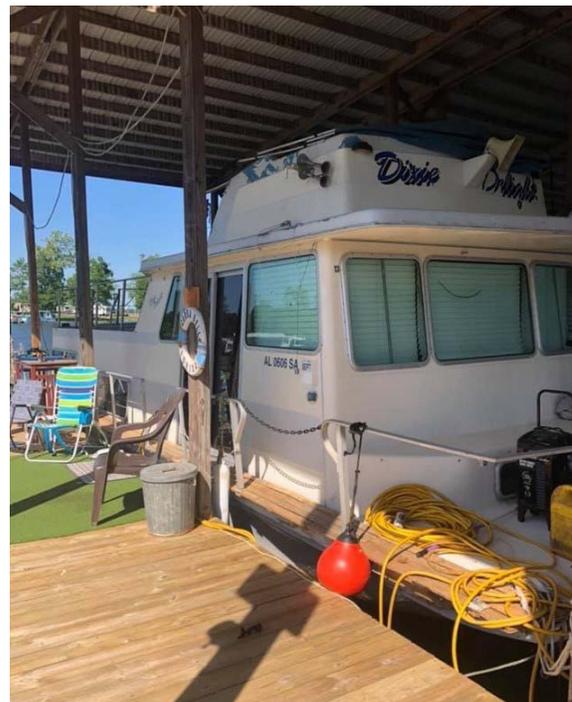
Dixie Delight tied to slip #36 at Jackson County Park Marina prior to the fire. (Source: A. Utech, via Facebook)
