Fire Aboard Small Passenger Vessel *Conception*  
Platts Harbor, Channel Islands National Park,  
Santa Cruz Island, 21.5 miles South-Southwest of  
Santa Barbara, California  
September 2, 2019

**Marine Accident Report**

NTSB/MAR-20/03  
PB2020-101011

National  
Transportation  
Safety Board

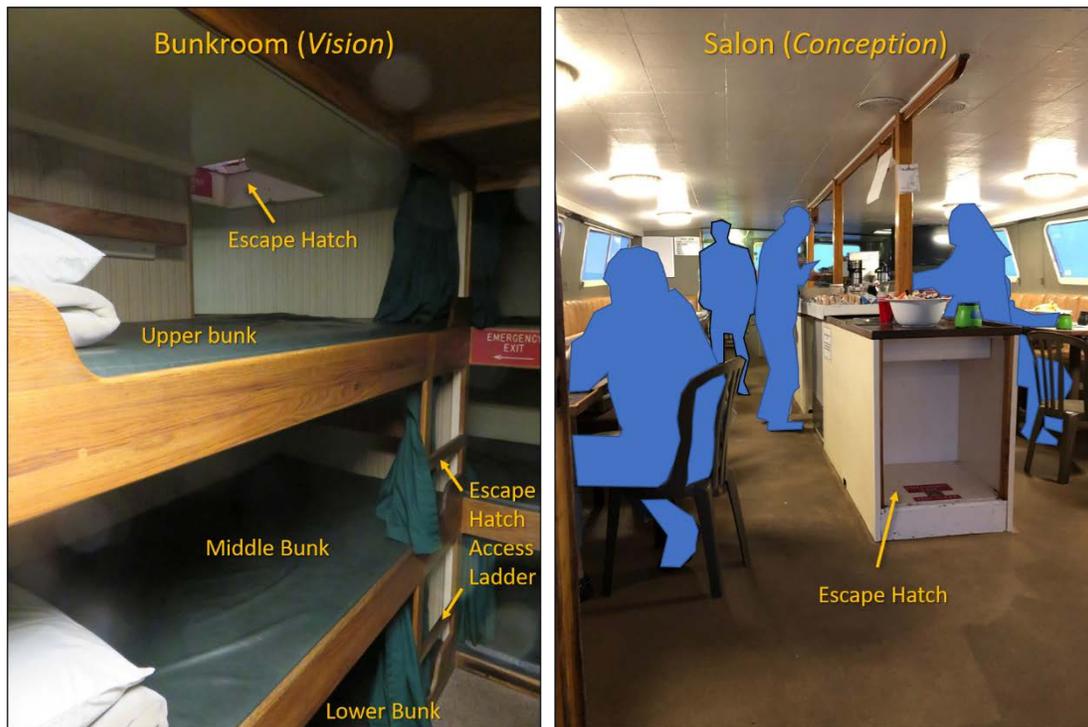
salon, and thus both escape routes from the bunkroom exited into the salon. The upper bunks nearest the emergency escape hatch had passengers assigned to them during the accident voyage.

**Figure 6.** Photo left is the escape hatch, viewed from the bunkroom, on the *Vision*, a Truth Aquatics dive vessel with arrangements nearly the same as the *Conception*. (Source: NTSB) Photo right, taken during a previous voyage, shows the escape hatch, viewed from aft in the salon, on the *Conception*. (Source: J. Palmer, annotated by NTSB)

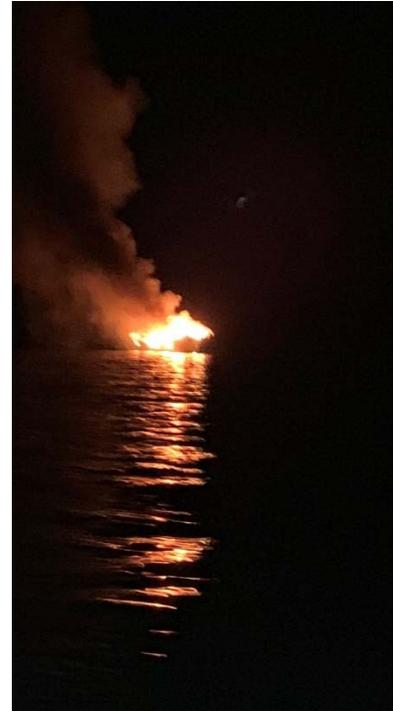
**Figure 10.** Cell phone photo of *Conception* on fire, taken from sportfishing boat *Grape Escape*. (Source: S. Hansen)

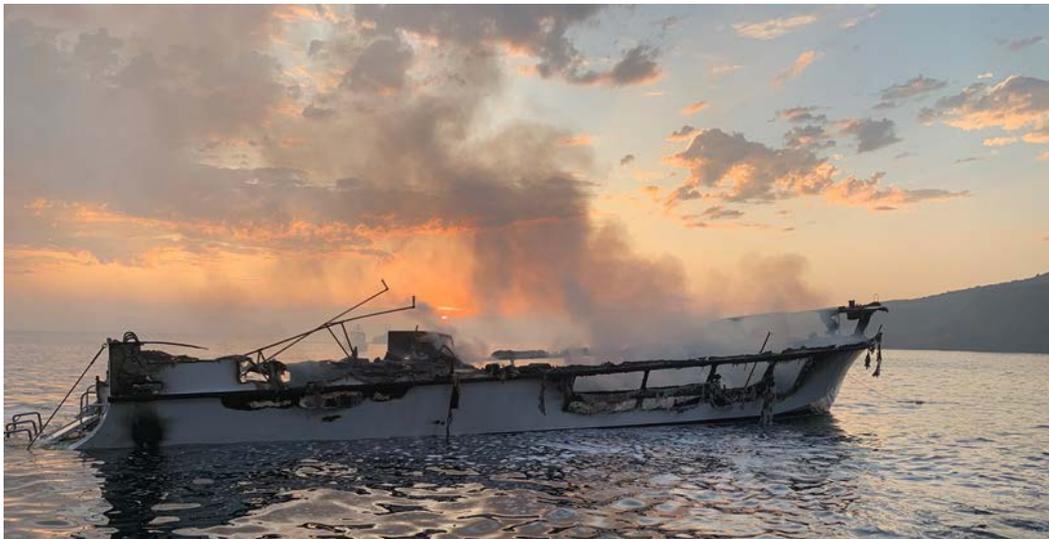
The fire was first reported extinguished at 0508 but re-flashed several times in the area of the fuel tanks and on the bow. Burned-out through-hull penetrations—where the main engine exhausts had been—eventually submerged, and the vessel sank stern first at 0654, approximately 20 yards from shore, in 61 feet of water. First responders were not able to safely board the vessel before it sank. Underwater recovery divers later found the wreckage lying on the seafloor in an upside-down position.

**Figure 12.** Small passenger vessel *Conception* at sunrise prior to sinking. (Source: VCFD)

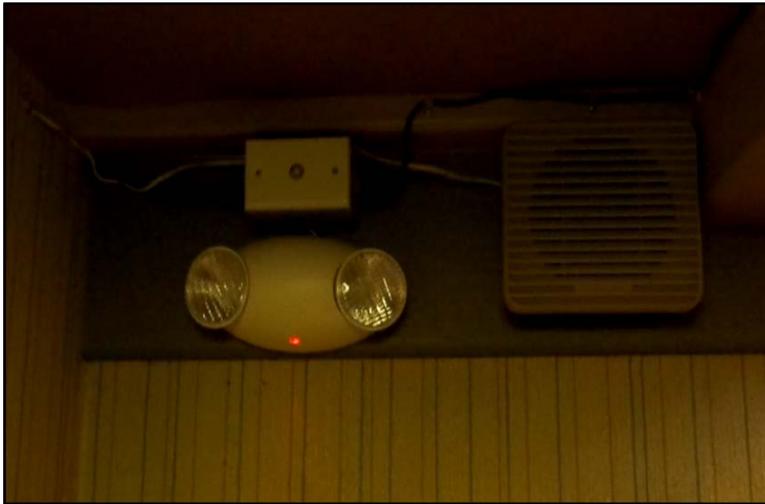
**Figure 14.** Bunkroom emergency lighting on board the similar vessel *Vision*. The lighting was of the same make and in a similar location as was on board the *Conception*. Also note the public address system speaker to the right of the lights.

**Emergency Lighting.** The *Conception* had emergency lighting in the bunkroom. It was mounted near the main stairs going up to the galley/salon at the top of the forward bulkhead of the bunkroom, and was designed to automatically activate, in the event of the loss of the vessel's service supply power, to provide lighting along the escape path to the main deck from accommodation spaces below. The emergency lighting was powered from the ship's service 120-volt AC system, and if this source was lost, batteries internal to the unit would supply power for lighting.

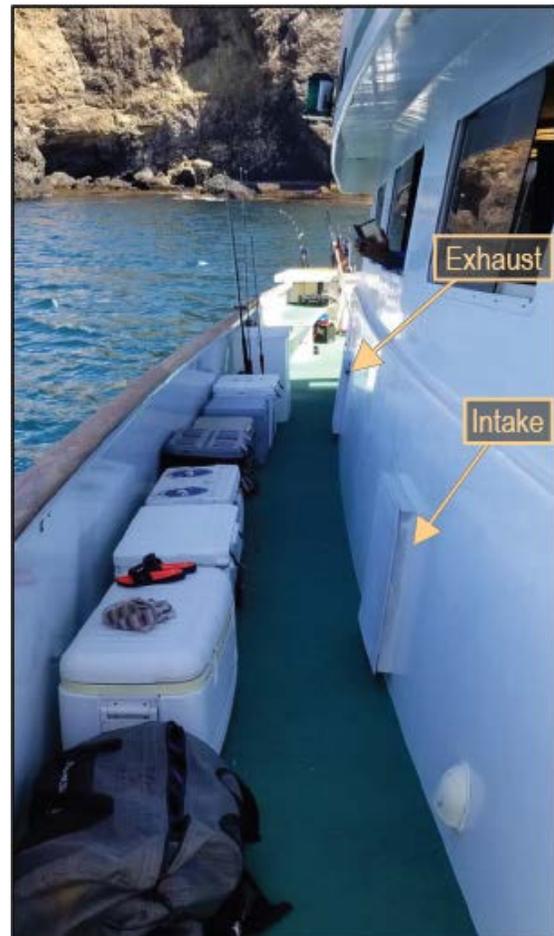
**Figure 15.** The starboard-side main deck of *Conception*, looking aft from forward of the galley. Arrows indicate the location of the bunkroom ventilation intake and exhaust ducts. Note the sliding windows. (Source: R. White)

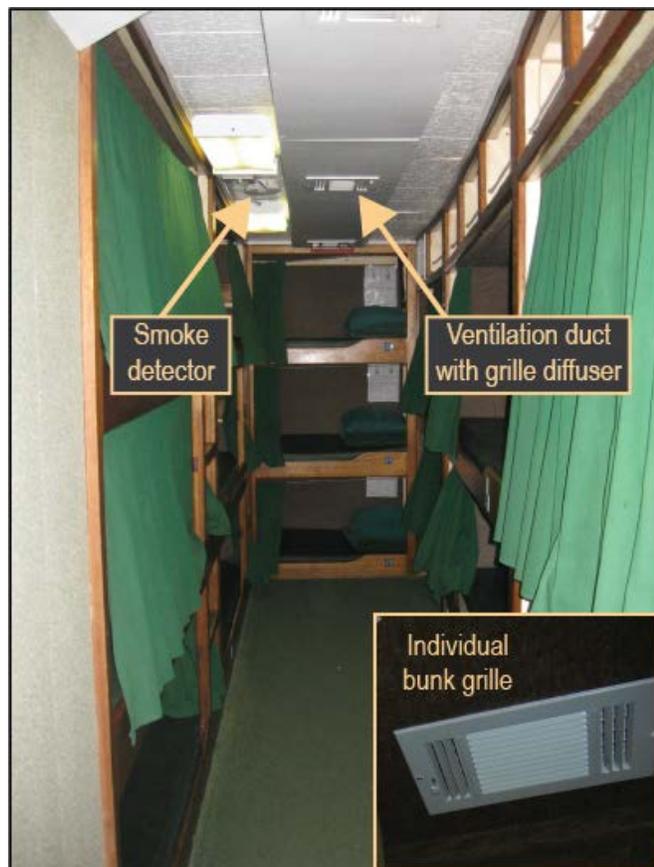
The bunkroom regularly used a combination of circulation fans and an air conditioning unit. The supply fan, located at the forward end of the space, drew air through ducting that originated 12 inches above the main deck. The ducting attached to air plenum boxes that were about 6–10 inches off the main deck. These boxes were located on both the port and starboard sides, just below the forwardmost side salon windows. Two exhaust fans, one located on each side of the aft area of the bunkroom, expelled air from the space to the main deck. The ducting for these fans led to identical plenum boxes, which were located aft of the intake plenum boxes.

**Figure 16.** Port side of the *Conception's* bunkroom looking aft, with inset of grille/diffuser. (Source: M. Ryan; Inset: S. Landis)

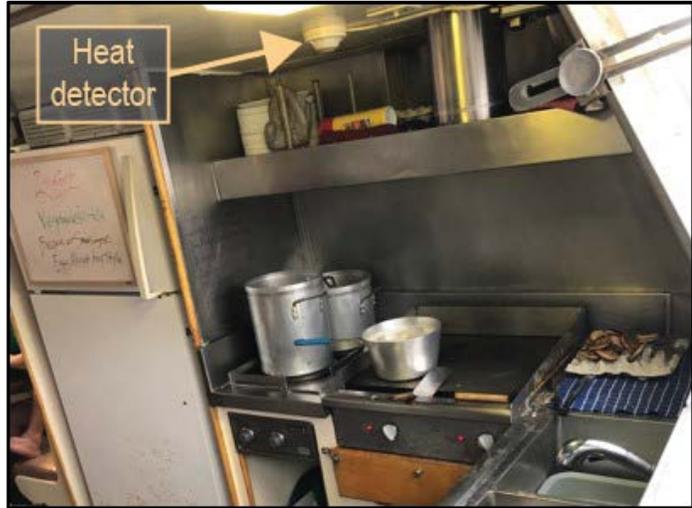
Neither Old T nor New T regulations required the salon and galley compartment to have smoke detectors installed. Heat detectors were installed in the engine room and galley. The smoke and heat detectors were not interconnected to other alarms or a central operating station in the wheelhouse. In the engine room, the heat detector, if activated, would initiate the carbon dioxide fixed fire-extinguishing system for the engine room. The galley detector was not connected to the range hood fan or any damper, nor was it required to be.

**Figure 26.** Photo of the galley of the *Conception* taken from the forward centerline window. (Source: NTSB eyewitness submission)

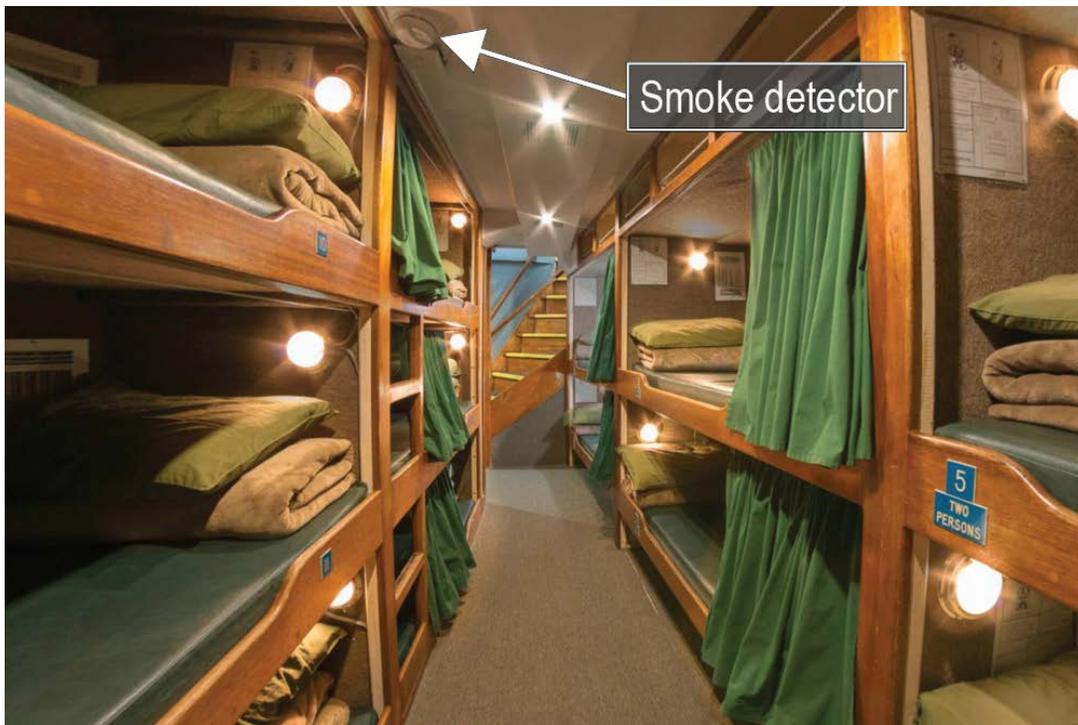
As required by 46 *CFR* 181.405(c), which applied retroactively to existing vessels with an overnight accommodation space, the bunkroom area contained two independent modular smoke detectors, installed in the overhead on the port and starboard aisles between the bunks. Investigators were informed by the vessel owner that the smoke detectors in the bunkroom were hardwired into the vessel’s electrical system, with a 9-volt battery backup. The smoke detectors were not interconnected to other alarms or a centralized system in the wheelhouse. Based on photos and video, the smoke detectors appeared to be common consumer-type smoke detectors, as specified in the regulations. The smoke detectors in the bunkroom were the only ones required to be on board. There were no additional smoke detectors installed on board.

**Figure 27.** Interior view of *Conception* bunkroom. (Source: Truth Aquatics; annotated by NTSB)

There were no requirements related to the testing and inspection of smoke detectors. The owner was aware that the bunkroom smoke detectors functioned properly less than a month before the accident voyage, when a contractor soldering on the air conditioning unit activated them. The owner told investigators that after the smoke detectors activated, the captain of the *Conception* “unplugged” them while the soldering was ongoing. When the work was completed, the smoke detectors were plugged back in, “fresh” batteries were added, and the detectors were tested. When asked whether there were routine inspections or testing of the smoke detectors on the *Conception*, the owner stated the captain was responsible for any inspections or testing.

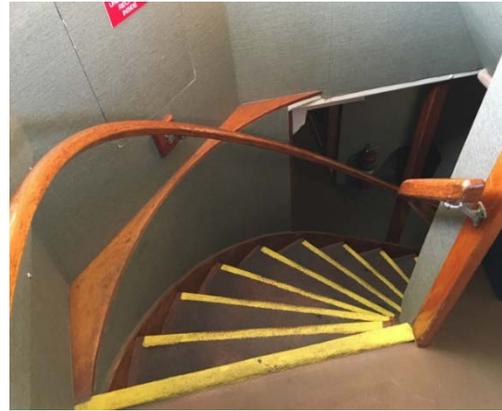
From the *Conception*'s bunkroom, there were two means of escape, both leading to the salon above: (1) the spiral stairs forward in the bunkroom ([figure 28](#)), and (2) the escape hatch installed centerline at the aft end of the bunkroom ([figure 29](#)). The hatch, marked with a two-inch plastic sign, was accessible from either aisle by climbing a wooden ladder, located in the corner where the aftermost middle and aft athwartship tiers of bunks were, onto the upper bunk; crawling to the centerline; and then pushing the plywood escape hatch up and out of the way. The hatch opened below the centerline countertop in the salon. Investigators measured the *Vision*'s escape hatch, which, according to the owner, was similar to the *Conception*'s escape hatch. The opening dimensions were approximately 22 inches by 22 inches through the main deck, with the aft-facing vertical opening having a clearance of about 35 inches from the main deck to the countertop above, or 28 inches from the top of the 7-inch main deck coaming. The two means of escape were at opposite ends of the bunkroom (so as to minimize the possibility of one incident blocking both escapes) and did not pass through a watertight door, thereby fulfilling the regulations applicable to the *Conception*. In the available documentation and inspection history of the vessel, no deficiencies or modifications were found related to the emergency escape hatch or the bunk ladders to the hatch.

**Figure 28.** Staircase from the main deck galley/salon leading down to the bunkroom on the *Conception*. (Source: NTSB eyewitness submission)

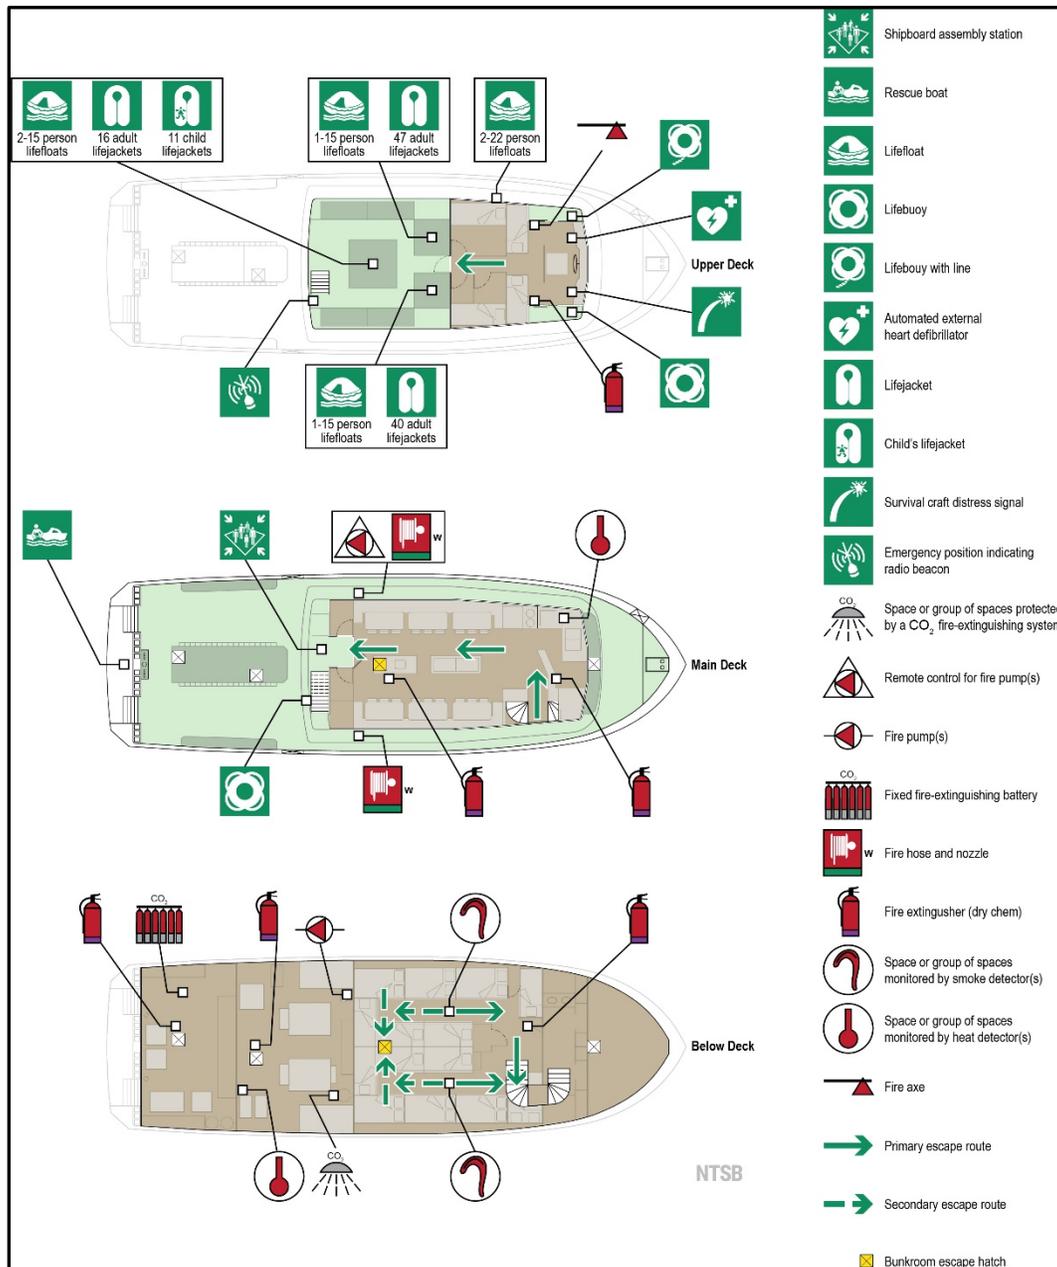
**Figure 30.** Locations of firefighting equipment, lifesaving appliances, and evacuation plan for the *Conception* at the time of the accident (compiled from the investigation and drawn by the NTSB).

The primary lifesaving appliances aboard the *Conception* included 6 various-sized life floats, with an aggregate capacity of 104, or 100 percent of the people allowed on board. All lifesaving appliances were located either on the upper deck or on top of the wheelhouse.
