Report on the investigation into a serious injury on board

mv MINERAL TEMSE

at the South Atlantic Ocean with one victim on May 5<sup>th</sup> 2020.

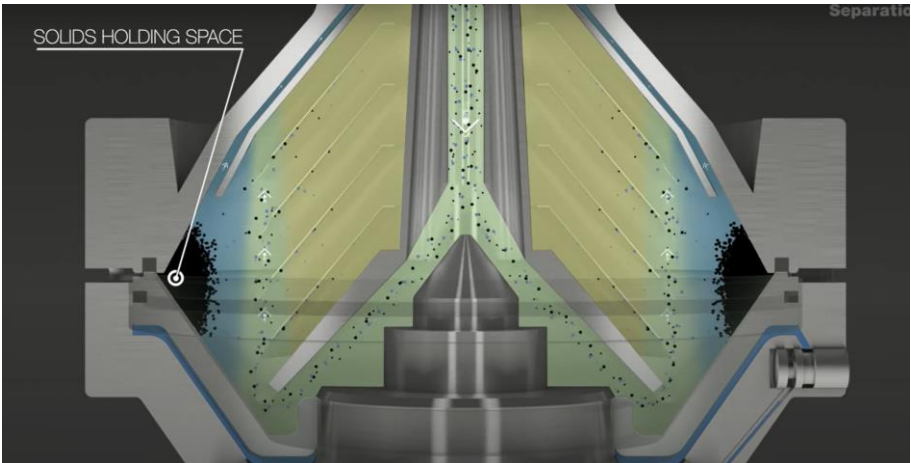
Figure 9 - Sludge accumulated inside the separator

During the cleaning process of the fuel oil in the separator, solids were accumulated on the outer side of the separator bowl due to the centrifugal force. This is represented in Figure 9. The sludge discharge opening is closed.

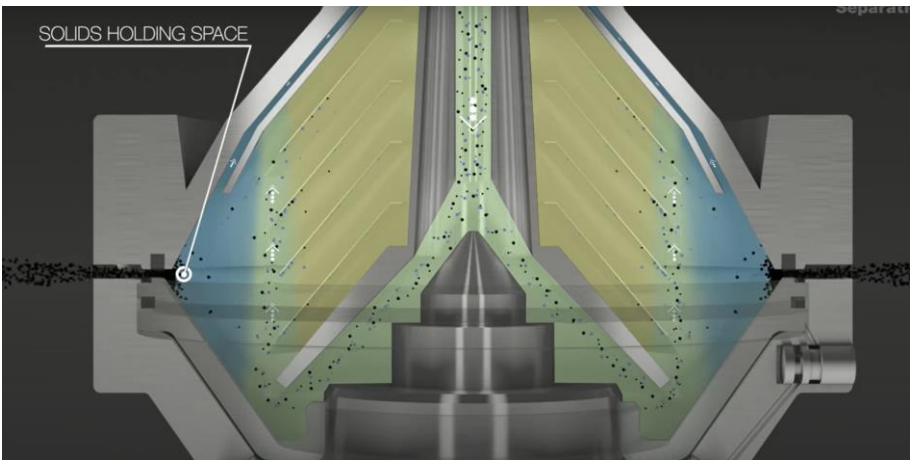
Figure 10 - Sludge discharge phase of a separator

Figure 10. Solids and water flow into the sludge discharge line.

When the discharge line is blocked, sludge can no longer be removed from the bowl and the bowl becomes contaminated. When that happened, an alarm was triggered. In this case a *Separator Fail* alarm and a *FO Bowl Leakage* alarm were triggered.

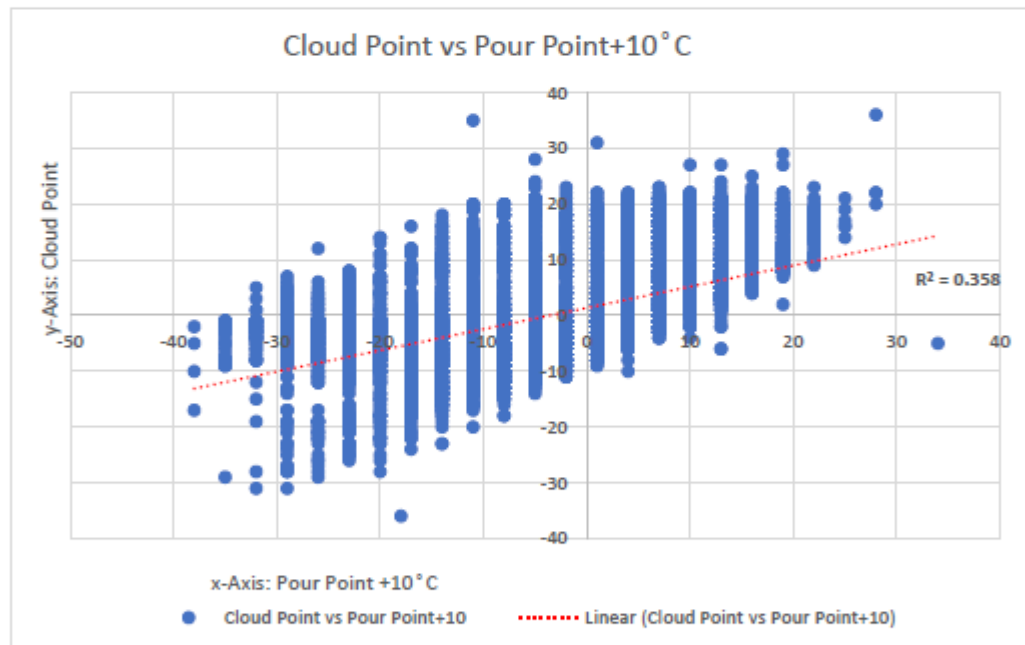
Figure 1 - Correlation of Cloud Point Vs Pour Point on Distillate Samples

Many distillate samples have been measured for both cloud point and pour point over the past few years by VPS. A graphical representation of the correlation between cloud point and pour point on distillate samples has been produced below. This data (>15,000 data points) shows a poor correlation with a measure of  $R^2=0.358$ , as indicated in the graph below. This demonstrates that pour point is a poor indicator of the cloud point (i.e. wax formation temperature) of fuel. This is perhaps unsurprising since pour point is affected by additives in the fuel, whereas cloud point is not as this is a fundamental fuel property.

The cold-flow properties of HFO are based on pour point because there are currently no methods available to measure cloud point due to opacity, and CIMAC guidance is to maintain a temperature at pour point+10°C to prevent problems. However, there is no correlation between pour point and cloud point as indicated in Figure 1 above. This illustrates the need for an accurate method for the measurement of cloud point in opaque fuels.

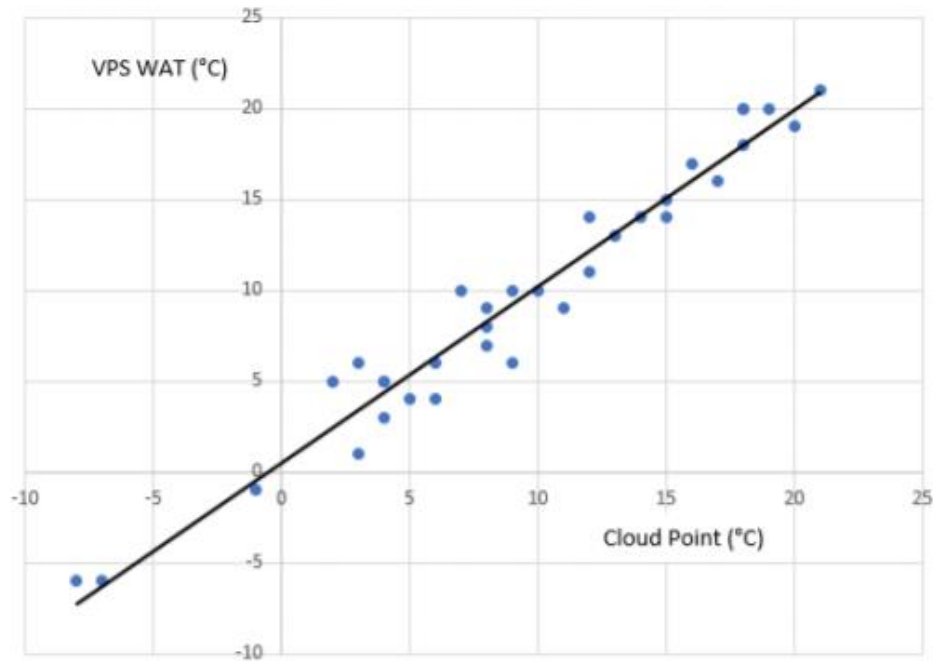
Figure 3 - Graph of WAT Using Method VPS (VPS-LP1307) Versus Cloud Point

In addition to the WAT, the method provides a measurement of the WDT. This is very useful as it is the temperature at which the last wax solids are melted into liquid when the oil is warmed. As such it provides an indication of the temperature that the fuel must be heated to in order to fully dissolve any wax solids that have precipitated.

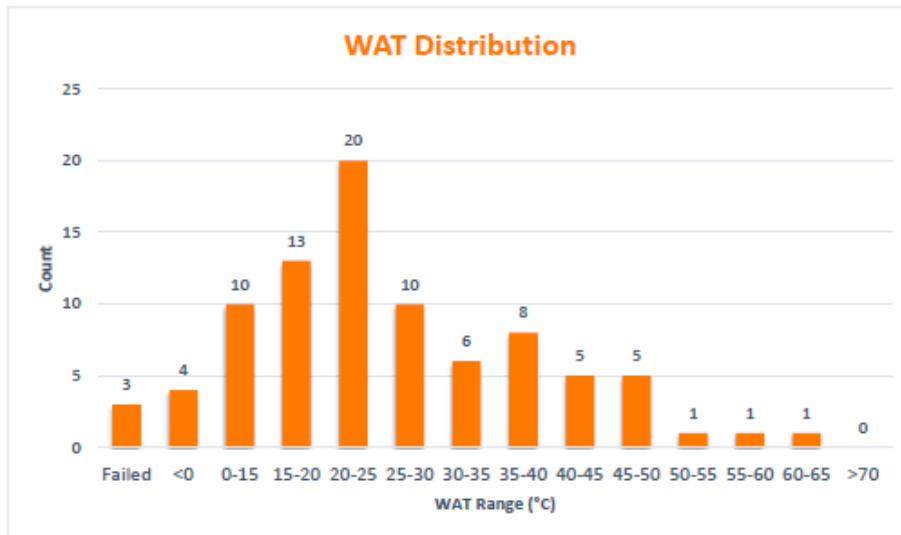
Figure 4 – Graph of WAT Distribution for VLSFO Fuels Bunkered to Date in 2019

A number of VLSFO samples (87 in total) bunkered over the past few months across ports in Singapore, Rotterdam, Houston and Fujairah have been tested using the new method. The graph below shows the spread of results. The WAT point results show a very wide range for VLSFO fuels already on the market and a number of these are at elevated temperatures. This demonstrates the importance of measuring WAT for the VLSFO fuels. The WDT results indicate the temperature that these fuels would need to be heated to in order to melt all wax solids if the fuel temperature has fallen below the WAT causing waxing.
