## MARINE TRANSPORTATION SAFETY INVESTIGATION REPORT M19P0029

### GROUNDING

Search and rescue vessel (*Spirit of Sooke*)

Christie Point, Sooke Harbour

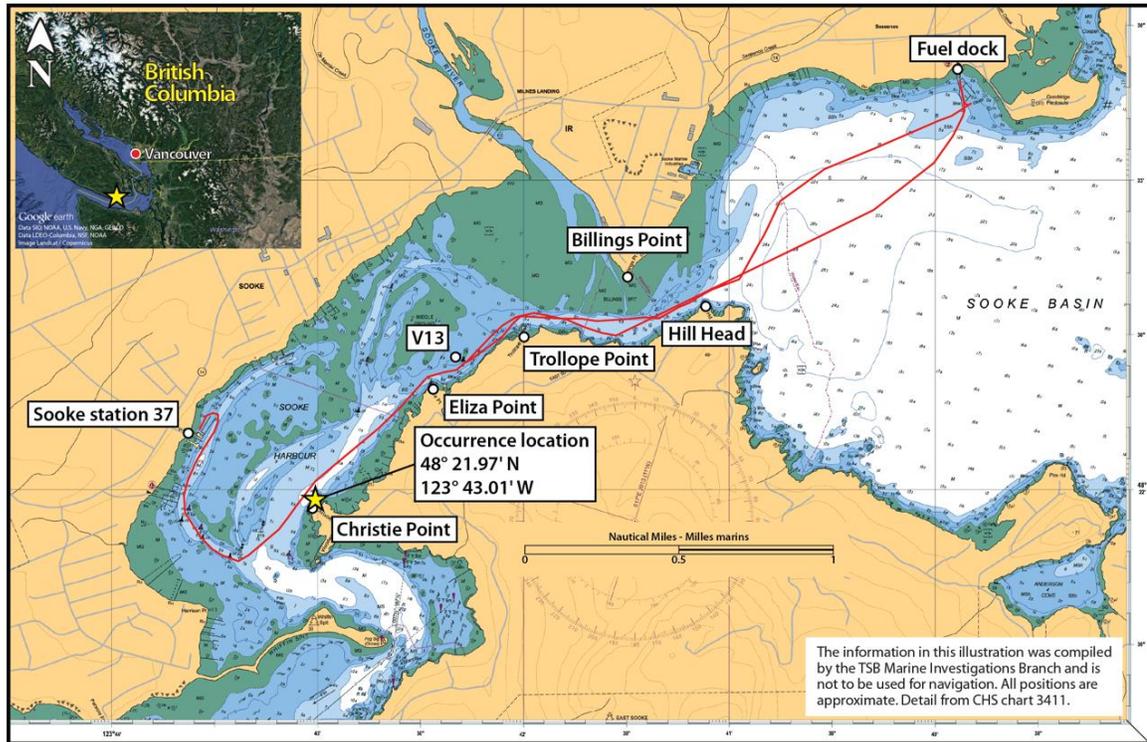
Figure 3. Area of the occurrence and the *Spirit of Sooke's* route (Source: Canadian Hydrographic Service with TSB annotations)

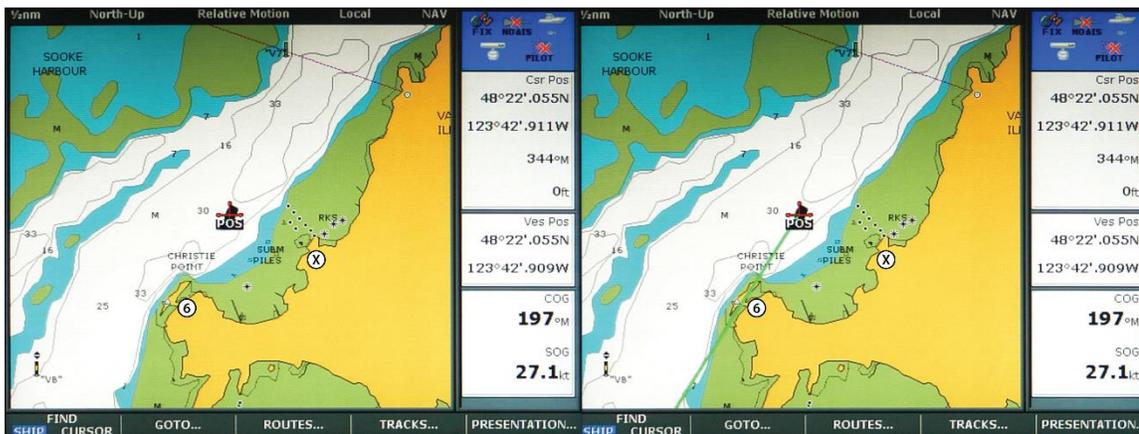
The coxswain consulted the chart plotter to cross-check the vessel's position. However, the plotter's usefulness was impeded because the course line, which projects the vessel's course into the future, was not enabled (Figure 11), and the orientation of the plotter differed from that of the radar. Because a plotted route and effective cross-checking of the vessel's position were not done, the likelihood of detecting that the vessel's course was not clear of Christie Point was reduced. Figure 12 shows what the chart plotter would display with the vessel's course line enabled.

Figure 11. Chart plotter with vessel's course line not enabled (Source: TSB screenshots of RCMSAR simulation videos; annotations by TSB)

Figure 12. Chart plotter with vessel's course line enabled (Source: TSB screenshot of RCMSAR simulation videos; annotations by TSB)
