MARINE SAFETY INVESTIGATION REPORT

Safety investigation into the serious occupational accident on board the
Maltese registered heavy lift /pipelay vessel

PIONEERING SPIRIT

MARINE SAFETY INVESTIGATION REPORT NO. 02/2021

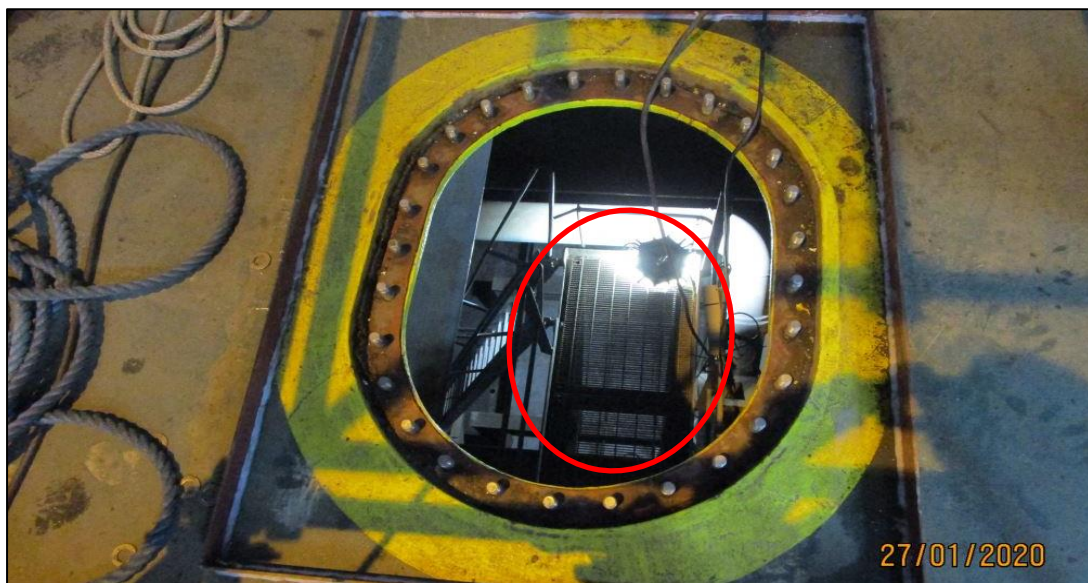
The accident happened inside WBT no. 1006, which was classified as an enclosed space. The tank, which was fitted on the vessel's starboard side just aft of the accommodation (with one side forming part of the vessel's outer hull), had a capacity of about 10,500 m³. Access to the WBT was through a manhole on the main deck. On the first platform, lighting had been fitted in preparation for the welding job in the tank, which illuminated the entire upper level of the WBT (Figure 8).

Figure 8: Access to WBT no. 1006 - First level platform with lighting installed marked

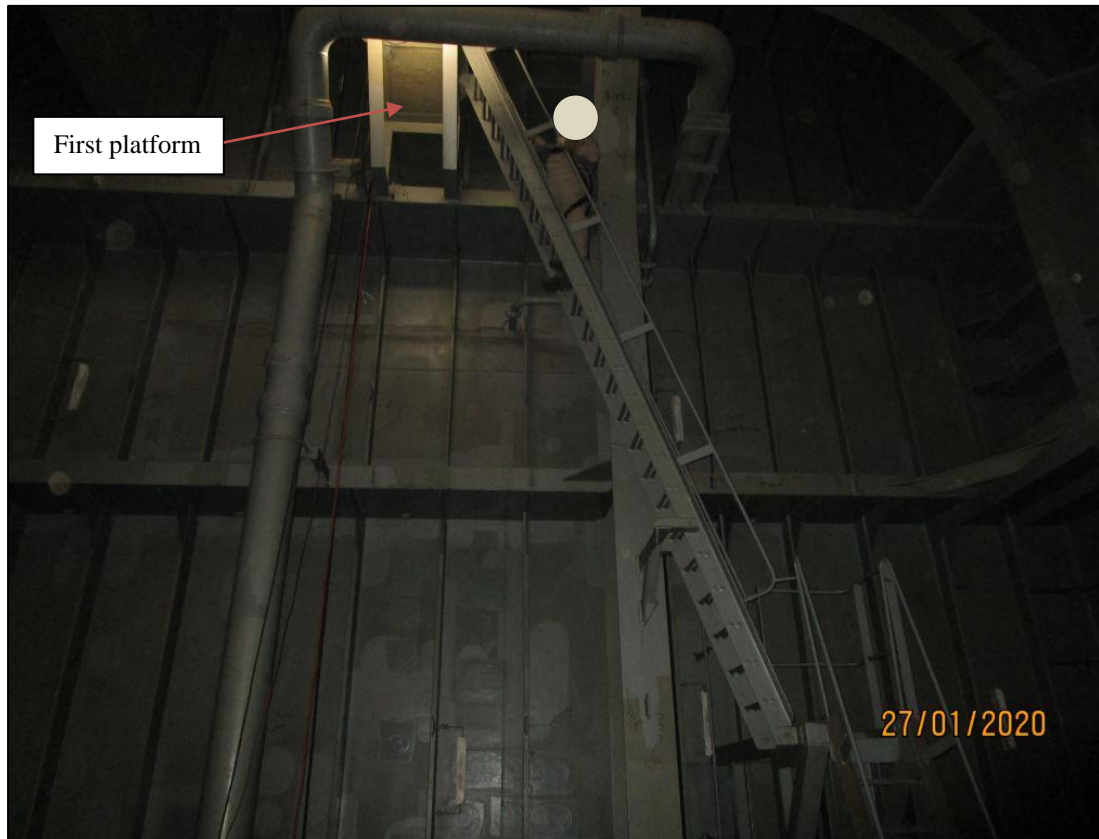
Inside the WBT, from the manhole, a vertical ladder led to the first platform, thence an access ladder with relatively steep steps led to the tween deck (Figure 9). The access ladder passed the trunk with approximately one metre of space in between (Figure 10), just before the ladder reached the tween deck. From the bottom of the stairs there was approximately five metres of passageway to an opening in the deck that led to the lower level of the tank (Figure 11), with another access ladder that led all the way to the bottom which was approximately 16 meters below. The five metres of passageway were bounded by a waist high guard rail.

Figure 9: Access ladder inside water WBT no. 1006

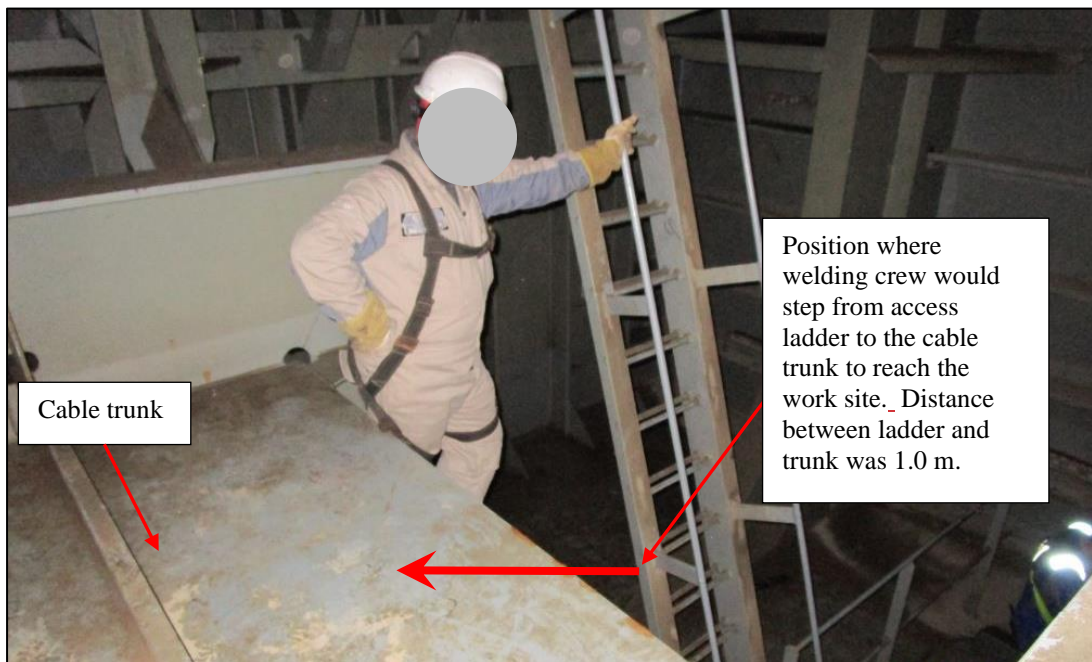
Figure 10: Access ladder passing cable trunk

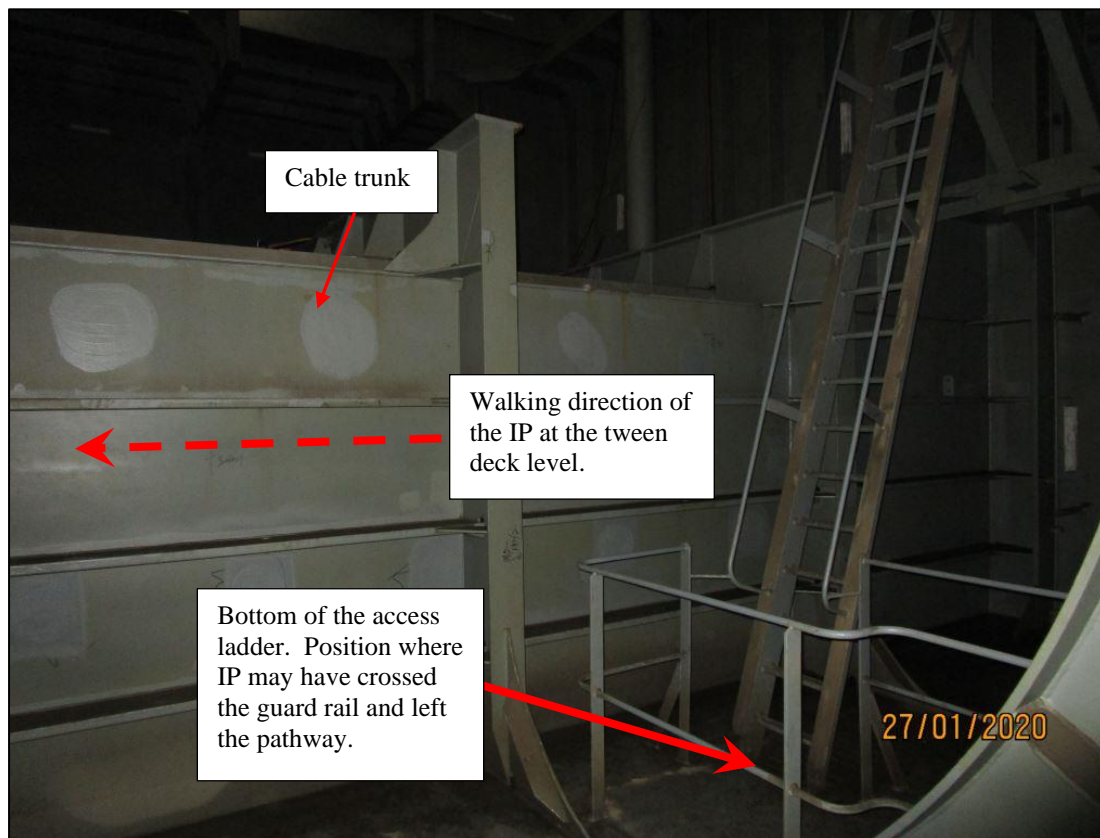
Figure 11: Access ladder ending at the tween deck

The IP deviated from the guided access inside the tank by crossing a guardrail which served as a barrier in between the access ladders and pathway, and the rest of the tank (Figure 11).. The IP fell through the opening in the deck on his way to the work site, landing on the bottom of the tank, a drop of about 16 m (Figure 15). The final location of the IP was slightly offset from the deck opening above, in an aft ward direction. This suggested that the IP was in motion and in the direction of the work site, when he fell through.

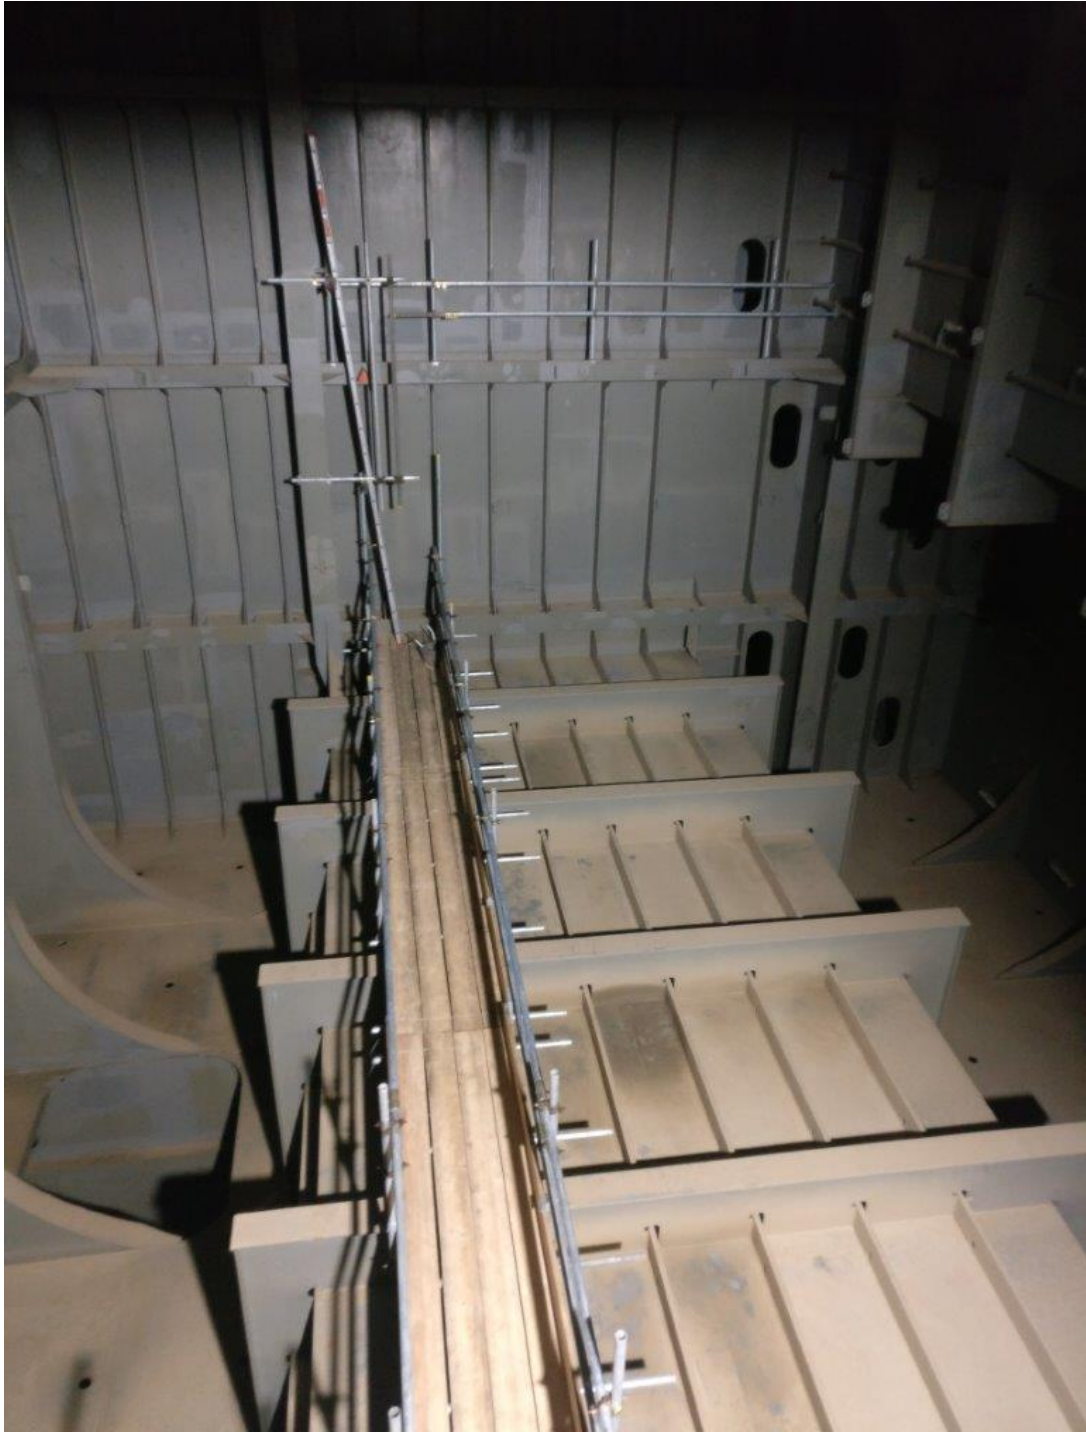
The previous work done at the work site, was done in Tenerife, during which a scaffolding was set up to provide access to the work site (Figure 13). A scaffolding was not erected for the welding job at the time of the accident, as this was considered to be a small and quick task.

Figure 13: Scaffolding during initial work in tank in October 2018

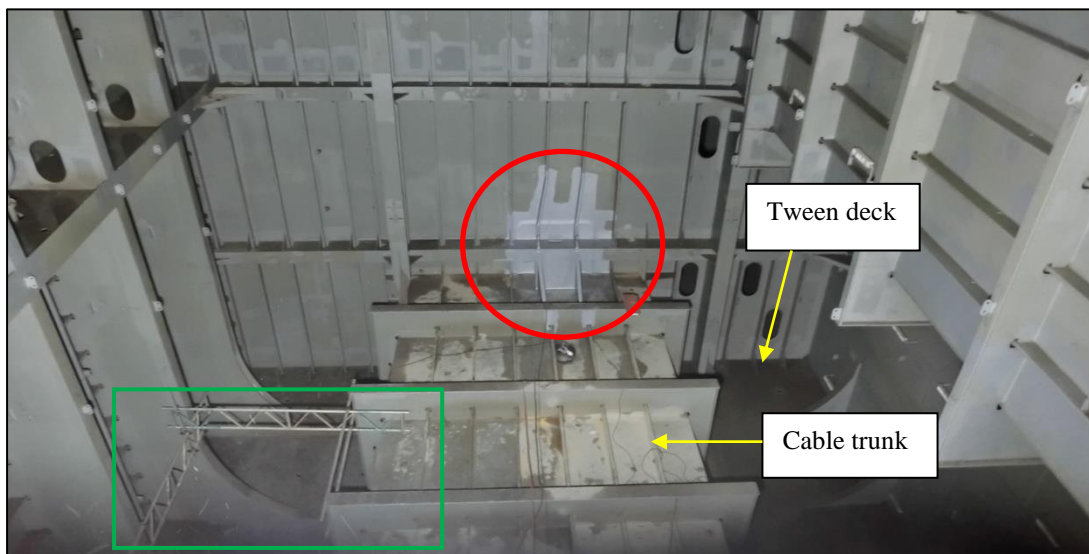
The welding job was to be carried out at the aft bulkhead on top of a large cable trunk, located on the tween deck of the tank structure (Figure 5), which the welder⁶ had stepped on to, from the access ladder. When the IP started lowering the hoses from the welding machine, the welder grabbed and dragged them to the work site. At this time, the two crew members that were inside the tank had visual contact with each other. After that, the welder observed the IP making his way down the second access ladder, and then he turned around, and started to mark where the stiffeners had to be welded on to the sheave-block assembly reinforcement.

Figure 5: View inside of the WBT. Position where stiffeners were to be welded on, marked in red. Scaffolding (marked in green) was rigged during the recovery of the IP
