**MARINE ACCIDENT
INVESTIGATION REPORT**

Vessel type and name: Cargo vessel JIA DE

Accident/Incident type: Foundering

Date and time: Around 21:39, October 12, 2019 (local time, UTC+9 hours)

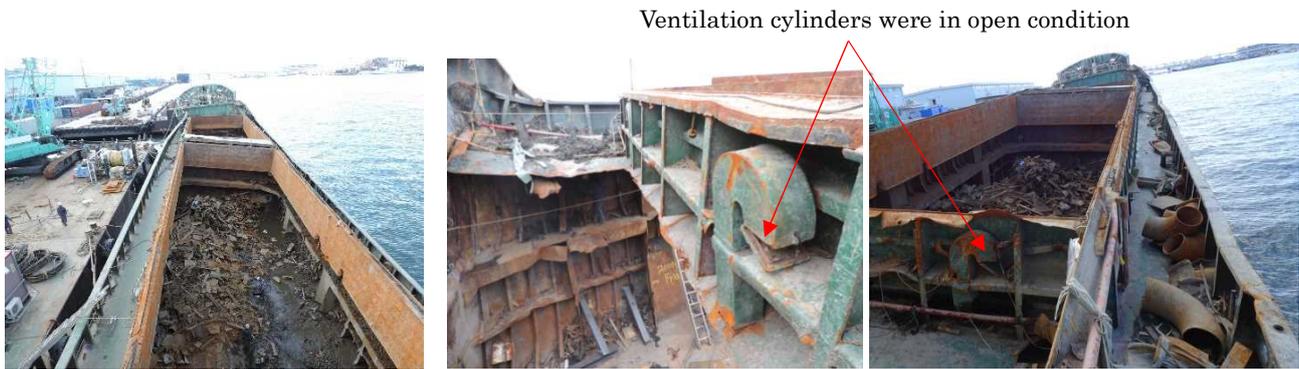
Figure 4 Cargo Holds and Ventilation Cylinders

When the Vessel was recovered, some lids of the opening parts of the ventilation cylinders were not tightened by the stopper devices, the stopper devices and the butterfly nuts were loosened fully on the screws, and thereby the four opening parts were in an open condition at least. The cross-sectional shape of the opening parts of the ventilation cylinders was a square where the length on one side was 200 mm.

Ventilation cylinder of No.1 cargo hold fore port side

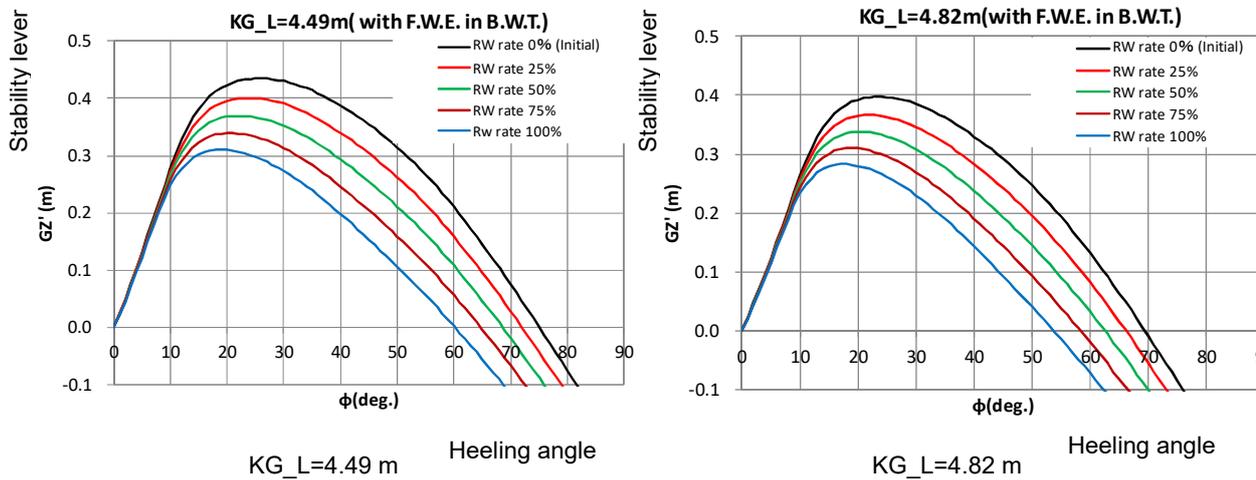
Figure 12 Curve of Stability (Influence of the Retained Water)

The results of analysis for the curve of stability, etc. in case of there being the Retained Water on the upper deck are as shown in Figure 12. The results show that as the height of the weight center is raised, the metacentric height and the stability become lower. However, it

could not be said that the influence of the Retained Water becomes high, even though the metacentric height in the case of a Full Retained Water ratio of 100 % (Full condition) was less than approximately 7 % (GM1=1.34 m, GM2=1.25 m) of the initial condition (GM1=1.44 m, GM2=1.35 m), and thereby it is assumed to be highly probable that the Vessel had significant residual stability, even though she experienced wave uprush and the Retained Water being on the upper deck due to upcoming sea water.

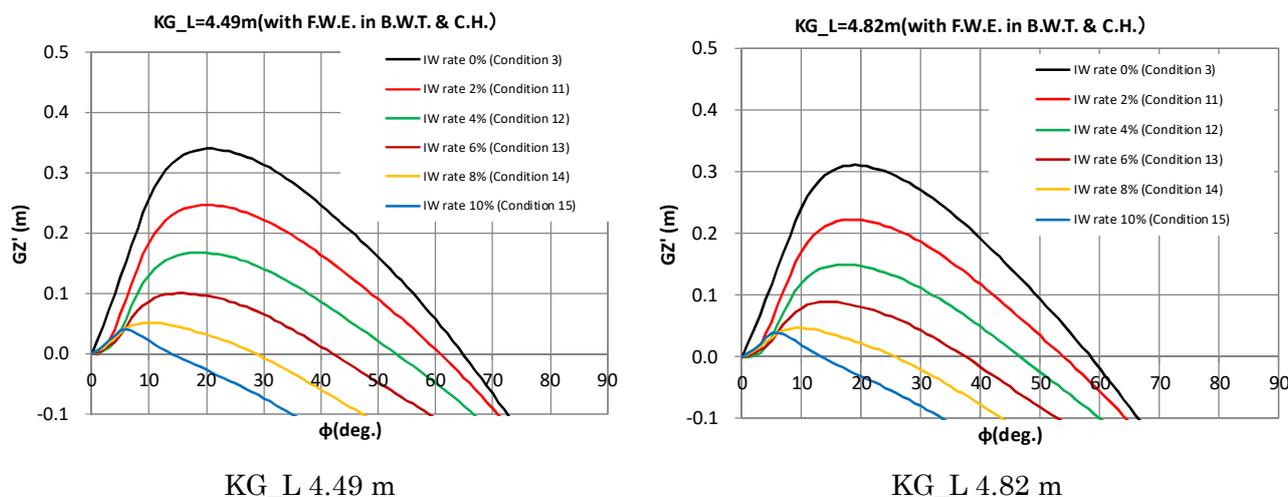
Figure 13 Curve of Stability and Hull Condition (Influence of Ingress Water in Cargo Holds)

In case of estimation of flooding due to taking on sea water into the interior of the cargo holds, the metacentric height was reduced significantly due to the large influence of free water movement in comparison with the case of no ingress water in the cargo holds. For example, in the case of Condition 11 (KG_L=4.49 m, IW ratio 2 %), the metacentric height (GM1) was

0.07 m, and the value was 5 % of the metacentric height in Condition 3 in which there was no ingress water in the cargo holds.

As shown in Figure 13, in the case of there being ingress water in the amount of 8 % of the volume of the cargo holds, the Vessel had fallen into a condition of readily rolling over if the heeling angle exceeded the peak of stability, which was approximately 10° , and furthermore, stability was zero when the heeling angle was between 25.5° and 28.5° in such a case of receiving gusts of wind due to the typhoon, and thereby she was in condition of not avoiding rolling over due to the action of a slight moment.

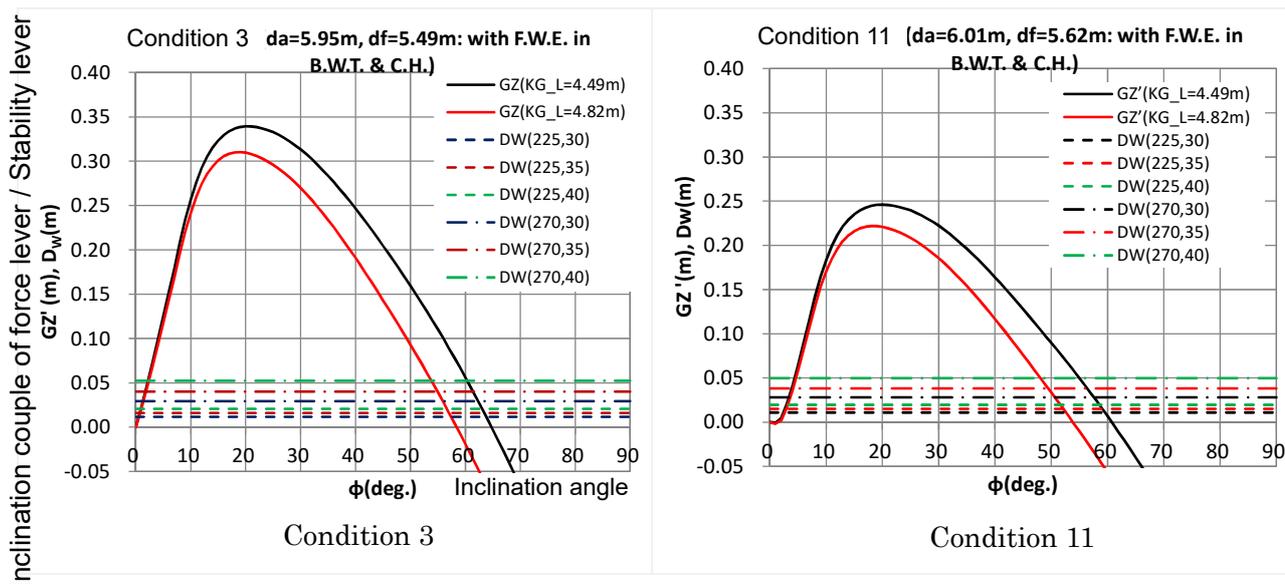
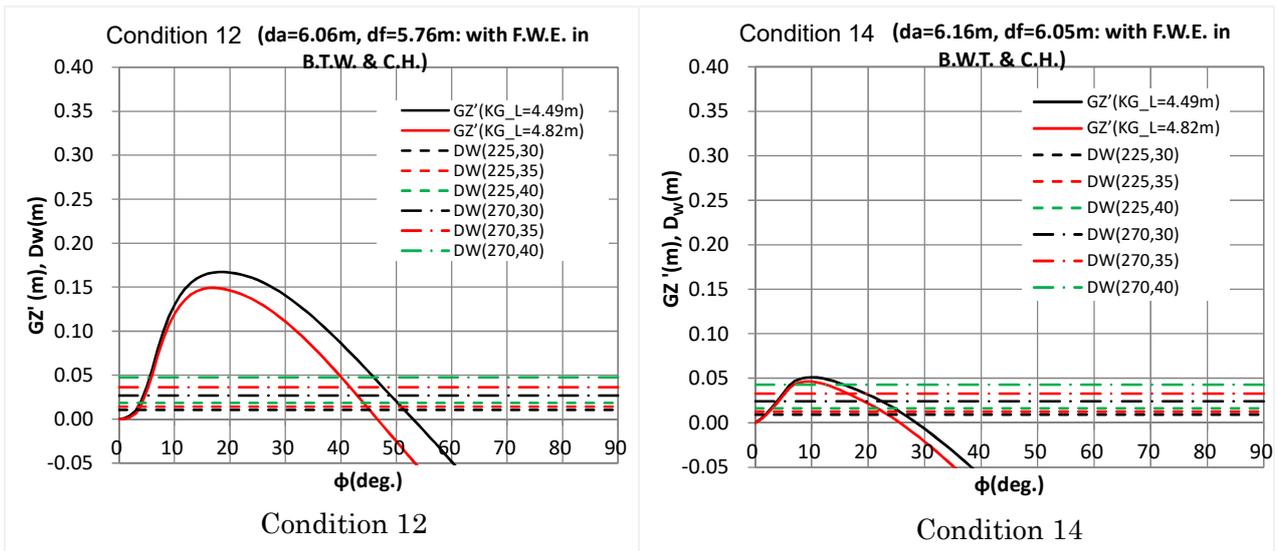
Figure 14 Stability and Heeling Couple of Force Lever due to Winds

The stability and the heeling couple of the force lever of Conditions 3, 11, 12 and 14 are as shown in Figure 14, and the notation shown as “DW(225,30)” in the Figure means the heeling couple of the force lever in the case of the heading of the Vessel being 225° and wind speed being 30 m/s.

As mentioned above, the greater the ingress water in the cargo holds increased, the lower the stability GZ and the heeling couple of the force lever decreased, and thereby the more the reduction in stability is remarkable. Therefore, the residual stability, which responds to the upper part above the heeling couple of the force lever D_w line parallel to the horizontal axis of the stability curve GZ indicated by a solid line in Figure 14, was greatly reducing accompanied by increasing flooding due to taking on sea water into the cargo holds. The effective stability was almost lost in the condition of an ingress water ratio of 8 % (Condition 14), in the case of the heading of the Vessel of 270° and wind speed of 40 m/s (heeling couple of force lever: green dashed line), even if her KG_L was at 4.49 m. (See Figure 14)

- (4) In accordance with 2.11.3 (4) i), the lateral heeling moment increases as wind speed rises, and ingress water increases as stability reduces. In Figure 14, in the case of receiving wind with a wind speed of 30 m/s in Condition 11 and Condition 12, and even though the Vessel had still secured stability, in the case of wind of a similar wind speed in Condition 14 (a Retained Water ratio of 75 % and ingress water ratio of 8 %), the range of stability on the line of heeling couple of force DW (270, 30) was at approximately 19° in KG_L 4.49 m and was at approximately 15° in KG_L 4.82 m. She could not avoid rolling over due to the action of a slight moment when these ranges of stability were exceeded.

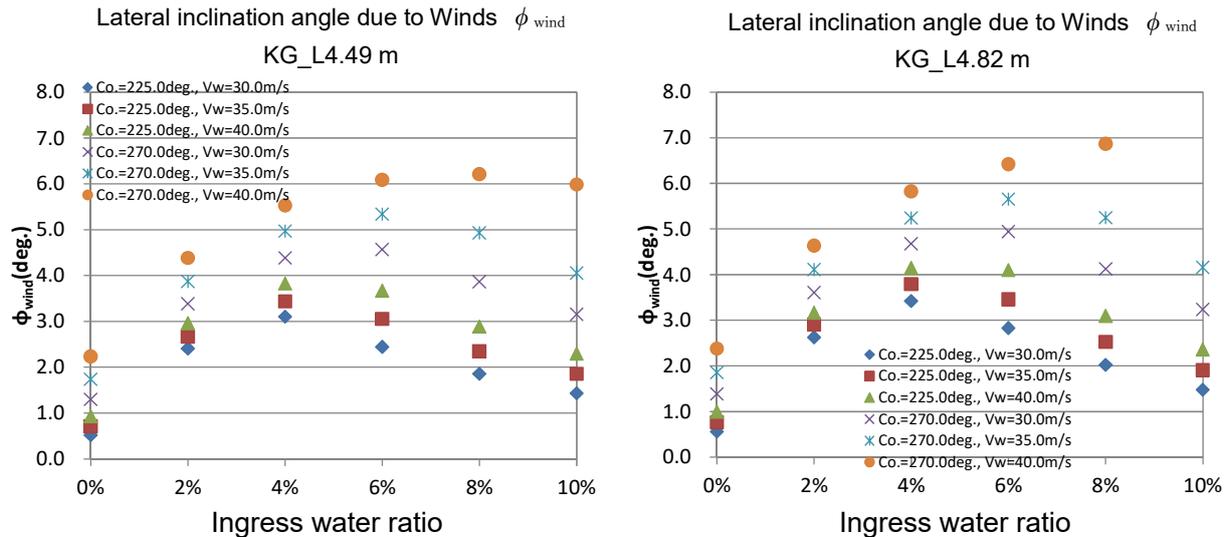
Figure 15 Condition of Ingress Water into Cargo Holds and Heeling Angle Due to Winds

The results for the estimated heeling angle due to winds in the case of Conditions 11 to 15 is shown in Table 14, and the condition of ingress water in the cargo holds and the condition of the heeling angle are shown in Figure 15. The cells shaded with gray in the table show that the heeling angle due to winds indicates a condition of exceeding the angle of the discharging holes of the bulwark being submerged into sea water.

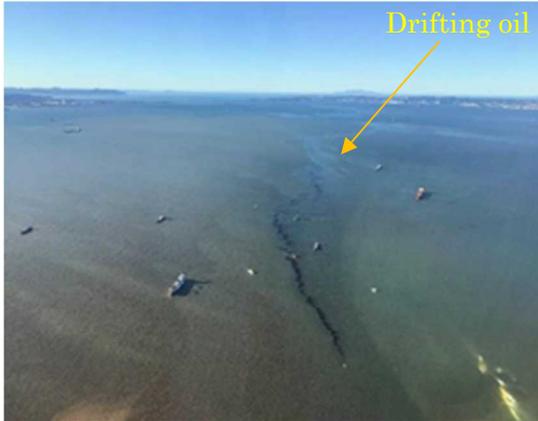
At around 09:00 on October 13

Circumstances of the accident location

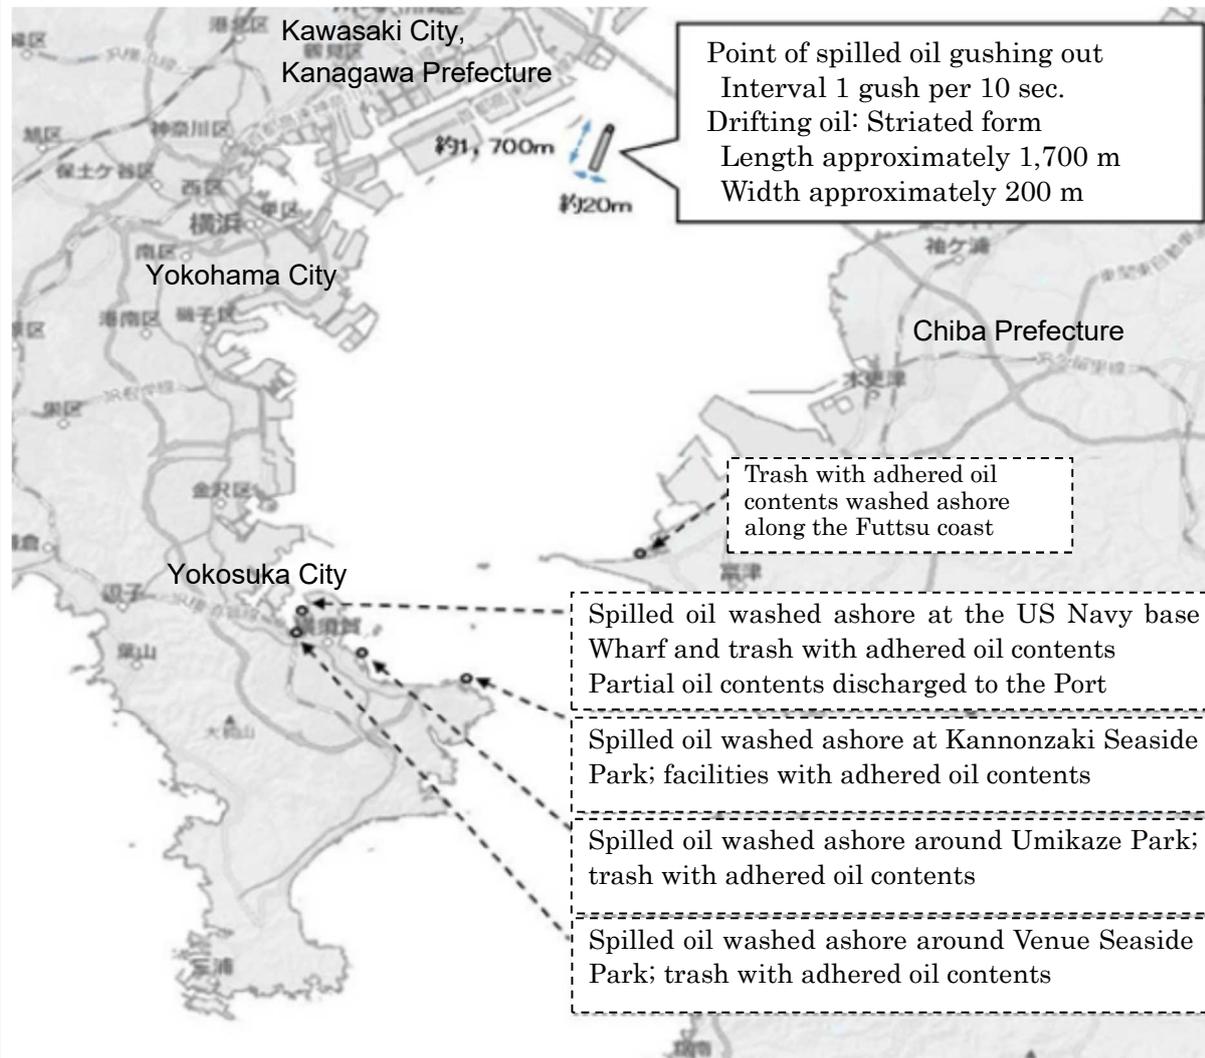
Time & Date: Around 06:35, October 18

Circumstances of drifting oil in Tokyo wan

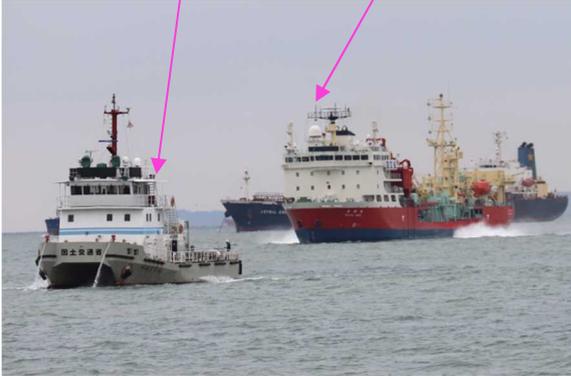
<p>Circumstances of drifting oil at around the accident location (i)</p>

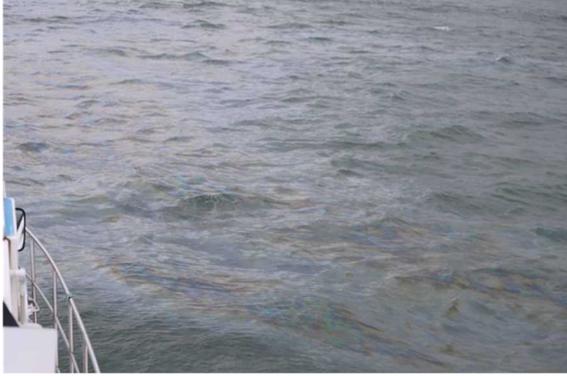
<p>Circumstances of drifting oil at around the accident location (ii)</p>

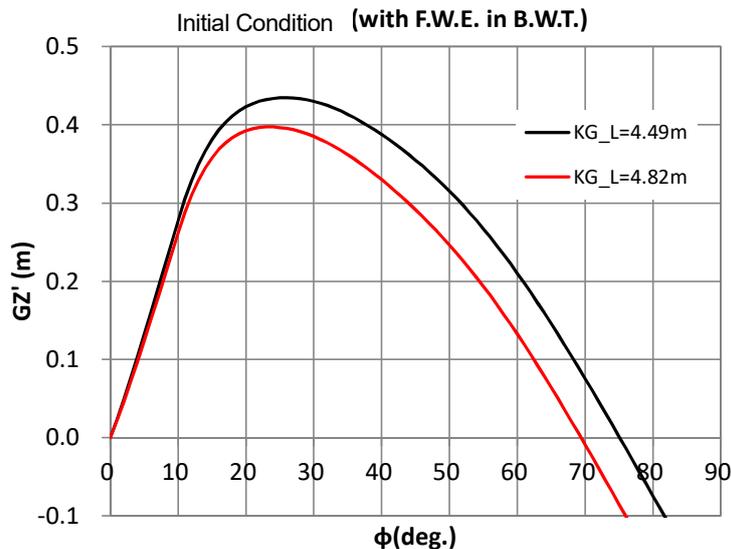
Figure 1 Stability Curve (Initial Condition)

When the height of the center of gravity under the light loading condition KG_L is 4.49 m, the Vessel's metacentric height (GM1) under the Initial Condition is 1.44 m, the maximum stability (GZ_{max}) is approximately 0.44 m, and the lateral heeling angle at which the maximum stability occurs (ϕ_{max}) is approximately 26 deg. The free water effects of any liquids other than the ballast water were not considered in this calculation, because the volumes of the tanks containing those liquids were unknown. Meanwhile, treating the free water effect of the ballast water as a virtual rise of the center of gravity may result in an overestimation of the free water effect at higher lateral heeling angles, because the amount of ballast water was relatively small compared to the volume of the ballast tanks (Table 3).¹⁾ For this reason, the free water effect of water in each ballast tank was taken into account as a change (due to heeling) in the center of gravity of water contained in a hypothetical tank that has a plane with the same length and area as the plane of the actual tank (i.e. a hypothetical tank that has an approximate rectangular plane). The plane shape and height of each actual tank were determined based on the general arrangement plan.

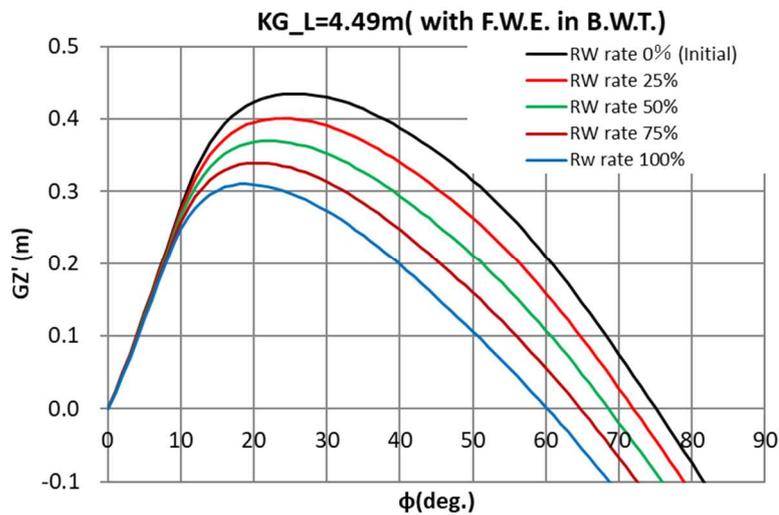
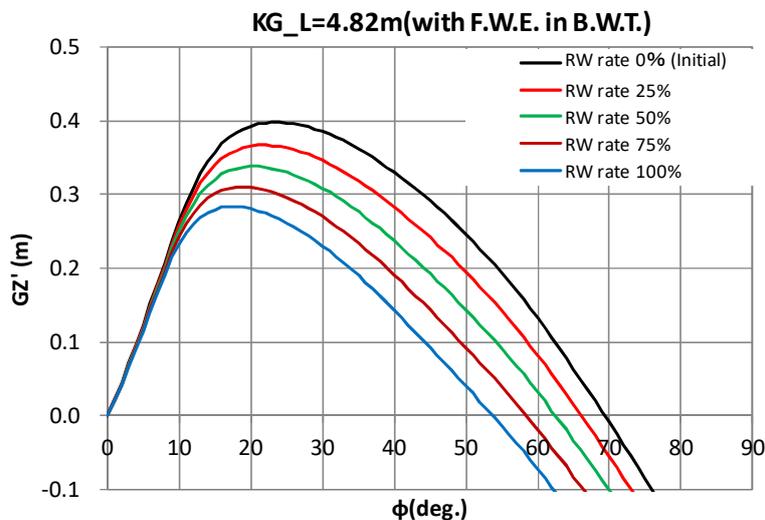
Figures 2 and 3 and Tables 6 and 7 show that with increase in Retained Water, the vertical position of the Vessel's center of gravity rises and its longitudinal position shifts toward the center of the hull, which results in a decrease in the trim by the stern, metacentric height, and stability. However, even when the passages on the upper deck are filled with sea water to the top (Condition 4), the volume of Retained Water is only about 210 tf (approximately 5% of the displacement under the Initial Condition) and the metacentric height decreases only by about 7% (GM1 = 1.34 m and GM2 = 1.25 m under Condition 4, as compared to GM1 = 1.44 m and GM2 = 1.35 m under the Initial Condition).

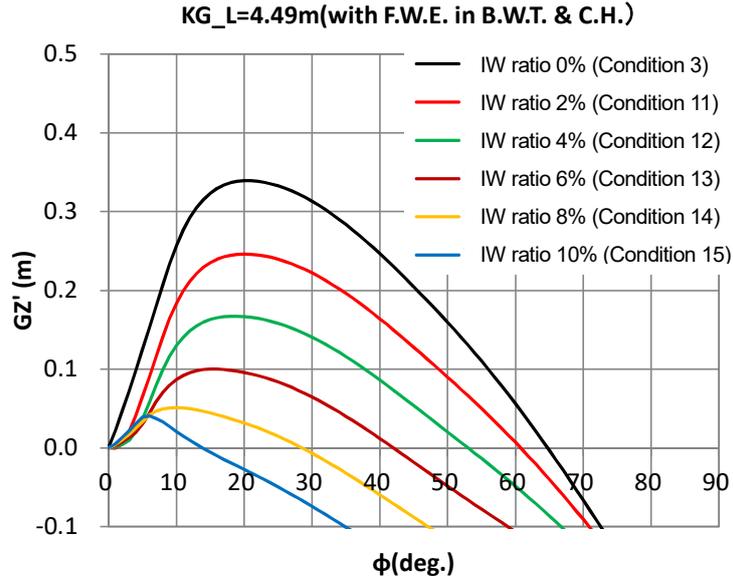
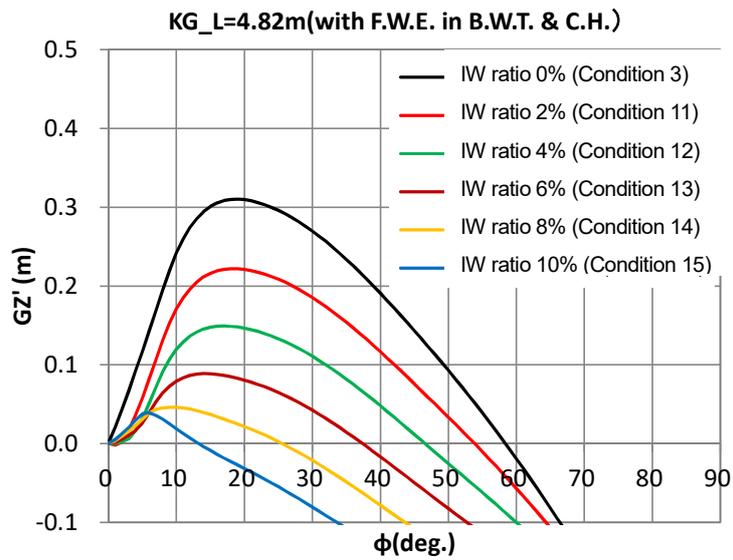
Figures 4 and 5 show the Vessel's calculated stability under each Condition. The stability generally decreases as ingress water increases. At the same time, the angle of loss of residual stability (φ_V) and the range of stability (φ_R), which define the characteristics of a vessel's stability, both decrease, while the maximum stability (GZ_{max}) and the lateral heeling angle at which the maximum stability occurs (φ_{max}) also decline. For example, when the height of the center of gravity under the light loading condition KG_L is 4.82 m and the IW ratio is 4% (Condition 12; weight of ingress water in Cargo Hold No. 1: 81.5 tf; weight of ingress water in Cargo Hold No. 2: 93.2 tf) (the green line in Figure 5), the angle of loss of residual stability (φ_V) is approximately 47 deg., the maximum stability GZ_{max} is approximately 0.15 m, and the lateral heeling angle at which the maximum stability occurs φ_{max} is approximately 17 deg., decreasing by about 20%, 50%, and 10%, respectively, compared to the condition where there is no ingress water in the cargo holds (Condition 3; $\varphi_V \cong 58$ deg., $GZ_{max} \cong 0.31$ m, $\varphi_{max} \cong 19$ deg.) (black line in Figure 5).

Meanwhile, the free water effect of ingress water is only significant at smaller lateral heeling angles, as this analysis assumes relatively small volumes of ingress water. For example, when KG_L = 4.82 m and the IW ratio is 2% (Condition 11), the metacentric height (GM2) calculated taking into account the free water effect is almost 0 m (Table 12); then, the pro-metacentric height starts to grow around a lateral heeling angle of 2 deg. and it becomes approximately 0.22 m at maximum, a significant stability value, at a lateral heeling angle of about 18 deg. (Figure 5).

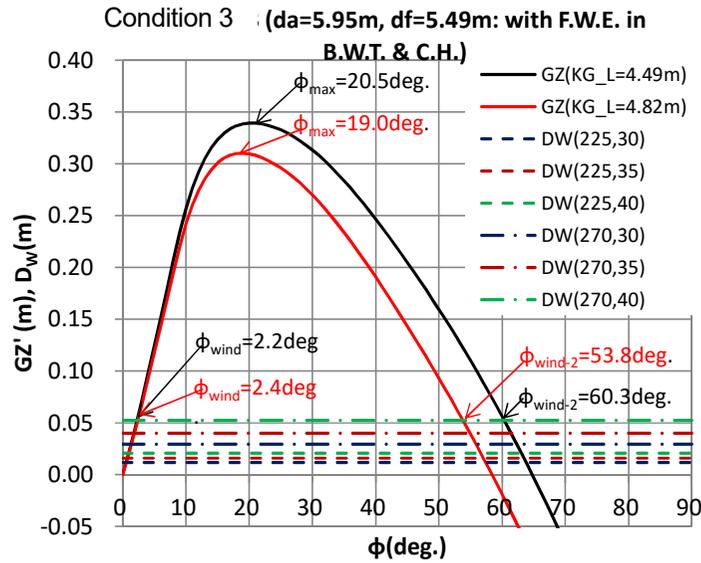
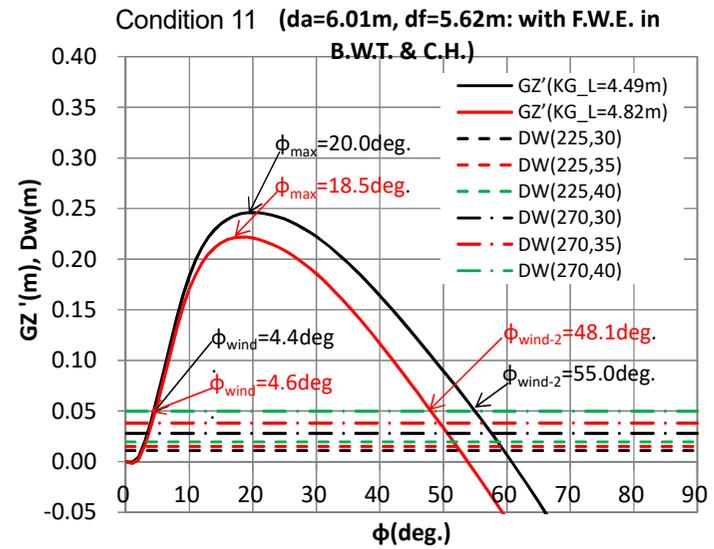
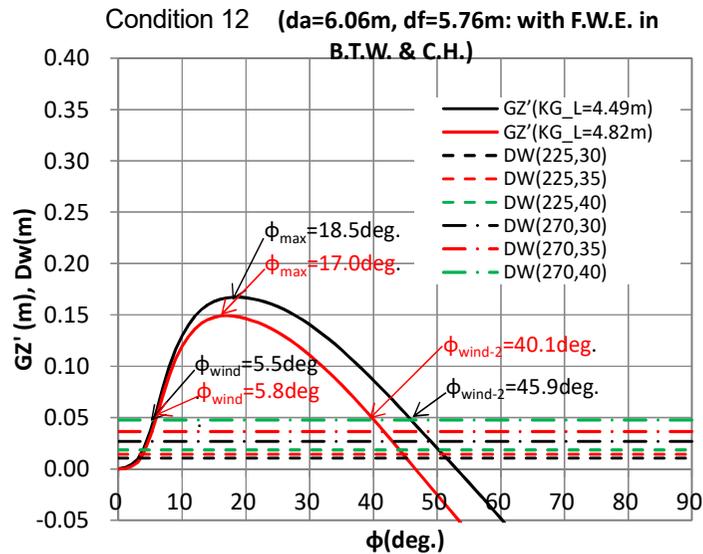
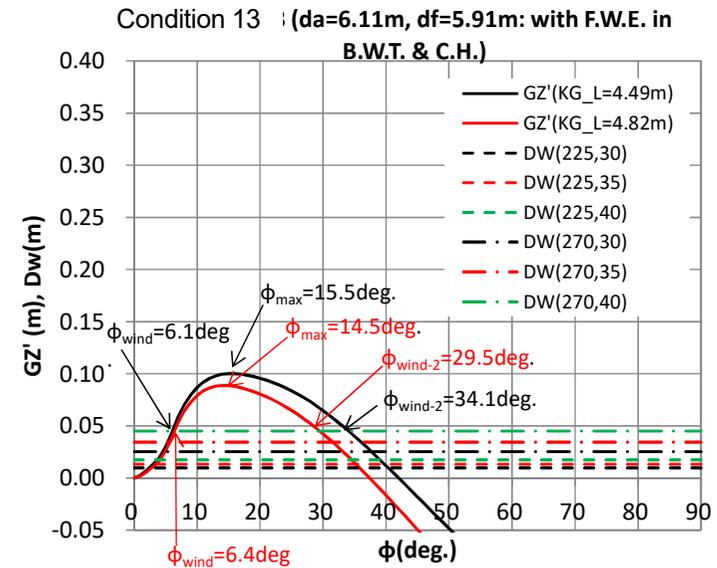
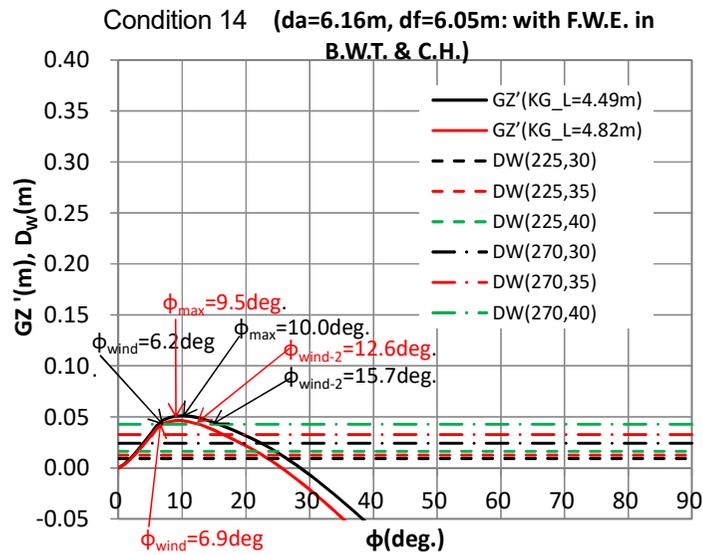
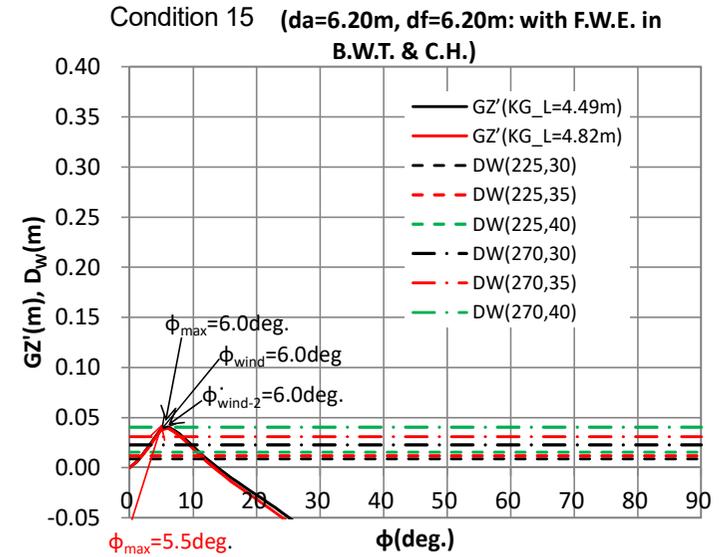
Figures 6 to 11 show the comparison of the Vessel's calculated stability and the calculated heeling couple of the force lever due to winds under each Condition. In the legends, the figures in the brackets are the Vessel's heading and the wind velocity (e.g. "DW (225, 30)" denotes the heeling couple of the force lever when the Vessel's heading is 225 deg. and the wind velocity is 30 m/s). For reference, the Figures also show the lateral heeling angle at which the maximum stability occurs (ϕ_{max}) and the value of lateral heeling angle at the intersection of the stability curve and the line of DW(270, 40) (i.e. the heeling couple of the force lever when the Vessel's heading is 270 deg. and the wind velocity is 40 m/s) (ϕ_{wind} and ϕ_{wind-2} ; ϕ_{wind} is further discussed in Section 2.1.2).

While, as mentioned above, both the Vessel's stability (GZ') and the heeling couple of the force lever (D_W) decrease as the IW ratio increases, the former decreases more rapidly. Figures 6 to 11 show that the residual stability (GZ'_R), which corresponds to the stability curve (GZ') represented by the solid line above the line of the heeling couple of the force lever (D_W) parallel to the lateral axis, drops rapidly as the IW ratio increases. In particular, in Figure 11, where the IW ratio is 10% (Condition 15), when the Vessel's heading is 270 deg. and the wind velocity is 40 m/s (heeling couple of the force lever: green dash-dotted line), the effective stability is almost null even when the height of the center of gravity under the light loading condition KG_L is 4.49 m (black solid line).

In Figures 6 to 11, the lateral heeling angle due to winds (ϕ_{wind}) corresponds to the smallest of the heeling angles at the intersections of the stability curve (GZ') and the line of the heeling couple of the force lever (D_w) (Formula (3)).

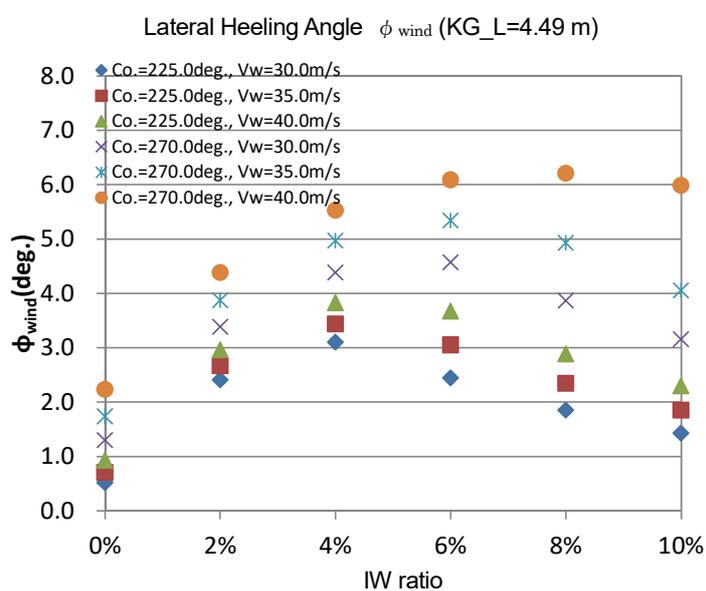
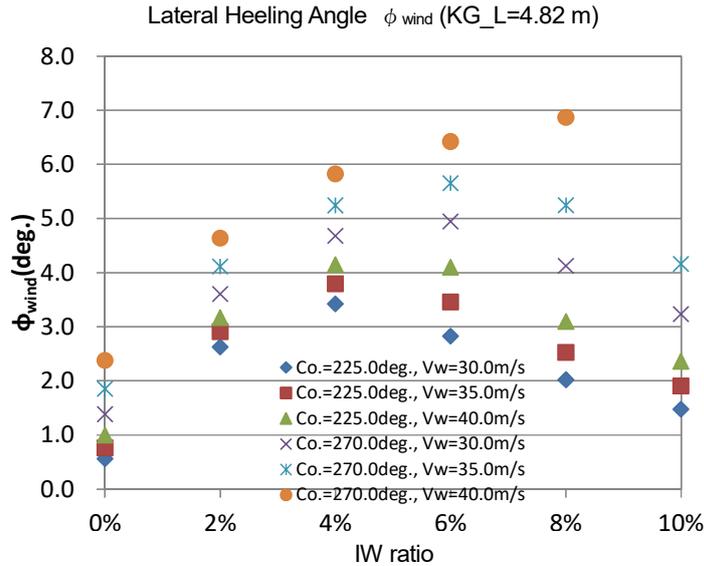
Based on Tables 18 and 19 and Figures 12 and 13, it is found that: [1] the lateral heeling angle due to winds at a heading of 270 deg. where the relative wind direction is close to lateral is about 1.4-3.5 times greater than that at a heading of 225 deg.; and [2] the lateral heeling angle due to winds becomes 5 deg. or greater only when the heading is 270 deg. and the IW ratio is 4% or greater.

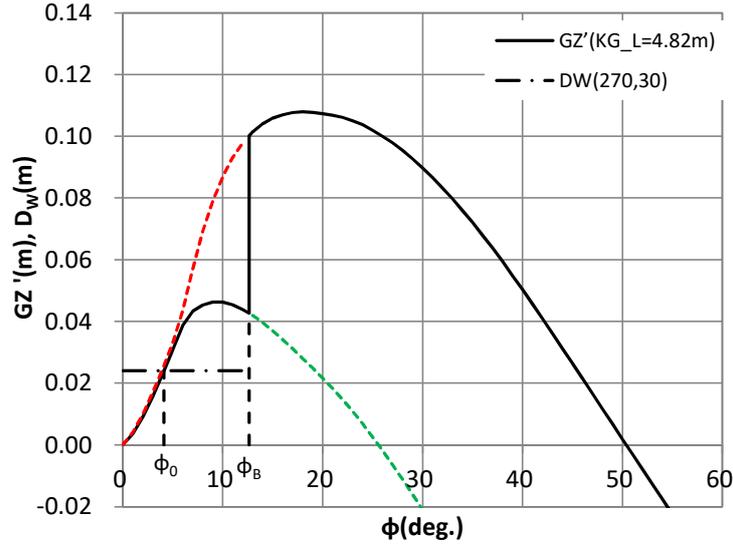
Figure 14 Stability Curve at the Time of the Accident occurred (Conditions 14 and 24; KG_L = 4.82 m) and the Heeling Couple of the Force Lever due to Winds (Heading: 270 deg.; Wind Velocity: 30 m/s; Condition 14)

Figure 14 shows the stability curve when the IW ratio is 8%. The submerged angle of the top of the bulwark (φ_B) is 12.6 deg. when the RW ratio is 75% and the IW ratio is 8% (Condition 14) (Table 13). According to the logic discussed above, when $0 \leq \varphi \leq \varphi_B$ (φ denotes the lateral heeling angle), the Vessel's stability equals that estimated in Condition 14 (RW ratio: 75%); when $\varphi_B \leq \varphi$, it is equal to that estimated under the condition where the RW ratio is 0% and the IW ratio is 8% (Appendix 1; Condition 24). In Figure 14, the red dotted line is the stability curve under Condition 24 (an RW ratio of 0%) when $0 \leq \varphi \leq \varphi_B$, and the green dotted line is the stability curve under Condition 14 (an RW ratio of 75%) when $\varphi_B \leq \varphi$.

If the Vessel rolls 10-20 deg. under this condition ((i) in the Accident Scenario), the stability may significantly change as the lateral heeling angle can exceed the submerged angle of the top of the bulwark (12.6 deg.) (ϕ_B), depending on the rolling degree. However, this situation would still not produce a steady heeling, which means that the Vessel rolls symmetrically centered on its upright position (i.e. the rolling amplitude is equal on the port and starboard sides).

The estimated heeling angle due to winds at the time of the accident shown in Tables 18 and 19 corresponds to ϕ_0 , the angle at which the stability GZ' equals the heeling couple of the force lever due to winds D_w in Figure 14. Figure 14 shows the stability GZ' when the height of the center of gravity under the light loading condition KG_L is 4.82m (solid line) and the heeling couple of the force lever due to winds D_w (270, 30) (i.e. the heeling lever at a heading of 270 deg. and a wind velocity of 30 m/s) (dash-dotted line). Here, ϕ_0 is 4.1 deg. (Table 19), a heel to starboard.

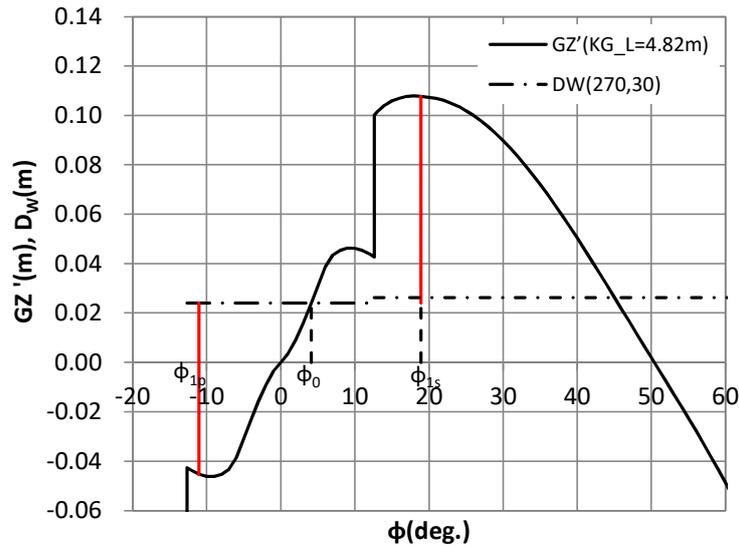
Figure 15 Calculated Roll Amplitude When the Vessel Has a Steady Heeling (Conditions 14 and 24; $KG_L=4.82$ m; Center of Rolling (φ_0): 4.1 deg.; Wave Roll Amplitude: 15 deg.)

Under the condition shown in Figure 14, if a roll amplitude (φ_a) of 15 deg. (the median of 10-20 deg.) ((ii) of the Accident Scenario) is applied to Formulas (4) and (5), the maximum heeling angle to the port side φ_{1p} is 11.1 deg. and the maximum heeling angle to the starboard side φ_{1s} is 18.9 deg. (Figure 15). Note that Formula (4) was calculated based on an assumption that the Vessel's stability and heeling couple of the force due to winds shift to those under Condition 24 (the condition where only the cargo holds are flooded and there is no Retained Water in the passages) when the lateral heeling angle exceeds the top of the bulwark's submerged angle (φ_B) (=12.6 deg.).

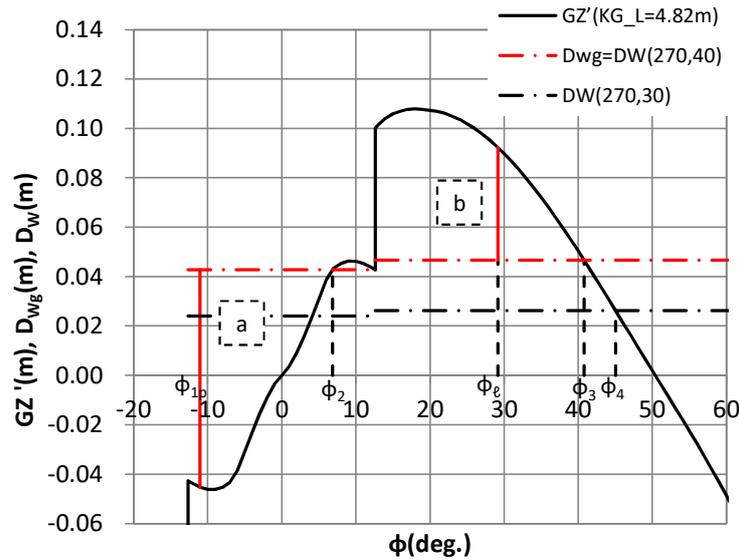
Figure 16 Calculated Energy Balance

Figure 16 was used for the calculation of the energy balance. Assuming that the heeling couple of the force lever due to a gust of wind (D_{wg}) is equivalent to the heeling couple of the force lever due to winds at a heading of 270 deg. and a wind velocity of 40 m/s ($D_w(270,40)$), the lateral heeling angle ϕ_2 is 6.9 deg. when the gust of wind acts quasi-statistically (Table 19). By applying the maximum heeling angle to the port side calculated in 2) ($\phi_{1p} = -11.1$ deg.) to Formulas (6) to (8), the maximum heeling angle to the starboard side (ϕ_l) is 29.2 deg. and the ratio of the dynamic stability to the heeling energy ($c = b/a$) is 1.29. Note that Formulas (7) and (8) were calculated based on an assumption that the Vessel's stability and heeling couple of the force due to winds shift to those under Condition 24 (the condition where only the cargo holds are flooded and there is no Retained Water in the passages) when the lateral heeling angle exceeds the top of the bulwark's submerged angle (ϕ_B) (12.6 deg.).

Meanwhile, the heeling angle at which the maximum stability occurs is approximately 18 deg. At the maximum heeling angle to the starboard side (29.2 deg.), the slope of the stability curve is negative (Figure 16). This means that the Vessel was unstable at the maximum heeling angle to the starboard side.³⁾ At the same time, the stability was undermined due to the the submerged bulwark dragging, subject to the weight of sea water. In this situation, the continuous effects of waves could have further increased the lateral heeling angle ((v) of the Accident Scenario). The angle of loss of residual stability ϕ_4 is calculated to be 45.1 deg. when the average wind velocity is 30 m/s under the condition assumed in Figure 16.

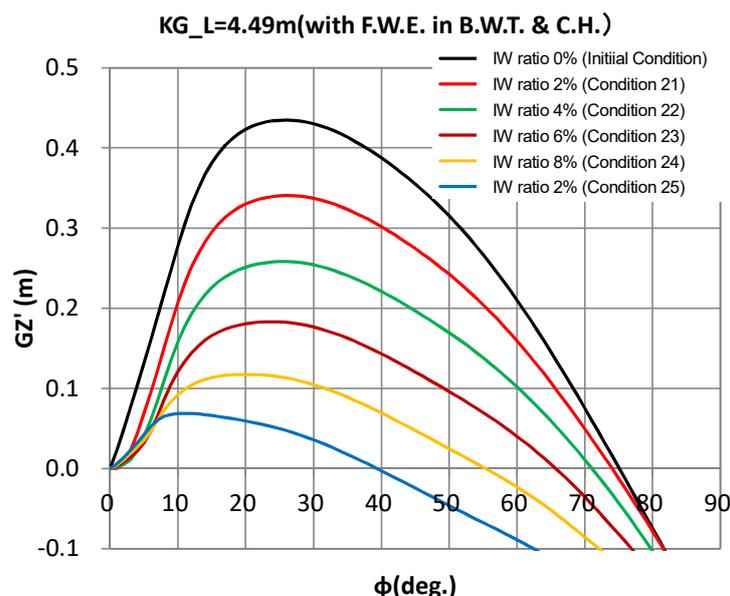
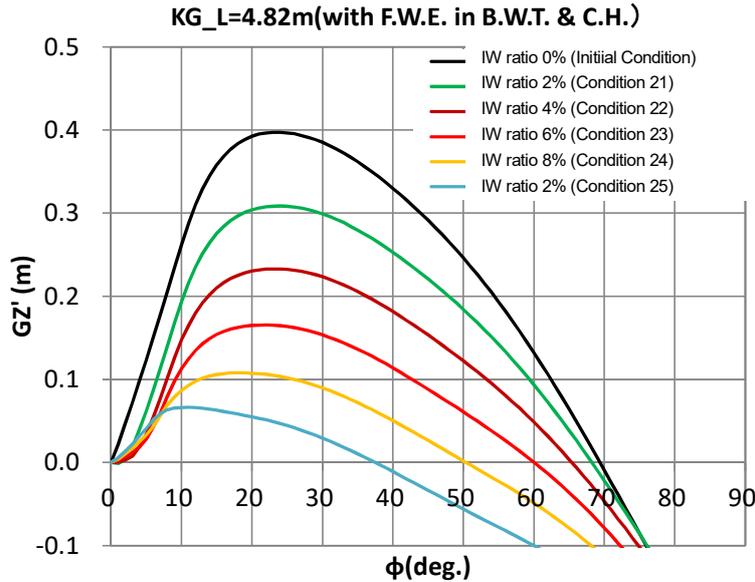
The Vessel's calculated stability for each condition is shown in Figures A1-1 and A1-2. In the same manner as Section 1.2, the free water effect of ingress water in each cargo hold was taken into account as a change (caused by heeling) in the center of gravity of water contained in a hypothetical cargo hold that has a plane with the same length and area as the plane of the actual cargo hold (i.e. a hypothetical cargo hold tank that has an approximate rectangular plane).¹⁾

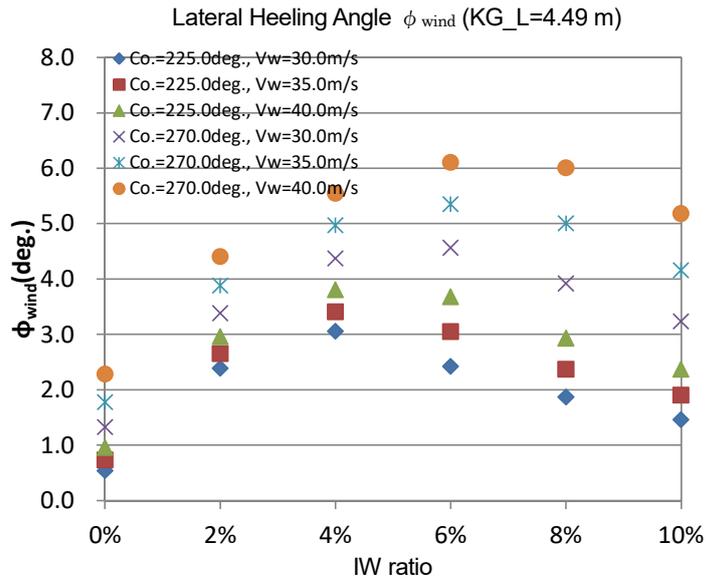
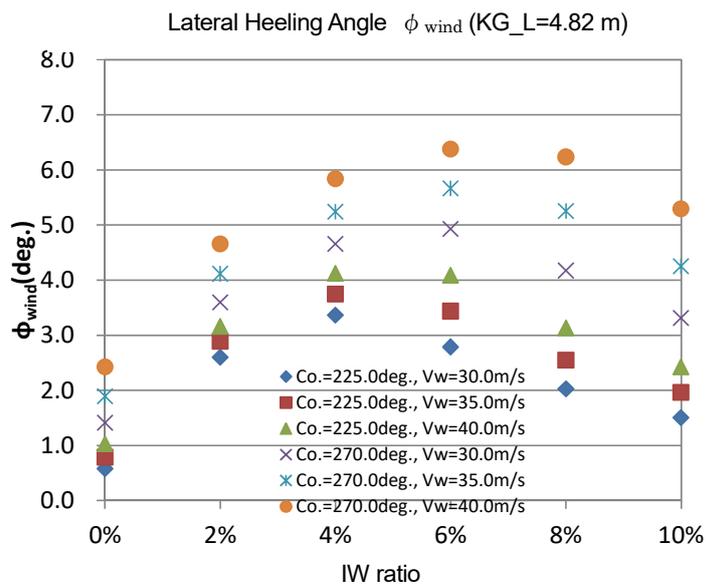
Under the Conditions assumed in this analysis, the lateral heeling angle due to winds increases with the volume of ingress water up to 4% (Condition 22) if the heading and the wind velocity stay the same. If the IW ratio is greater than 4%, the lateral heeling angle may decrease as ingress water increases, depending on the combination of the heading and the wind velocity, since the stability (GZ') and the heeling couple of the force due to winds (D_w) decrease at different rates against the increase in ingress water. Also, when the IW ratio is greater than 6%, the lateral heeling angle decreases with the increase in ingress water with any combinations of the headings and wind velocities.
