# National Transportation Safety Board

## Marine Accident Brief

### Contact of *Savage Voyager* Tow with Jamie Whitten Lock & Dam

<b>Accident type</b>	Contact	<b>No.</b> DCA19FM049
<b>Vessel name</b>	<i>Savage Voyager</i> and tank barge <i>PBL 3422</i>	
<b>Location</b>	Jamie Whitten Lock & Dam, Tennessee-Tombigbee Waterway, mile 411.9, near Dennis, Mississippi 34°31.35' N, 088°19.41' W	
<b>Date</b>	September 8, 2019	
<b>Time</b>	0355 central daylight time (coordinated universal time – 5 hours)	
<b>Injuries</b>	None	
<b>Property damage</b>	\$4.4 million est.	
<b>Environmental damage</b>	117,030 gallons (2,786 barrels) of crude oil released into lock chamber; estimated 942 gallons (22 barrels) unrecovered	
<b>Weather</b>	Visibility 1.25 miles in mist, clear skies, calm air, air temperature 63°F, average water temperature 71°F	
<b>Waterway information</b>	The Jamie Whitten Lock & Dam is the uppermost lock of the Tennessee-Tombigbee Waterway and forms Bay Springs Lake.

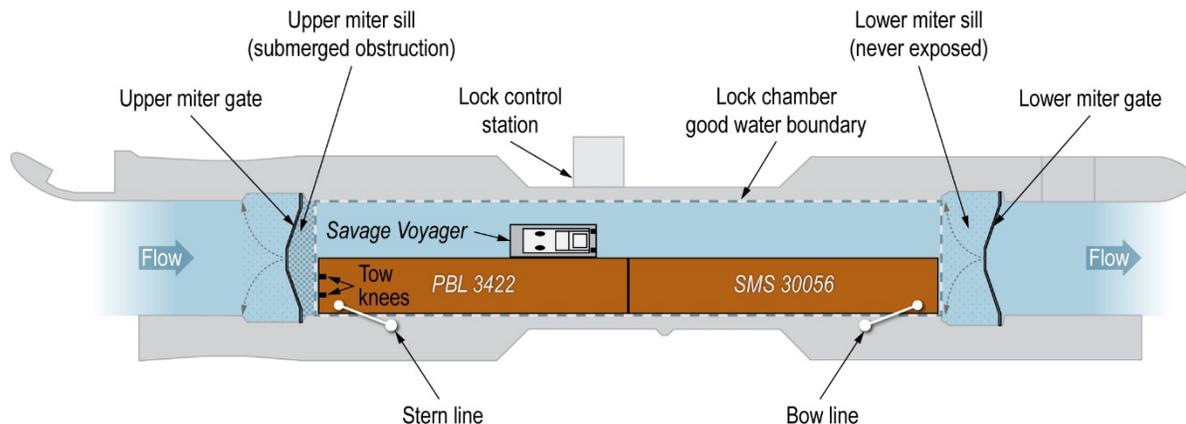
Since the length of the *Savage Voyager* tow measured 678.5 feet, the towboat would not fit in the lock chamber positioned behind the aft barge. The crew was therefore required to complete a “knockout” lockage in which the *Savage Voyager* would be positioned next to the tow (the two barges measured a combined 595 feet long) in the 600-foot-long lock chamber.<sup>3</sup> The deckhand released the *Savage Voyager* from the tow, and the pilot positioned the tug’s starboard side alongside the *PBL 3422*. The deckhand secured lines from the towing vessel to the *PBL 3422* and returned to his position on the rake of the *PBL 3422* to tend the tow’s stern line; he stated that the barge “didn’t move” during the maneuver, and “if it wasn’t where it’s supposed to be, I would have seen it.” The tankerman also reported that there was no shifting of the barges. The pilot stated that he kept the starboard engine in neutral and the port engine ahead in order to keep the *Savage Voyager* tight alongside the barge.

Depiction of *Savage Voyager* tow prior to locking down (towboat position approximate).
