# RISK ALERT

## Containerised Cargo – Stowage and Securing

Written by  
**Nahush Paranjpye**  
Loss Prevention team

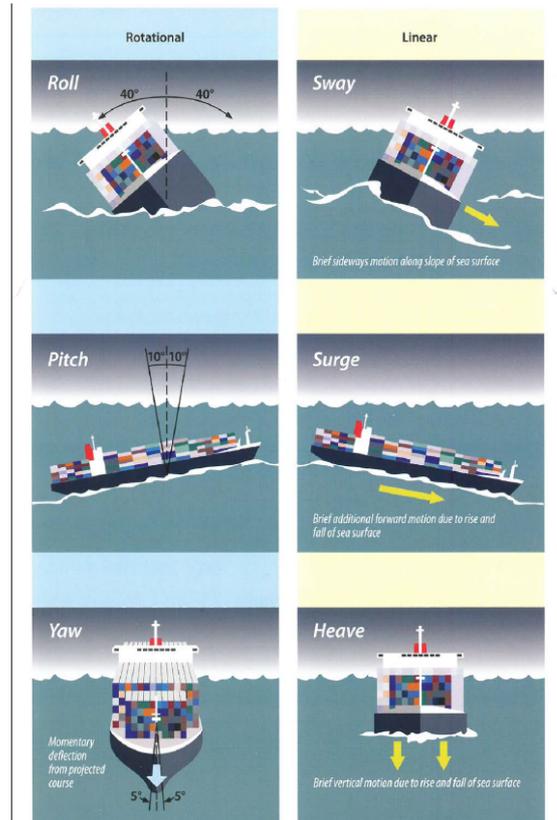
**Ships motions in heavy seas – MAIB REPORT NO 2/2020**

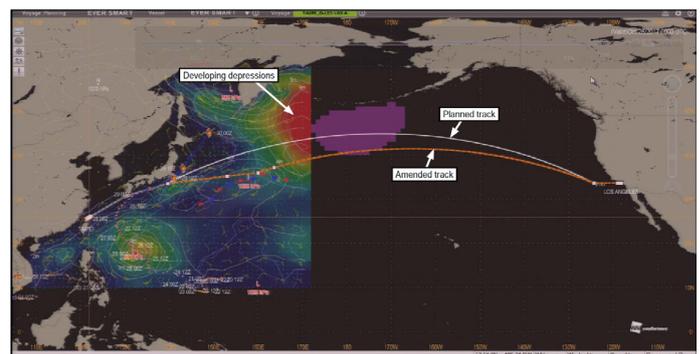
Vessel's Track (local time): Ref: [MAIB REPORT NO 14/2020](#)

Master had changed the ship's passage plan to avoid severe weather caused by a developing depression east of Japan. The ship continued in heavy seas; **rolling and pitching heavily with frequent bow flare slamming.**

Once the weather had abated, the crew discovered that the container stacks on the aft most bay had collapsed and toppled to port. Of the 151 containers in the stow, 42 were lost overboard and 34 were damaged. Superficial damage was caused to the ship.

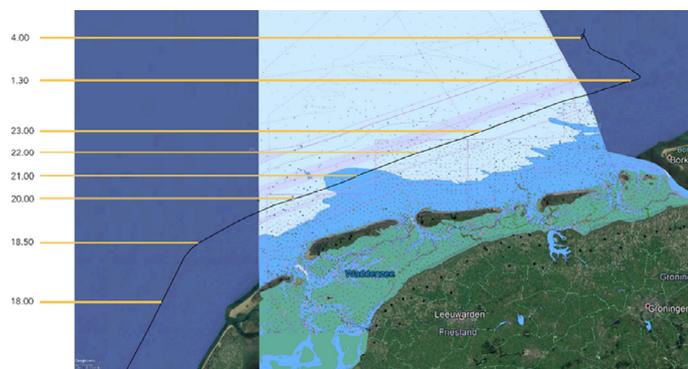
Track of MSC ZOE (time indication local time): Ref: [Joint investigation report - MSC ZOE 01 - 02 January 2019](#)

At 0100h on 2 January 2019, when looking aft, the Master noted several containers were no longer visible in the expected position. Upon shining an Aldis lamp it appeared that several containers had fallen over. During a subsequent inspection several containers were noted to be hanging overboard.

Attempts to assess the damage was difficult due to the darkness and fallen containers on deck obstructing access. Containers in bay 58 were noted to have collapsed and were hanging overboard and a similar situation was noted in bays 10 and 26.

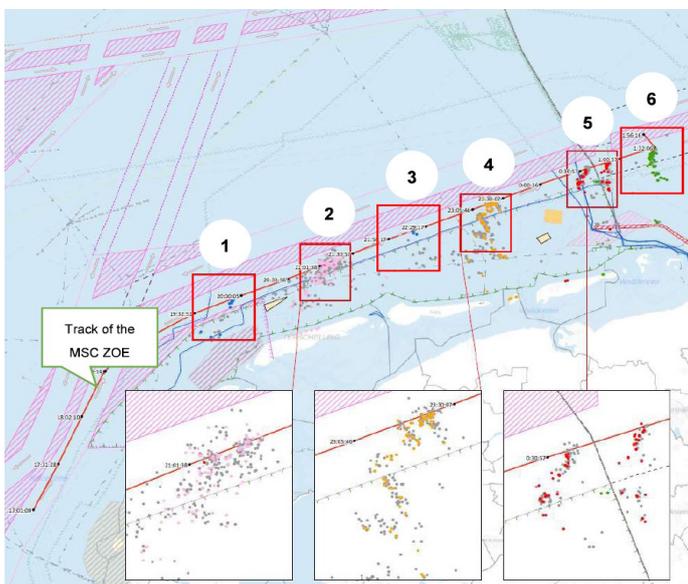
- Impact on the Dutch and German coasts, marine life and environment attracted considerable public concern in the Netherlands and in Germany.
- Debris sank or washed ashore as the fall from height and the waves destroyed most of the containers.
- Seabed survey identified more than six thousand objects.
- 2 of the lost hazmat containers contained IMDG cargo of Class 5 (Oxidising Agents and Organic peroxides) and Class 9 (lithium-ion batteries).
- Loss of raw materials destined for the plastics industry (Millions of small particles of plastic dispersed by wind and difficult to remove from the environment).

Six main recovery locations of lost containers. Ref: [Joint investigation report - MSC ZOE 01 - 02 January 2019](#)
