MA2021-3

**MARINE ACCIDENT
INVESTIGATION REPORT**

MARINE ACCIDENT INVESTIGATION REPORT

Accident type: Collision
Date and time: Around 19:25, June 10, 2019
Location: Keihin Port, Tokyo Section 3
Around 347° true bearing, 950 m from the Tokyo West Breakwater
Lighthouse
(Approximately 35°35.6' N, 139°46.9' E)

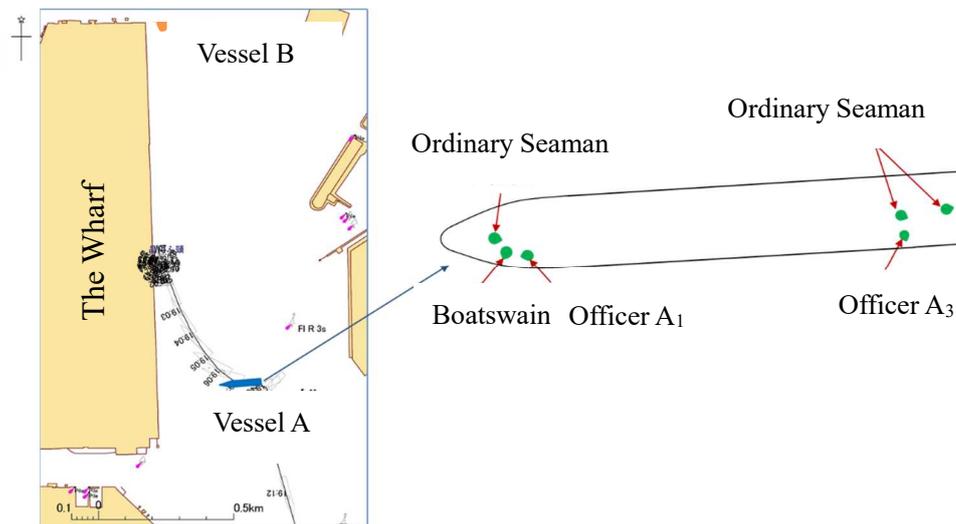
Figure 1 The Navigational Track of Vessel A and the position of Vessel B (Around 19:07) and the Departure station on the Deck Section of Vessel A

Master A was notified by the Japan Coast Guard that Vessel B had been proceeding southeast from the northeast end of the Wharf and approached Vessel A on her port stern side. He learned that Vessel A continued her navigation, unaware that she had collided with Vessel B, which was navigating parallel to her port, in the vicinity of Oi Container Wharf.

Master B first recognized Vessel A near the northeast end of the Wharf at around 19:07, where she appeared to be headed to the Wharf. (See Figure 1)

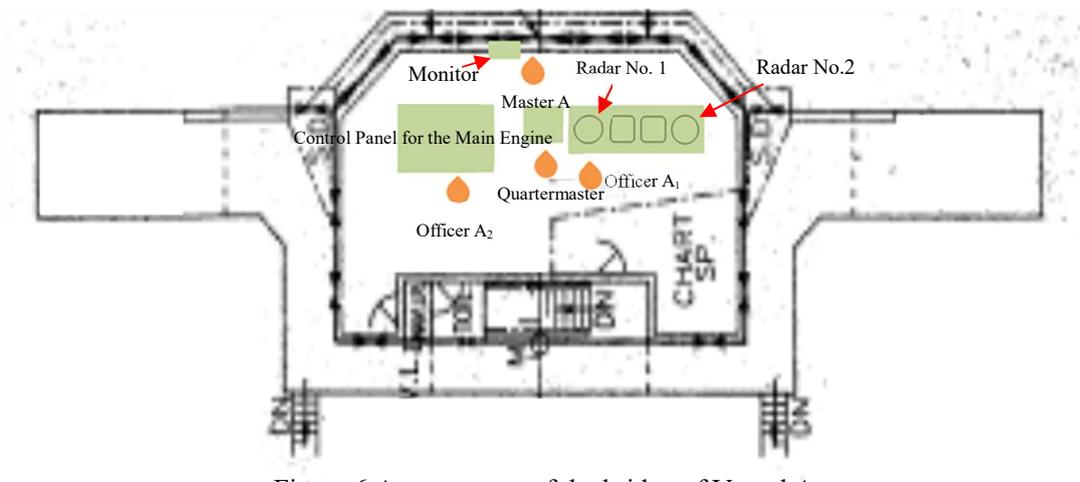
Figure 6 Arrangement of the bridge of Vessel A

- ① Vessel A had a steering stand at the center of the bridge, with radar no.1, radar no.2, and other navigational instruments on the starboard side, and the main engine and other control panels on the port side. The layout was set up to allow the image from radar no.1 to also be viewed on a monitor installed in front of the glass window in the wheelhouse. (See Figure 6)

- ② According to the VDR record of Vessel A, at the time of departure on the day of the accident, radar no.1 was set to 0.75 nautical miles (M) range with the STC⁵ of 30. At about 19:10, Master A switched the range to 1.5 M, set the off-center⁶ function for a better lookout of the direction of the bow, and due to the heavy rain, he also increased the strength of the rain and snow reflection remover by adjusting the FTC⁷ setting to 10. By around 19:20, he further strengthened the setting to 15. Between about 19:16 to 19:26, the VDR recorded 40 images but due to Vessel B being within the minimum detection distance, as well as the effects of the STC and FTC adjustments, no sign of Vessel B was recorded on radar no.1.

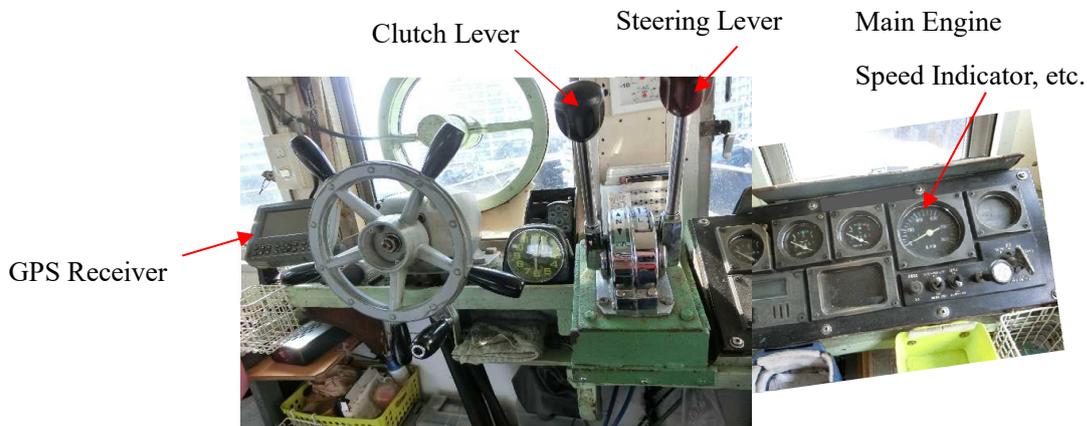
Figure 7 The Wheelhouse of Vessel B

Vessel B had an engine room located near the stern side of her wheelhouse, and the noise of the main engine running was so loud that it could hamper normal conversations inside the wheelhouse. (See Figure 7)

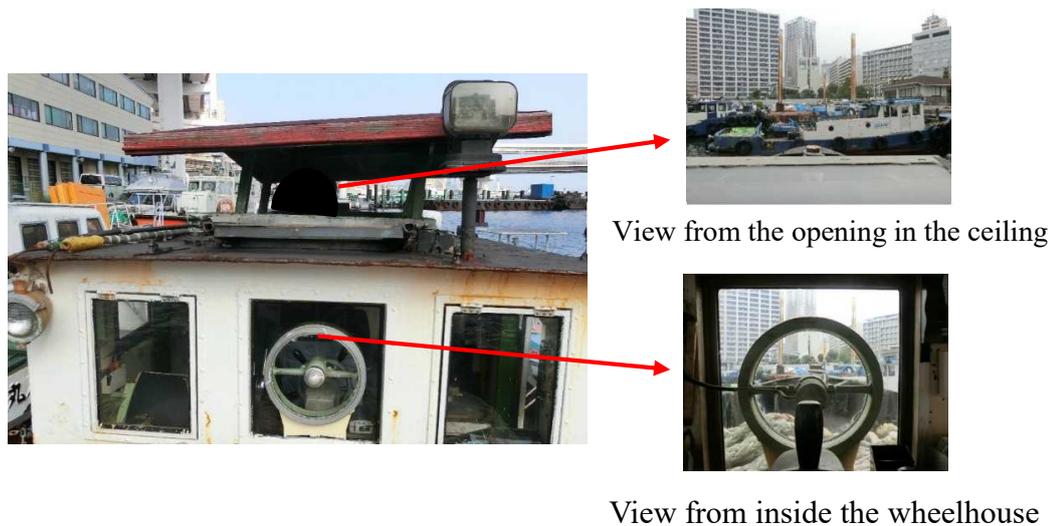
Figure 9 Bridge watch visibility of Vessel B

① The view from inside the wheelhouse was restricted by the window frames and clear view screens, but lookout without any visibility restriction was possible by keeping a standing lookout while protruding one's head through the opening in the ceiling of the wheelhouse.

- ② Master B stood in the wheelhouse with his head protruding through the opening in the ceiling of the room from the time of departure as he wanted to thoroughly observe the surroundings, but as he had to constantly wipe his rain-soaked face with a towel while keeping a lookout, it was difficult to assess the situation of his surroundings.
- ③ Master B kept lookout while sitting on a chair after Vessel B began navigating in the vicinity of Oi Container Wharf.

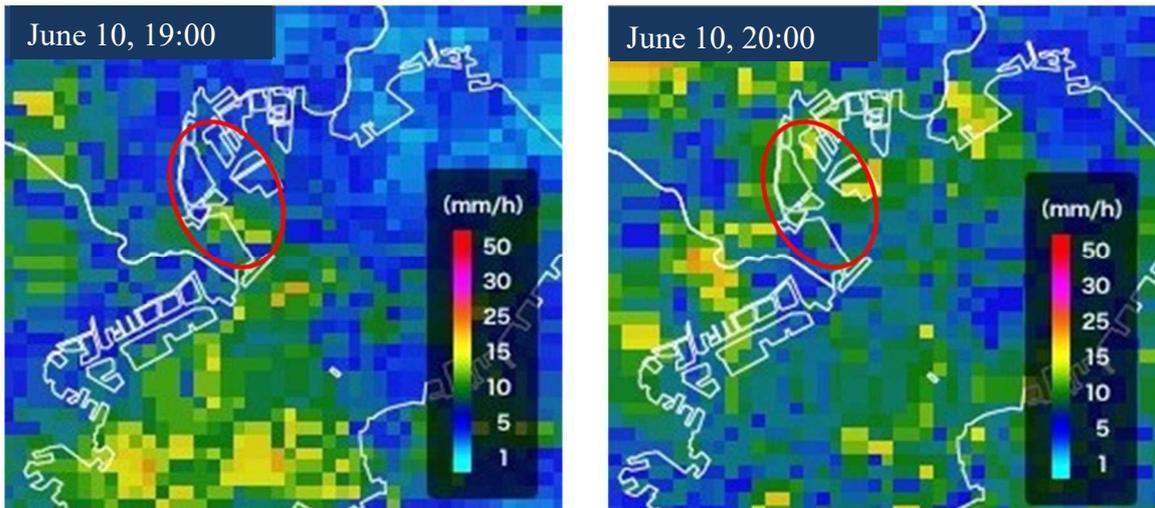
Figure 10 Rain Cloud Radar of Tokyo (Published by the Japan Weather Association)

On June 10, a heavy rain advisory was issued for Tokyo at 13:00, followed by a heavy rain warning at 19:55. The rain clouds over Tokyo at 19:00 and 20:00 are shown in Figure 10, and according to the color, the precipitation of the area near the Wharf was around 5-15 mm per hour.

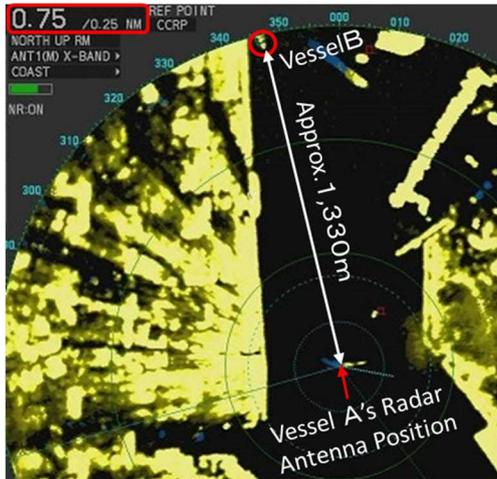
Figure 11 Image from the Radar of Vessel A at 19:07:37

- (3) Signs of Vessel B appeared at 19:07:37, approximately 1,330 m north of Vessel A's radar antenna (see Figure 11), and after that, the distance between the two vessels gradually decreased. At about 19:15:50, Vessel B was shown at 237 m to the port stern side of Vessel A's radar antenna (see Figure 12), but from 19:16:14 to 19:25:00, signs of Vessel B were not visible. At about 19:26:14, the distance between the two vessels widened, and Vessel B was visible again at about 695 m to Vessel A's radar antenna's starboard stern side. (See Figure 13)

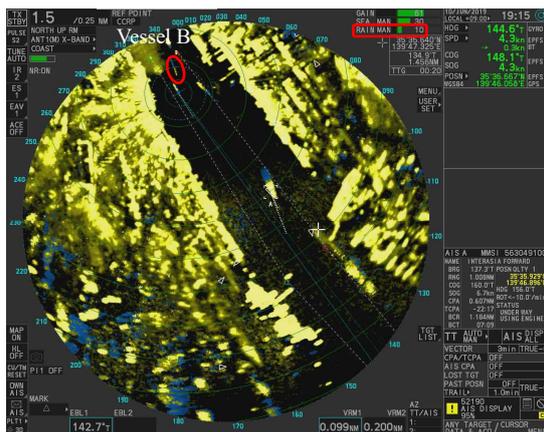
(3) Around 19:15:50

Approx. 0.1 M to Vessel B FTC 10

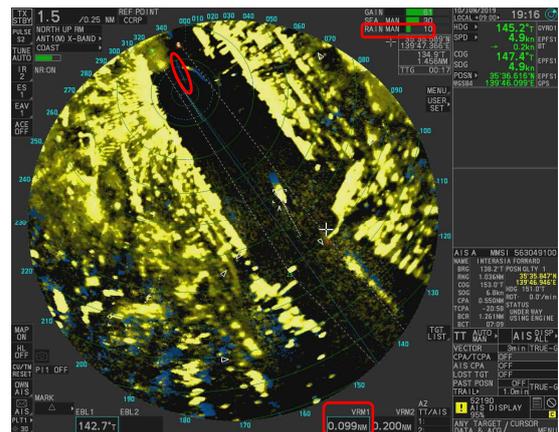
(4) Around 19:16:38

No recordings of Vessel B, only her track was shown

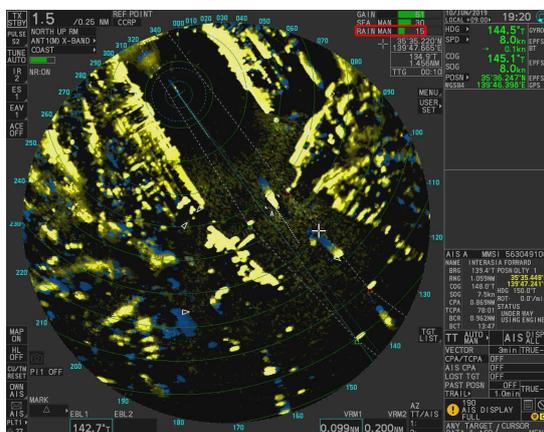
(5) Around 19:20:26

FTC15 No recordings of Vessel B

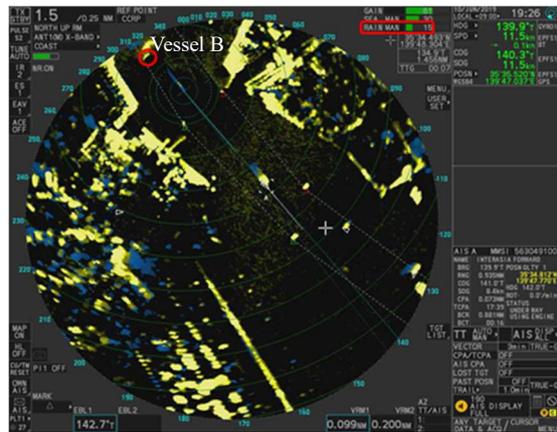
(8) Around 19:26:14

No recordings of Vessel B Distance approx. 0.4 M
