SAFETY INVESTIGATION REPORT

REPORT NO.: 08/2021

TUGBOAT *SPINOLA* Serious injury to crew member, while berthed at Timber Wharf, Malta 13 April 2020

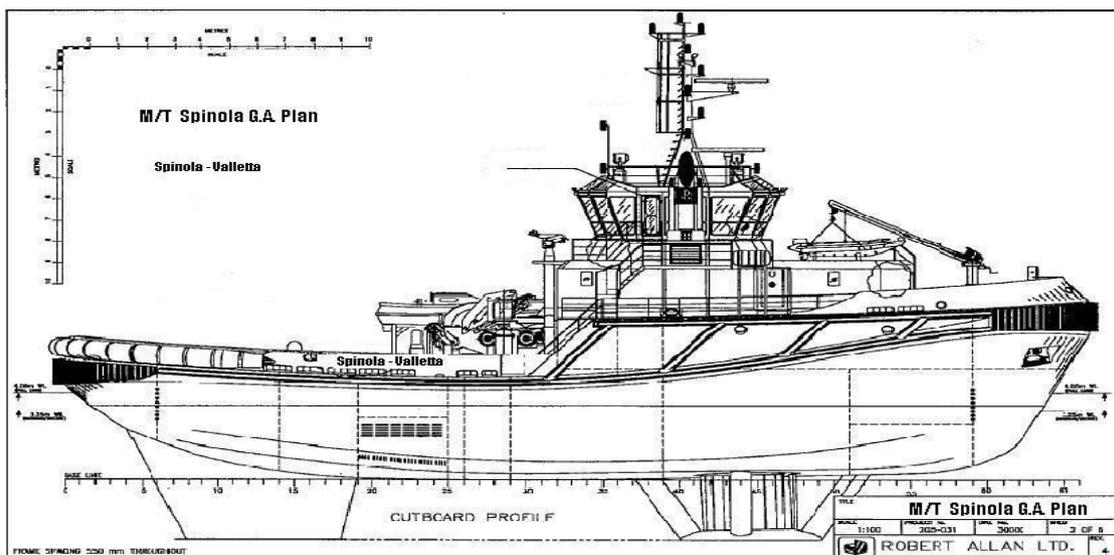
Figure 1: Tugboat *Spinola* GA plan

Spinola, was a 701 gt Maltese-registered escort tugboat (Figure 1) built by Armon Shipyards, Spain, in 2009. She was owned and managed by Tug Malta Limited and was classed with RINA.
