REPORT

Marine 2021/05

*PART TWO REPORT ON THE COLLISION
BETWEEN THE FRIGATE
HNOMS 'HELGE INGSTAD' AND THE
OIL TANKER SOLA TS OUTSIDE THE
STURE TERMINAL IN THE HJELTEFJORD
IN HORDALAND COUNTY
ON 8 NOVEMBER 2018*

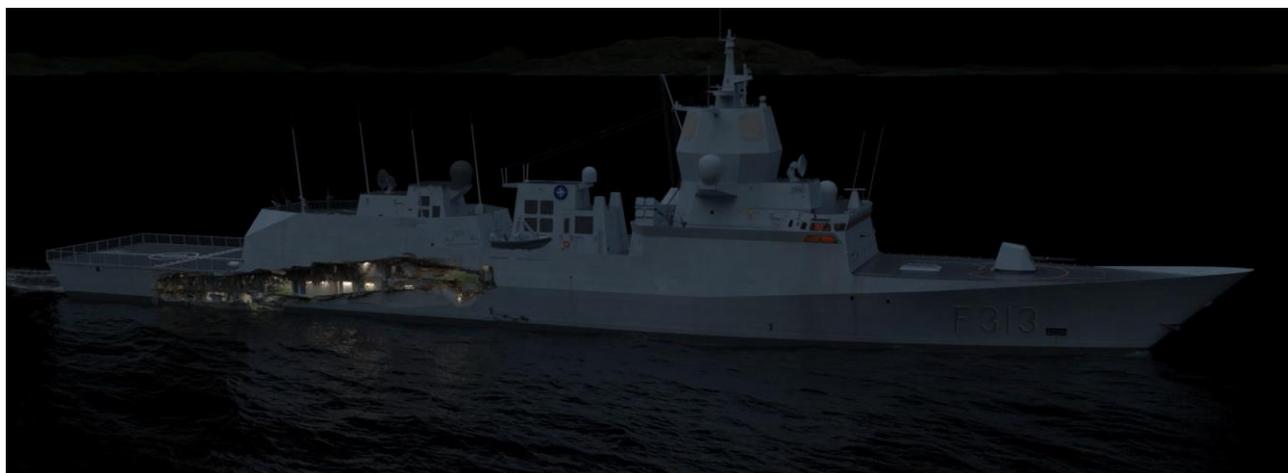
Figure 1: HNoMS 'Helge Ingstad' after the collision. Illustration: CIAAS/NSIA

The damage sustained in the collision caused flooding of several compartments. After the frigate ran around, water also ingressed to the reduction gear room through the hollow propeller shafts. Eventually, the flooding was considered so extensive that the frigate was deemed to be lost, and it was decided to evacuate the crew. Doors, hatches and other openings in the frigate that were supposed to be closed to maintain stability and buoyancy were not closed by the crew at the time of evacuation. The frigate subsequently sank.

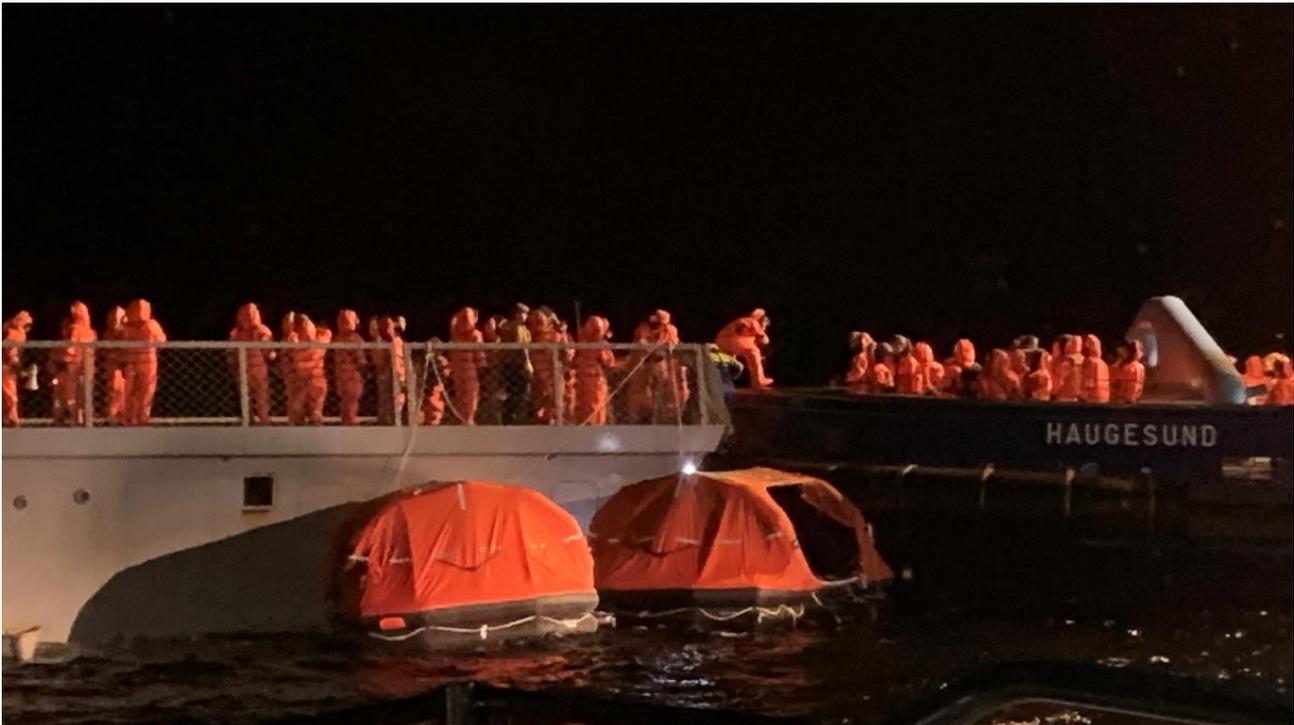
Figure 2: Evacuation from HNoMS 'Helge Ingstad'. Photo: Norwegian Sea Rescue Society

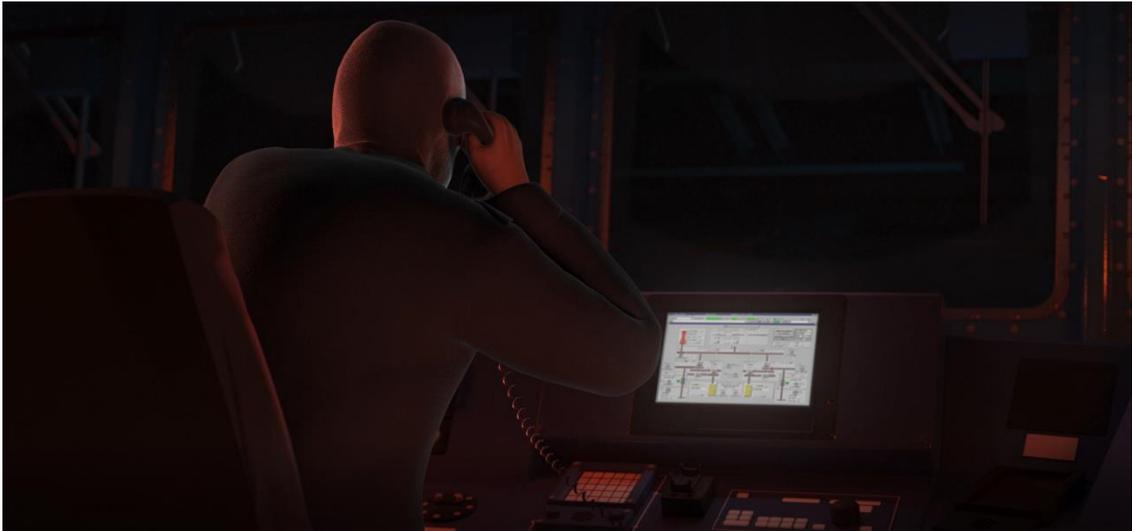
After the collision, the officer of the watch (OOW) immediately ordered the bridge team to put on flashgear⁶. The OOW attempted to contact damage control headquarters (HQ1) on the audio unit⁷ to get them to sound the general alarm,⁸ but was unable to establish contact, see Figure 5. Based on observations of damages and flooding, HQ1 shortly afterwards, raised the general alarm over the PA system,⁹ with a report of flooding on 2 deck.

Figure 5: OOW attempting to contact HQ1 on the audio unit. Illustration: CIAAS/NSIA

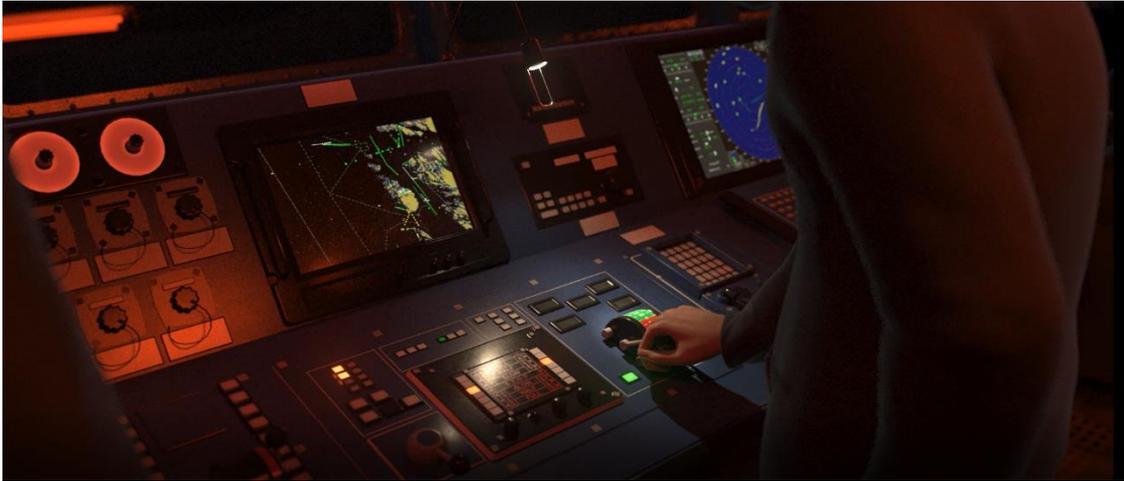
During the period between 04:05 and 04:07, the crew made several attempts to control the propulsion system from the centre console. There was no response when they attempted to throttle back to stop the vessel, see Figure 7. They then attempted to use backup mode¹² and finally the emergency stop function, without this having any effect, since the communication cables were severed in the accident. The frigate was now about 0.5 nautical miles from the shore, moving at a speed of approximately 5 knots.

Figure 7: Attempt to throttle back. Illustration: CIAAS/NSIA

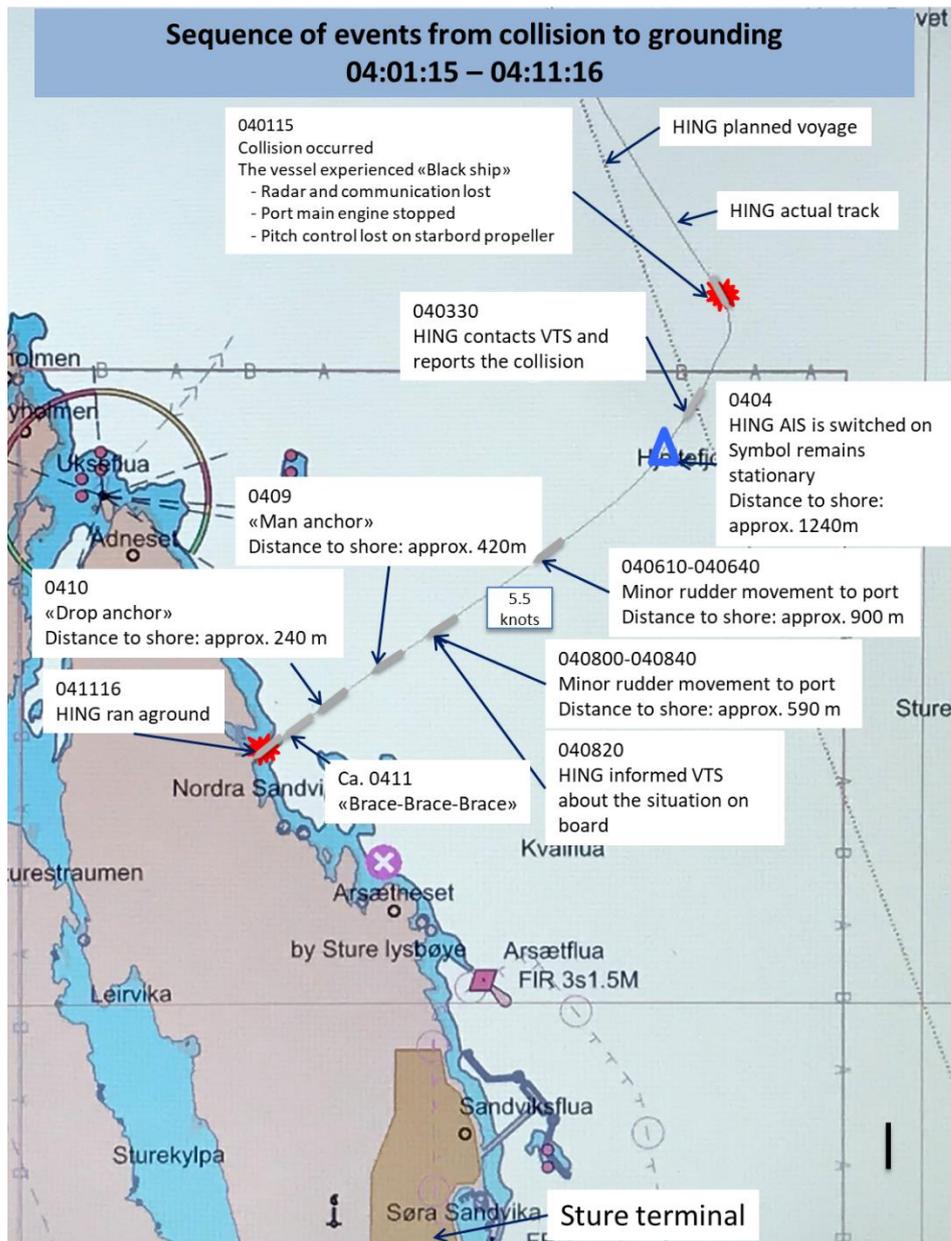
Figure 9: Schematic drawing of the frigate's movements after the collision until she ran aground. Illustration: NSIA

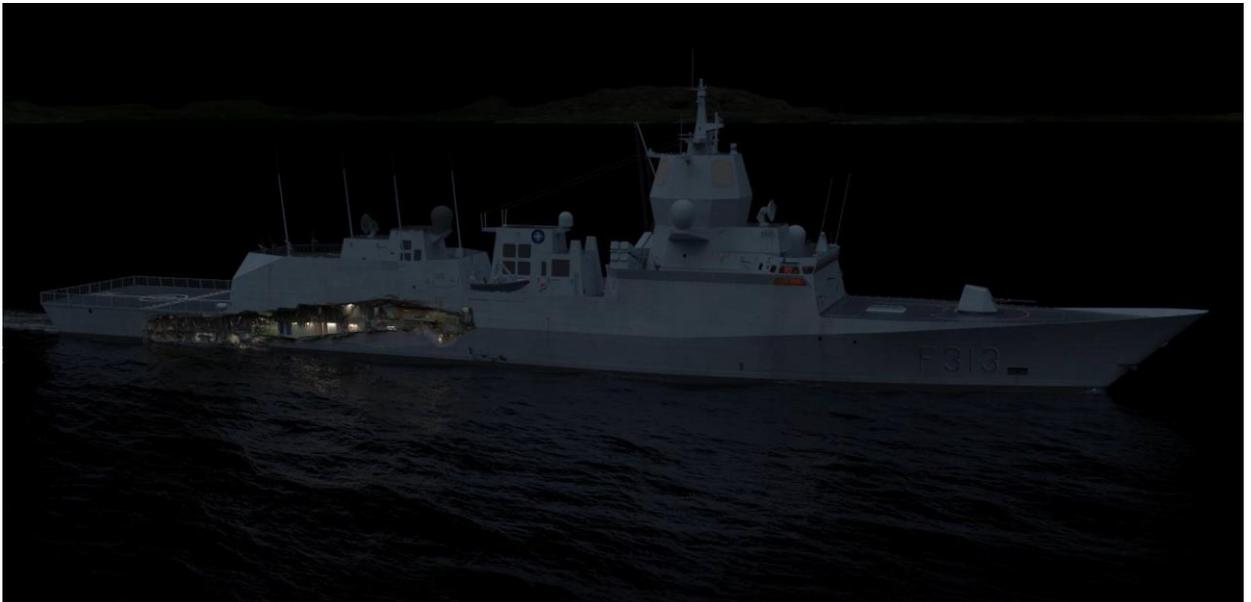
Figure 10: The vessel heading towards shore after the collision. Illustration: NCIS²⁰/CIAAS/NSIA

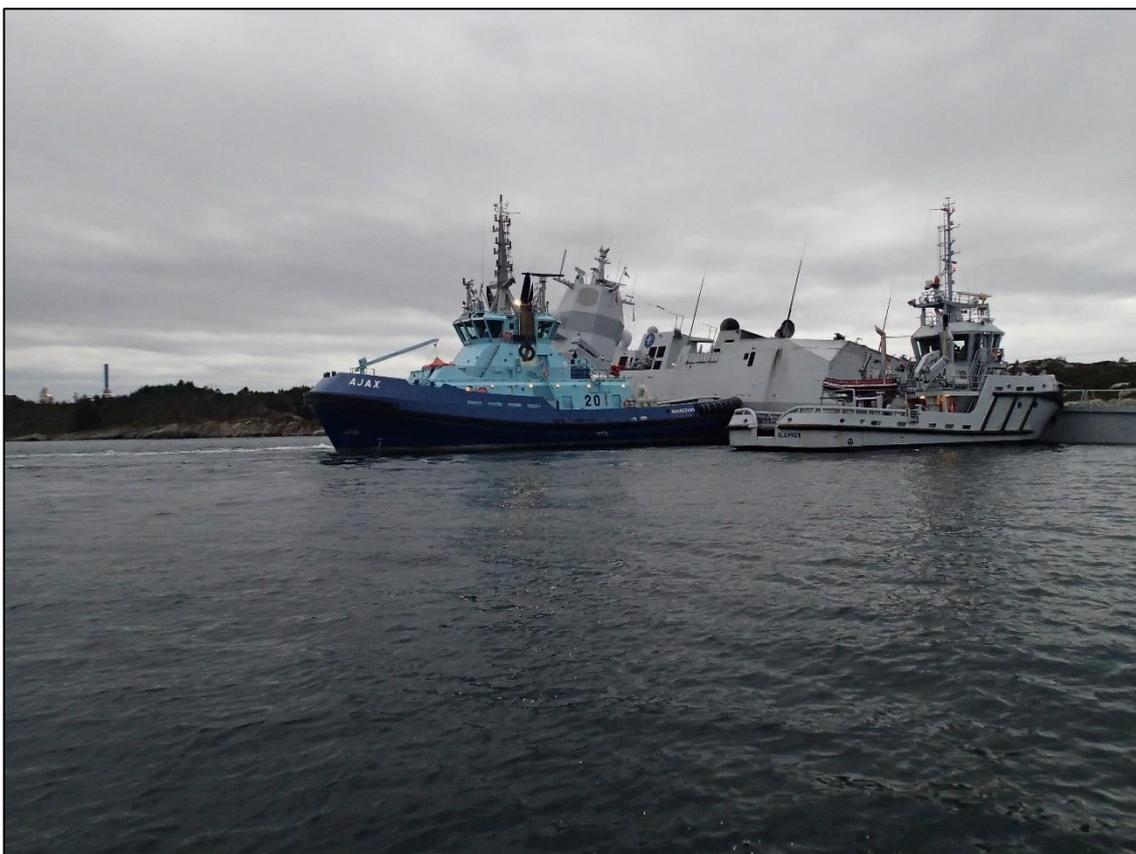
Figure 15: Tugs pushing HNoMS 'Helge Ingstad' towards shore. Photo: CGV 'Bergen'

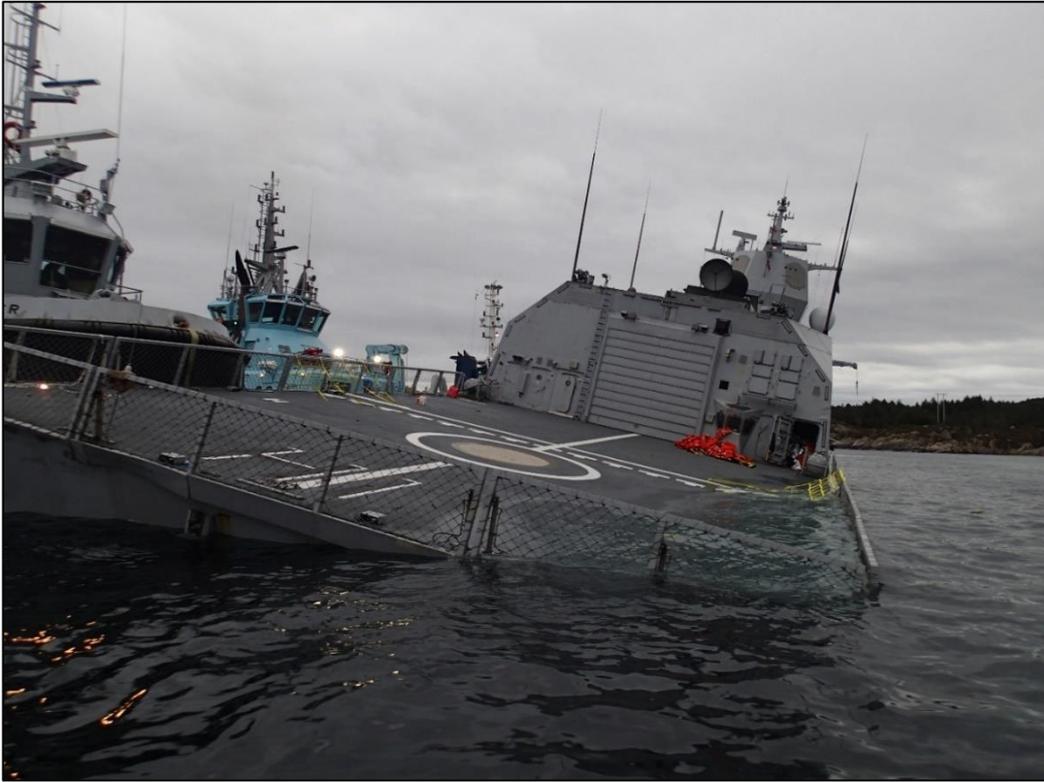
Figure 17: HNoMS 'Helge Ingstad' being pushed sideways by tugboats at 09:47. Photo: CGV 'Bergen'

At 10:27, while the tugboats kept pushing on HNoMS 'Helge Ingstad', the frigate suddenly heeled over to starboard. The IPMS data show that the frigate ended up with a list of around 30 degrees, after which the tugboats interrupted the operation. The afterbody then sank rapidly so that the shaft/rudder was lodged on the seabed.

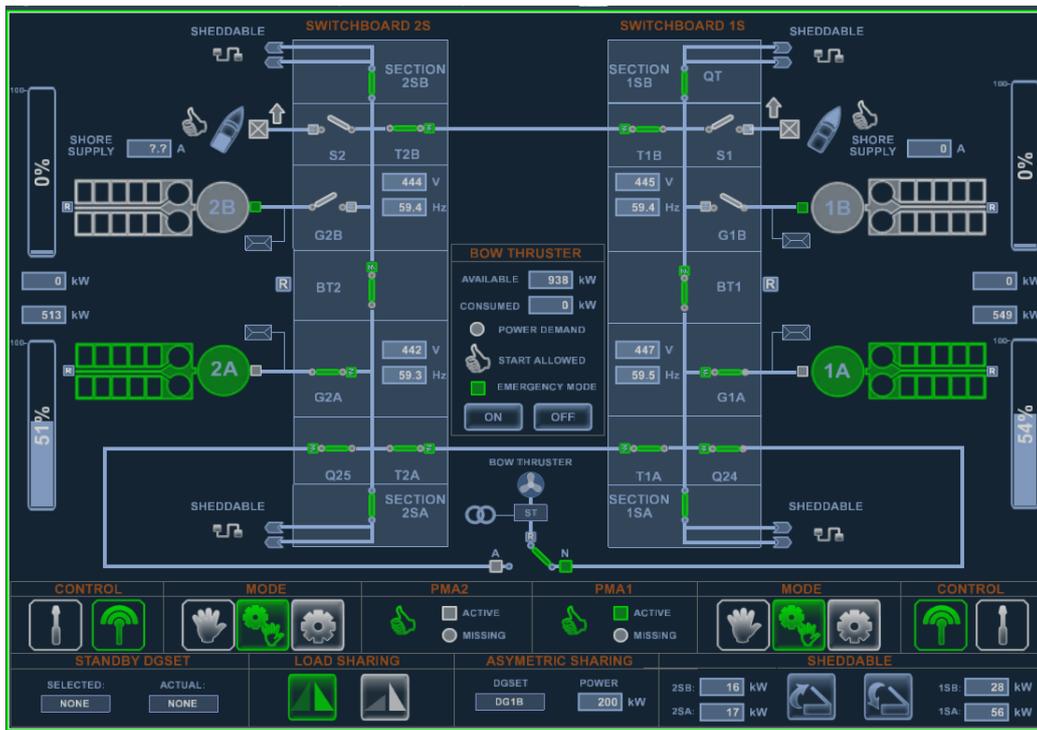
Figure 27: Power production status prior to the collision, shown in IPMS. Screenshot: NSIA

In 2015, one of the other frigates experienced 'black ship' while sailing with the switchboards in combined mode. Based on that incident, a CAO⁶¹ was issued in which the frigates were ordered to sail with the switchboards in split mode. At the time of the accident, HNoMS 'Helge Ingstad' was sailing with the switchboards in combined mode; see Figure 27.

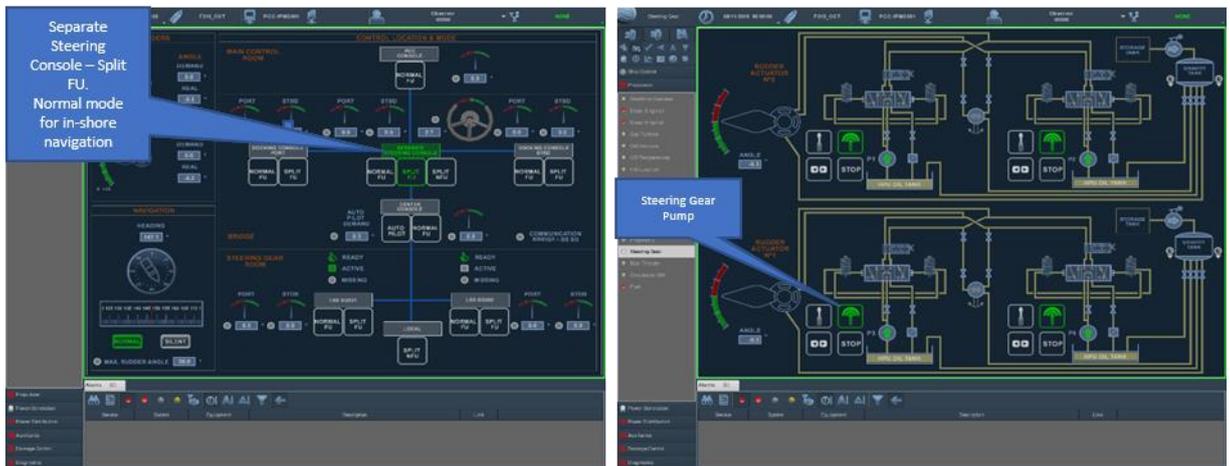
Figure 32 shows the rudder configuration before the collision. The rudders were controlled from the SSC and set to manual control in split mode ('Split follow up'). All four steering gear pumps were running.

Figure 32: IPMS configuration of steering and steering gear pump at 04:00:46, immediately before the collision. Modified creenshot: NSIA

After the collision, all four steering gear pumps stopped working for about 20 seconds, before pump 2 started up again. One minute and 13 seconds after the collision, all pumps were up and running again, with the exception of pump 3. After that, the rudders functioned in that condition up until approx. 04:08 when LC7 was disengaged. This caused one of the steering gear pumps connected to the port rudder to stop, so that each rudder was operated by one separate steering gear pump.

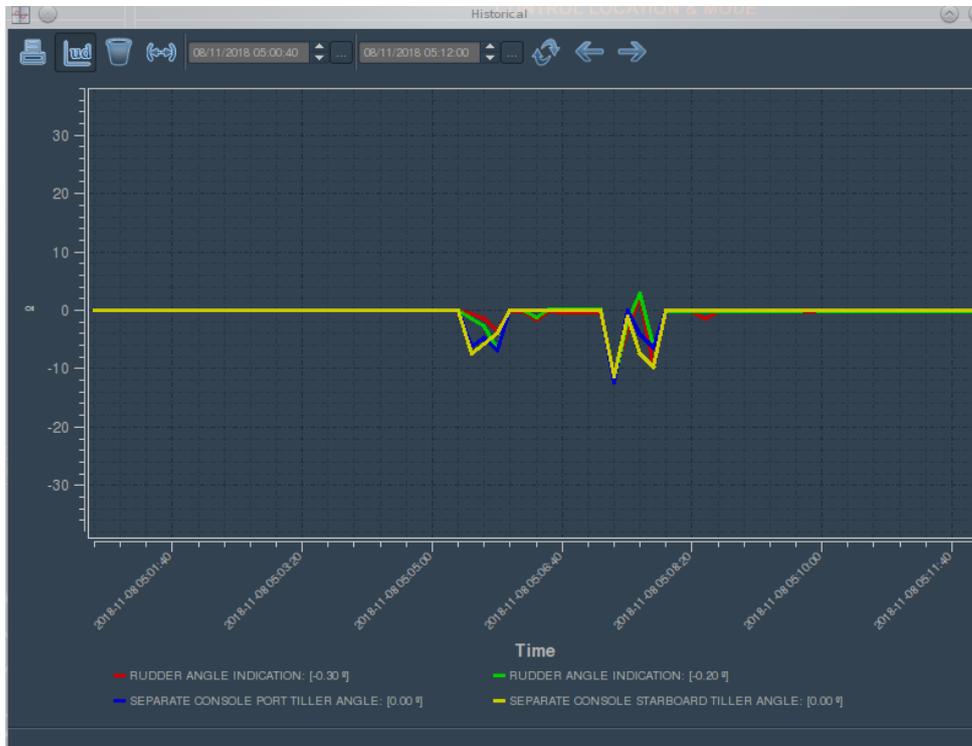
The IPMS logged rudder movement data, both tiller angles and relevant rudder angles. At 04:06:16, the rudder was set 5–7 degrees to port. The rudder angle was maintained for approx. 20 seconds. At 04:08:04, the rudder was again set 10–12 degrees to port. The rudder angle was maintained for approx. 30 seconds. Figure 33 shows console tiller angles and actual rudder angles for the starboard and port rudders.

Figure 33: IPMS data showing console tiller angles and actual rudder angles for the starboard and port rudders. Screenshot: NSIA

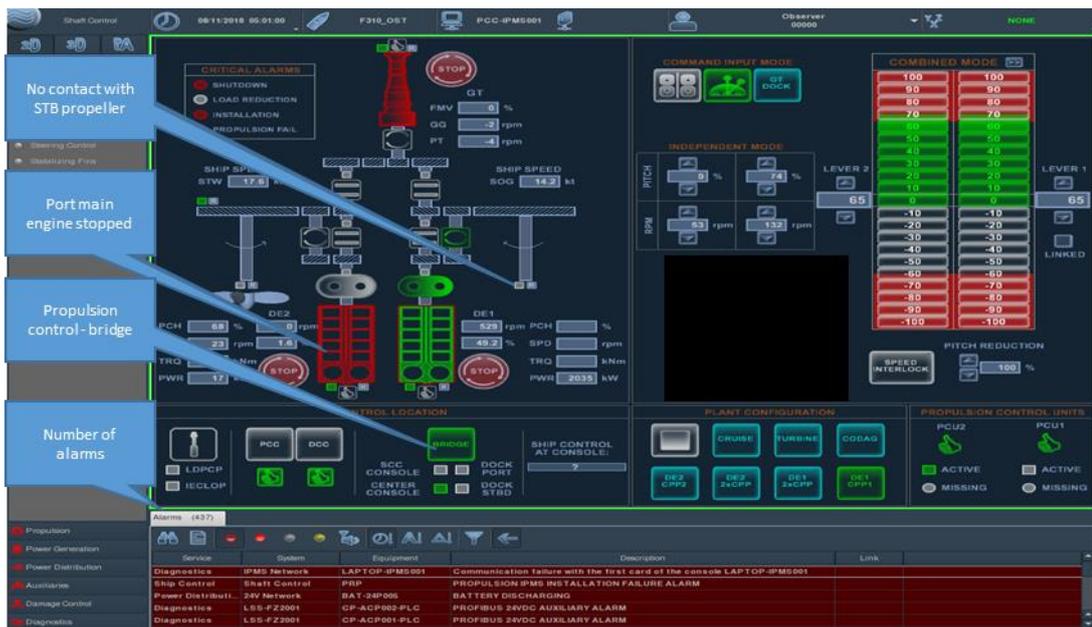
Until approx. 04:07, ‘Ship control’ was from the centre console on the bridge, after which control switched to ‘Local’, without such a switch being made from the LDPCP or IECLOP. Before the collision, the propulsion line was set to cruise mode, at 65% ahead thrust and with a speed over ground (SOG) of 17.1 knots; see Figure 40. ‘Ship control’ in the IPMS after the collision is shown in Figure 41.

Figure 41: 'Ship control' in the IPMS immediately after the collision at 04:01:39. Screenshot: The Navy, modified by NSIA

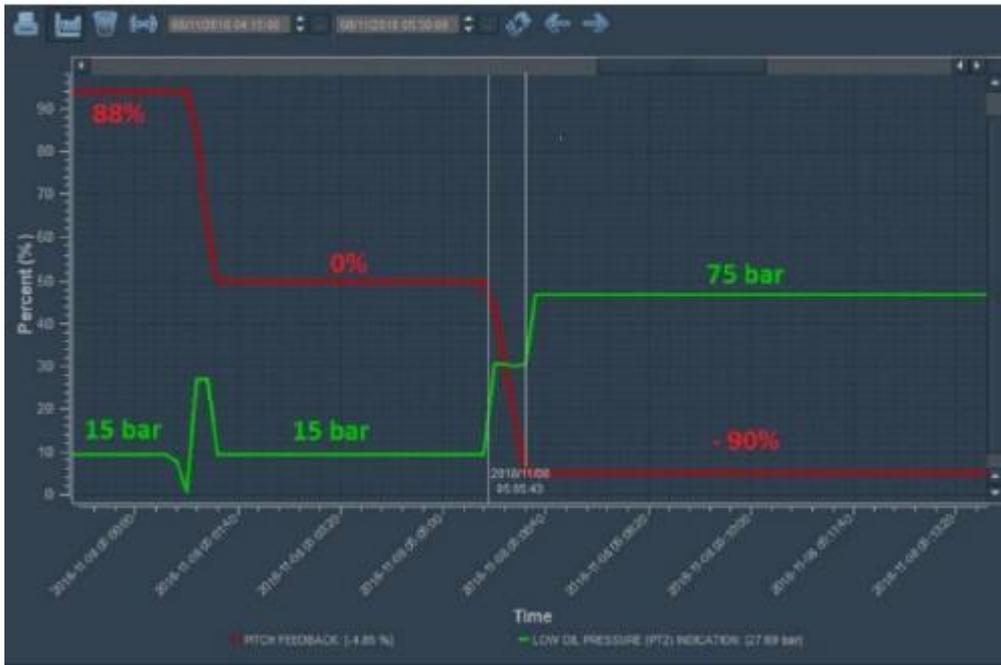
After the 'black ship' condition, the two electrical lube oil pumps for the gears did not start, as the two load centres that supplied the pumps were without electric power. Both pumps were without power up until approximately 04:03. When the secondary gear lost lube oil pressure, an emergency stop signal was transmitted to the port main engine. When the engine stopped, the pitch of the port propeller was automatically reduced to 0% by the IPMS. After the 'black ship' condition, the pumps for the port propeller were automatically restarted. At approximately 04:07, the backup system was activated and the pitch automatically changed from 0% to -90%; see Figure 42. The direct cause of this change has not been determined. For further information about findings related to the port main engine, see section 2.9.7.

Figure 42: Change in pitch of port propeller, shown in IPMS. Screenshot: Navantia

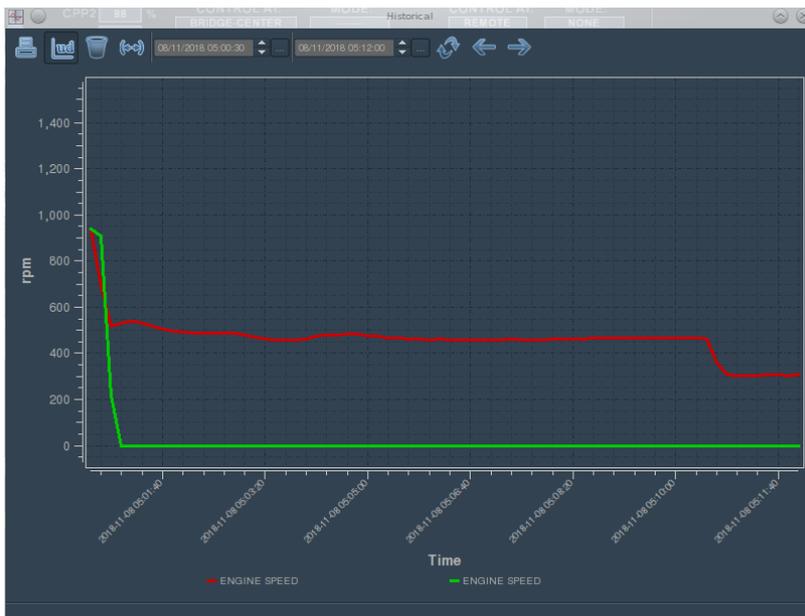
After the collision, the starboard propeller lost communication with the IPMS as a result of collision damage; see section 2.9.7.4. This meant that remote control of the propeller’s pitch from the IPMS was no longer possible. The starboard CPP therefore remained in the most recently set position (89%).

From 04:02:30 and until the frigate ran aground, she continued moving at 5–5.5 knots. The starboard main engine was running at low speed (460 rpm). After the grounding, the starboard engine continued to run, until it stopped at 04:26; see Figure 43. Attempts to stop the starboard main engine from IPMS is not registered.

Figure 43: Speed curves for the starboard and port propulsion lines, shown in IPMS. Screenshot: The Navy/NSIA

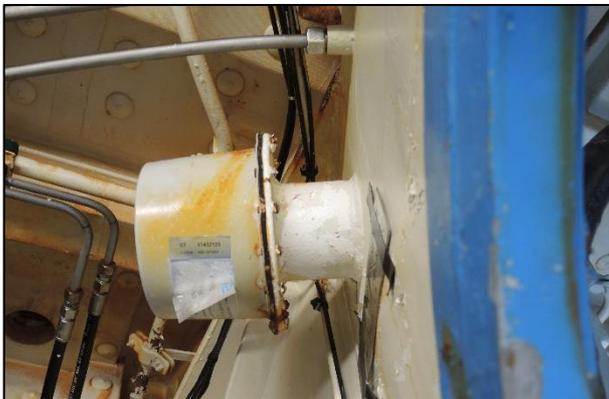
There were several hatches and openings in this compartment. There were six mooring hatches and six work hatches that were normally kept closed when at sea. In addition there were spring loaded overpressure valves in bulkhead # 188 starboard and port, and in 1 deck there were several sealed wire penetrations. The overpressure valves were watertight only from one side (from section 13 to 12).

Figure 51: Spring-loaded over pressure valve. Photo: NSIA

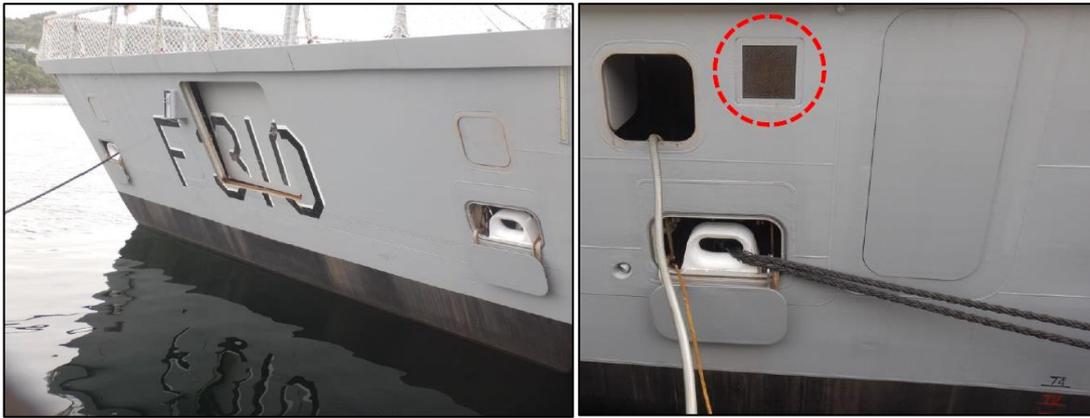
Figure 52: On the left: work hatches, mooring hatches and ATAS door in the stern. On the right: work hatch, mooring hatch and ventilation opening (marked with a red circle) on the starboard side). Photo: NSIA

The work hatches, mooring hatches and ATAS door were not marked on HNoMS 'Helge Ingstad'. They were closed at the time of the accident. According to SMP-17 (B), shipboard openings with a bearing on the vessel's CBRN and damage control state shall be marked with letters.

The NSIA has been informed, however, that there were challenges involved in keeping the hatches closed on a sister vessel. It was stated that gaps would arise unless the hatches were secured properly with cleats. There had also been instances of damaged hatches and use of jack straps to keep them closed. In addition, the work of maintaining the hatches was demanding because they tipped outwards as a result of their design, which meant that they had to be removed or that the vessel had to be docked while maintenance was being carried out. As part of their maintenance routine, the Royal Norwegian Navy carried out tests of watertight integrity of doors and hatches. This included either chalk test of watertight seal, hose testing of frame (outside) or ultrasound. No deviations were identified before the event.

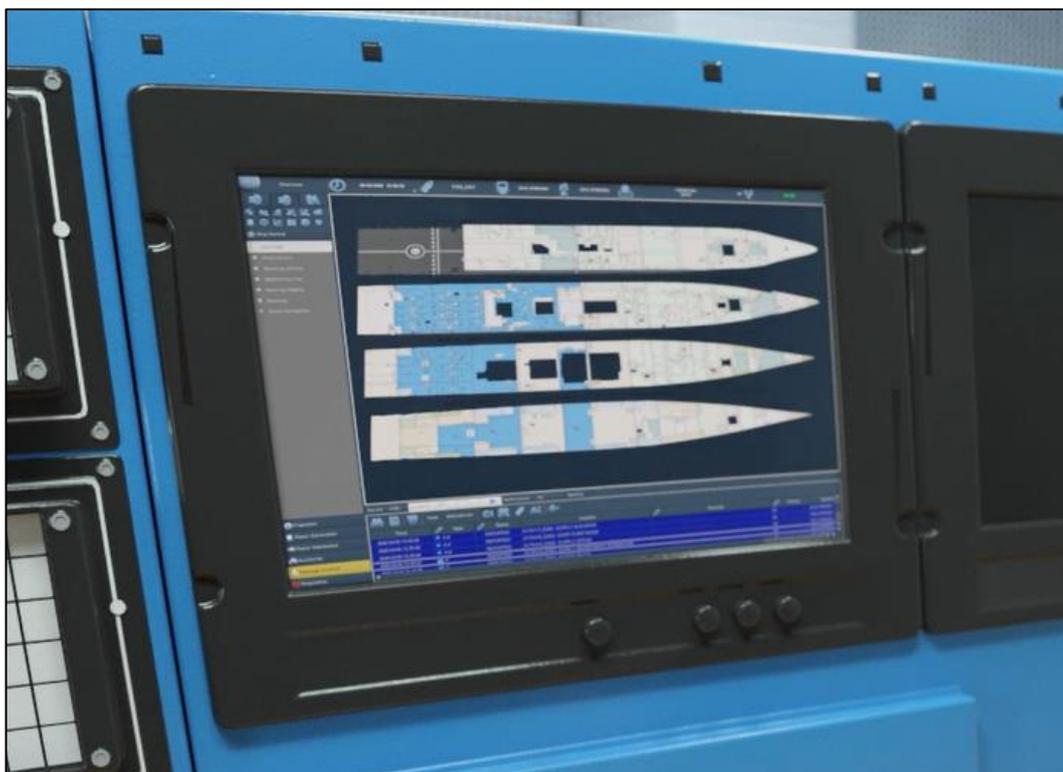
Figure 54: The stability calculator in HQ1. Illustration: CIAAS/NSIA

- *We have not been able to validate the stability calculator in the most recent version of the IPMS in relation to known load conditions described in the stability handbook. The reason for this is that there are too many errors in the software itself. We therefore recommend that the stability calculator be used for training purposes only until troubleshooting of the software has been completed.*

- *The stability calculator on HNoMS 'Helge Ingstad' has not been used much on account of lack of training in how to use the software and inadequate knowledge about stability. There should therefore be more focus on training. We also recommend that some changes be made to the user interface to simplify the data input process and to make critical information more visible.*

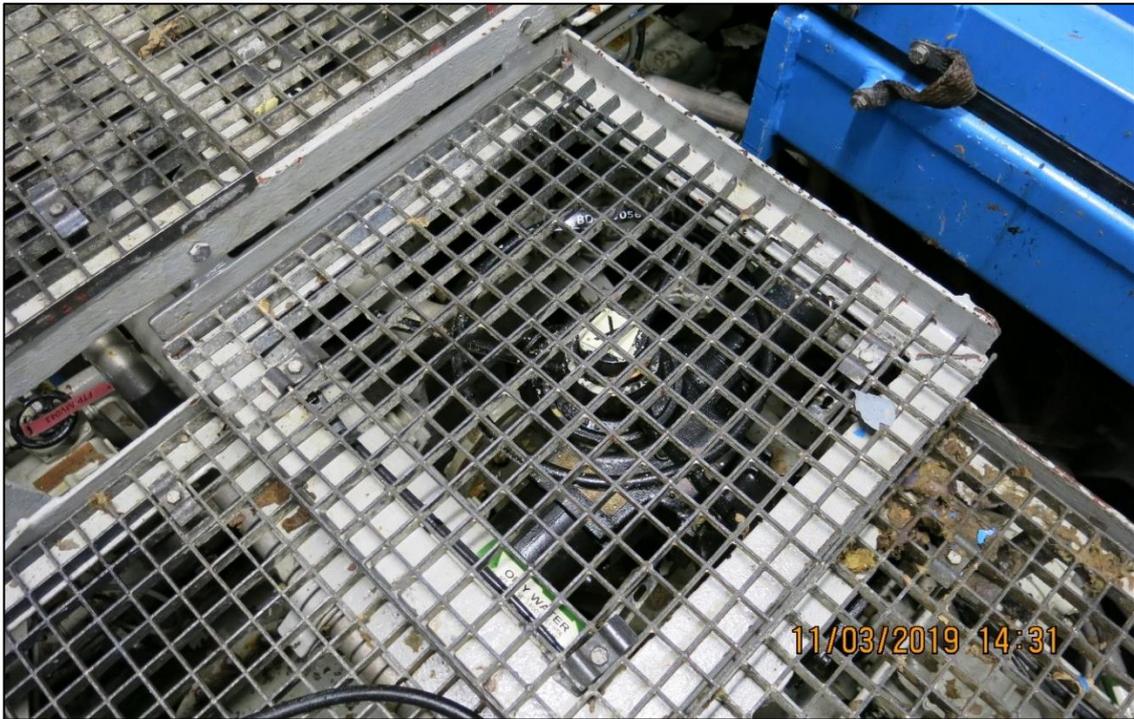
Remote control of the bilge system and seawater system by closing/opening the motorised valves was primarily from the IPMS in the MCR. These valves could also be operated from local panels on 2 deck. The motorised bilge valves could also be operated manually from the machinery spaces in the event that the power supply failed. At the time of the accident, many of the bilge valves were located under bolted-down floor grates due to shock protection. These grates had to be removed for access; see Figure 57.

Figure 57: Suction valve (tag BD-MV056) in black, located under floor grate in the aft generator sets room. Photo: NSIA

The status of all valves was checked during an inspection on board after the frigate had been refloated, and the suction valve (one of the three black bilge valves) in the aft generator sets room was found to be closed. It has not been possible to ascertain why this particular valve was closed, but since it was located under a bolted-down floor grate (see Figure 57), the reason why it was not opened manually may have been that it was not readily accessible to the crew. Because of the severed cables, remote operation of the valve from HQ1 or the local panel on deck 2 was also not possible.

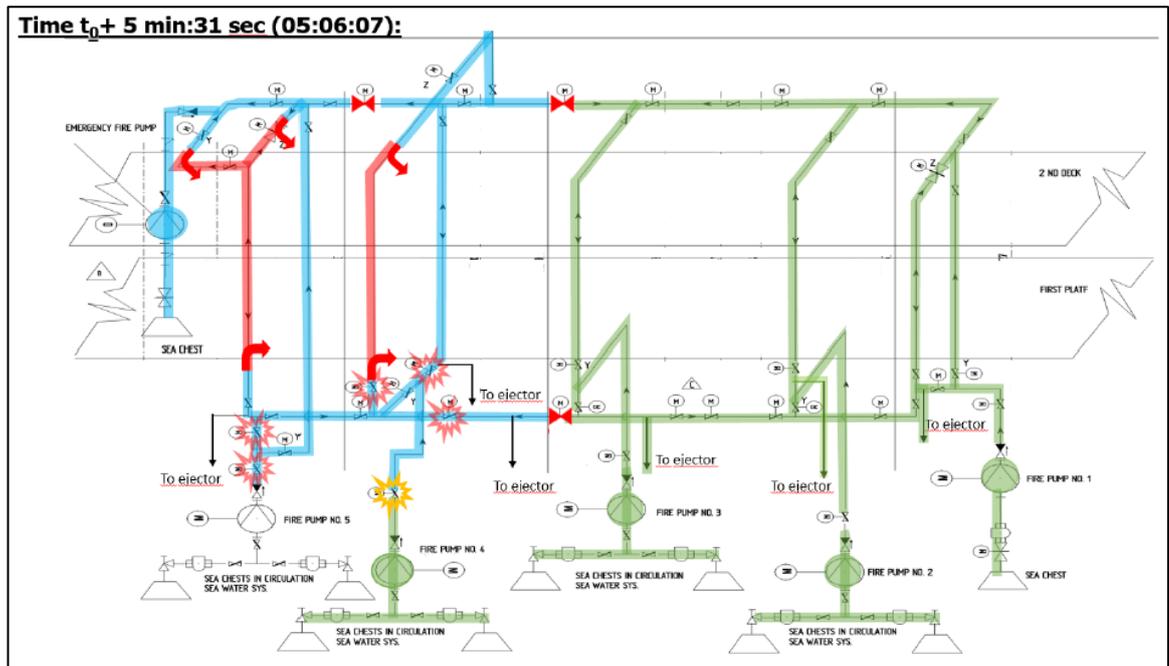
After the collision, the pressure in the seawater main system fell to 0 bar. Loss of communication with several valves on the seawater main in the afterbody made it difficult to segregate the seawater main in the afterbody using the IPMS. Before the seawater main was isolated, the IPMS operator started seawater pumps N-1, N-2, N-3 and N-4, but there was no pressure build-up in the system because the seawater was being pumped into the ship through the damaged seawater main in the afterbody. The pressure reading at pump N-4 was 10 bar, but valve MV-FM058 was closed and could not be opened because the local control panel was damaged.

Figure 59: Schematic⁷⁸ diagram showing how the seawater main was isolated at approx. 04:06. Schematic: IPMS report, Navantia, modified by the NSIA

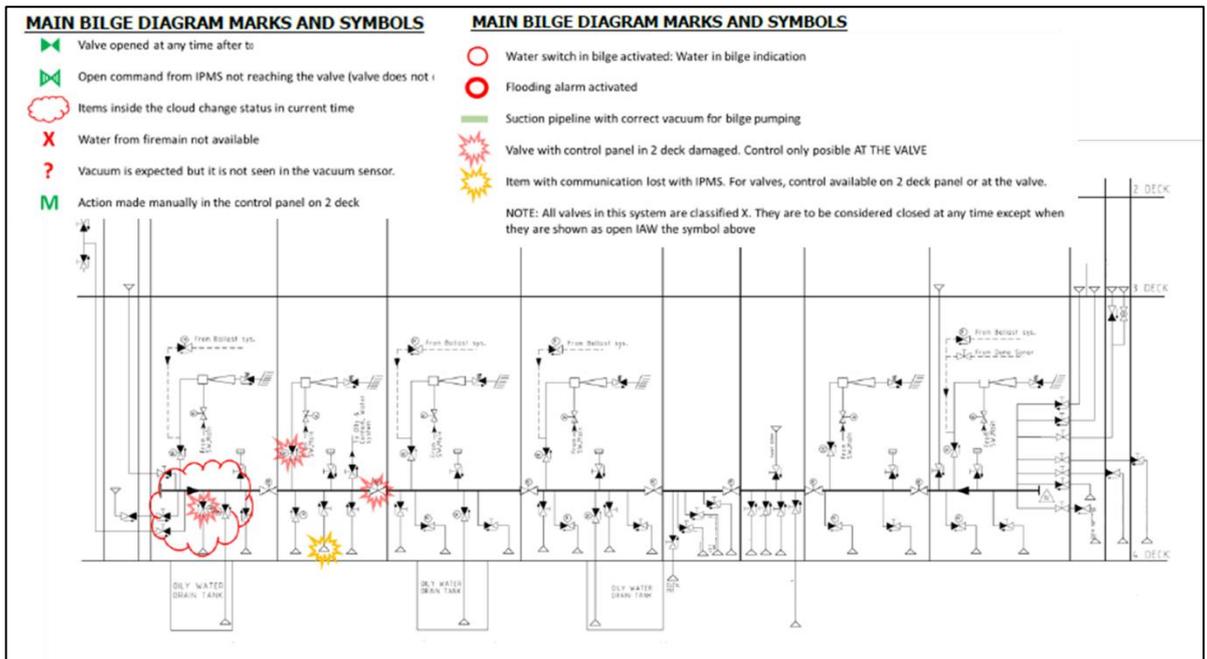
Several bilge system valves lost communication with the IPMS immediately after the collision, without such communication being restored after the ‘black ship’ condition. Among others, isolation valve BD-MV046 in the aft main engine room, suction valve BD-MV049 to the eductor in the aft main engine room and suction valve BD-MV056 in the aft generator sets room were impossible to operate during the incident, both from the IPMS and locally from the panel on 2 deck, because of damage to local panels and loss of remote control from the IPMS; see Figure 60.

Figure 60: The isolation valve in the aft engine room, the suction valve to the eductor in the aft engine room and the suction valve in the aft generator sets room were impossible to operate from the IPMS and locally from the control panel on 2 deck. Schematic: IPMS report, Navantia, modified by the NSIA⁷⁹

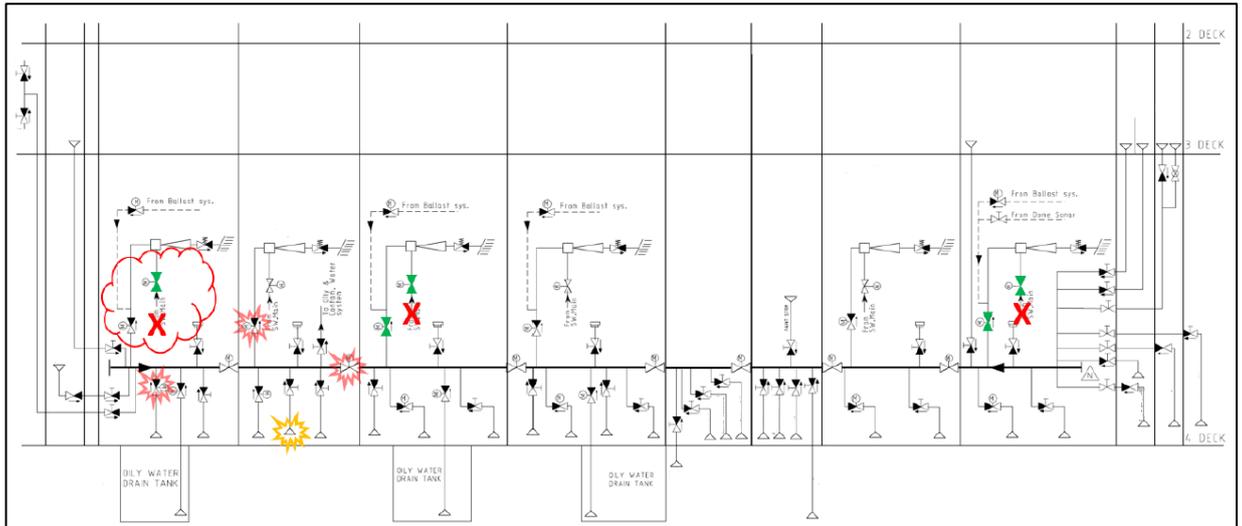
During the first two to three minutes after the collision, attempts were made to activate eductor 1 (bow thruster machinery room), eductor 4 (reduction gear room) and eductor 6 (aft generator sets room) from the PCC. Seawater pressure for the eductors was not established because the seawater main had not been isolated from the damaged section. At approximately 04:04, an attempt was made to open suction valve BD-MV056 in the aft generator sets room from the ACC, but it was not possible to operate this valve from the IPMS or from the local panel on account of the damage. Another unsuccessful attempt at the same was made from the DCC approximately two minutes later.

Figure 61: Schematic diagram of attempted activation of eductors 1, 4 and 6 from the PCC. Schematic: IPMS report, Navantia, modified by the NSIA⁸⁰

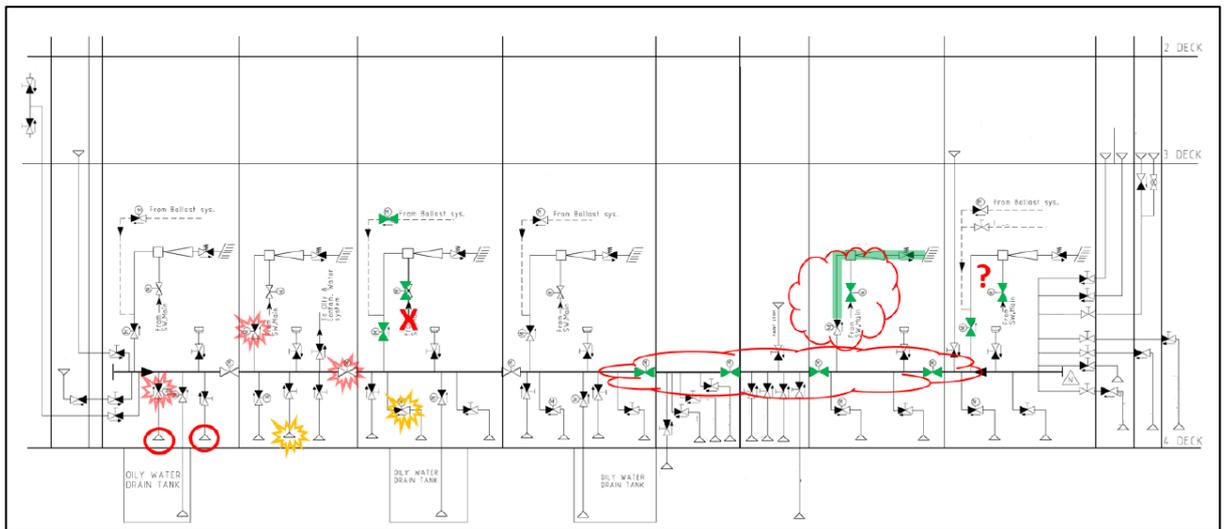
At approximately 04:07, the isolation valves in the forward main engine room and bow thruster machinery room were opened from the PCC. The eductors in these rooms did not achieve the expected suction, except in the forward auxiliary machinery room. The suction valve to the eductor in the auxiliary machinery room, intended to isolate the eductor from the bilge line, was closed at the time, while the suction valves to the eductors for the other machinery spaces were open; see Figure 62.

Figure 62: The schematic diagram shows open isolation valves on the bilge line at approx. 04:07. Schematic: IPMS report Navantia⁸¹

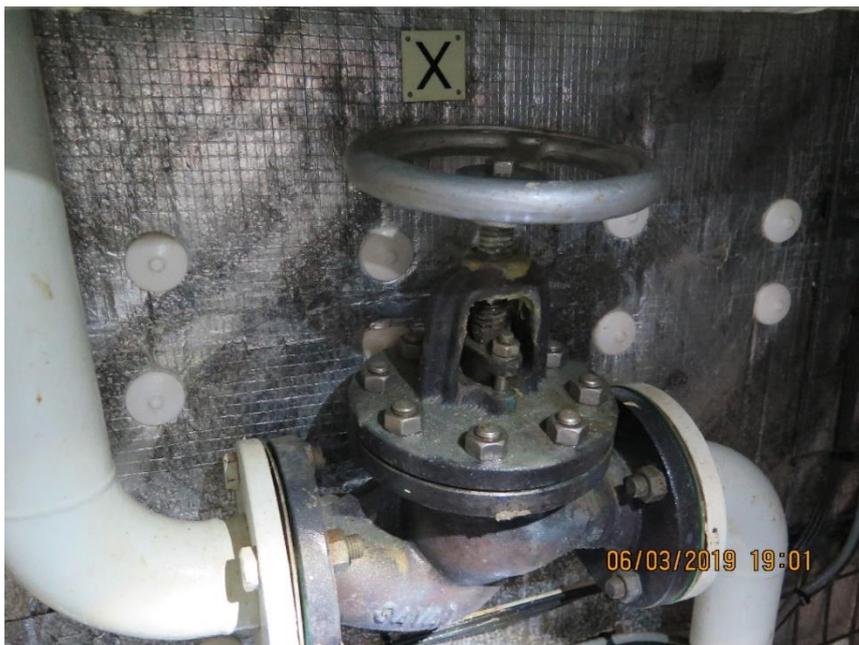
Tests carried out of the bilge system (see section 2.9.4) show that the two manual suction valves in the food waste treatment room and the pyrotechnics magazine were not properly closed and drew in air. This contributed to insufficient vacuum in the eductors that had open lines to these valves. Since the root valve in the auxiliary machinery room was closed against these valves and had sufficient driving water pressure, vacuum was achieved in this particular room.

Because the crew were unaware that these two manual valves were open, they probably found it incomprehensible when vacuum was not achieved in the three eductors that now had driving water pressure. The manual valves were not displayed in the IPMS and could only be checked by physical inspection of their status. These valves were marked with an 'X' (see Figure 73) and should have been closed in accordance with the marking system.

Figure 73: Example of manual bilge valve marked with an 'X' in the bilge system. Photo: NSIA

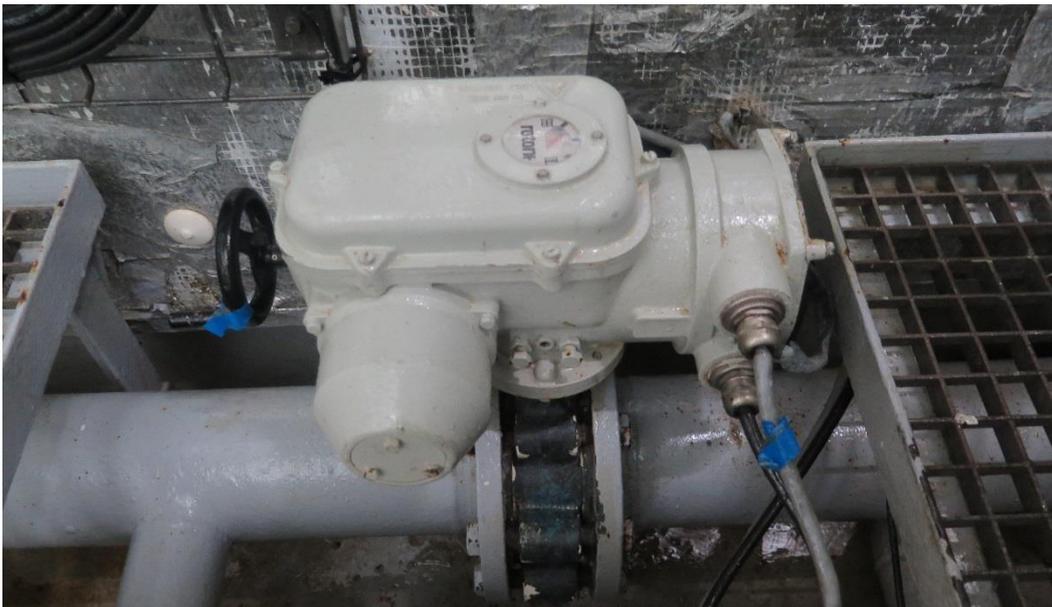
It was not possible to open the isolation valve in the aft generator sets room after the grounding, as it quickly became submerged in water and possibility of remote operation was lost due to disengagement of LS7. In theory it was possible to use emergency cables to the cabinet to control the valve from 2 deck, however, due to the unclarified situation, this was not done. This meant that it was impossible to pump out water from the aft generator sets room by use of eductors in compartments forward of that room. There was no possibility of operating the valve manually from a higher level should the remote control function fail and a valve become submerged in water.

Figure 74: Example of isolation valve. Photo: NSIA

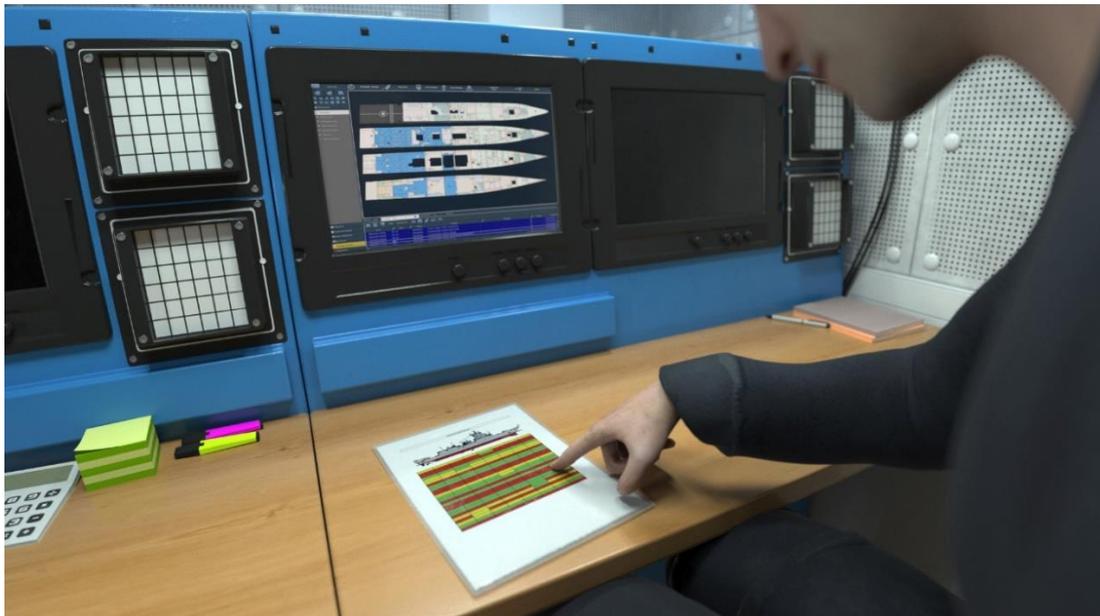
In the NSIA's opinion, the carpet plot in the stability manual was not very helpful for assessing survivability if the frigate was damaged in several places and such damage did not extend continuously over several watertight compartments. Damage in several places along the length of the hull must be assumed to be highly relevant on a warship. This was also described as a challenge in the crew's project assignment on the stability calculator. The project assignment was completed before the accident occurred; see section 0.

The frigate's stability calculator was not in use; see section 2.6.9.5.2. The NSIA was given a brief demonstration of the stability calculator by Navantia in February 2020, but has not conducted any test or gotten a full demonstration of the calculator. Hence, the NSIA does not know how sophisticated or user-friendly the stability calculator might have been. Nor has the NSIA assessed the expediency of integrating the stability calculator in the IPMS compared with an independent solution, but it assumes that such an assessment is carried out by the Navy and NDMA.

Figure 77: The carpet plot and the stability calculator. Illustration: CIAAS/NSIA

The NSIA believes that it might have made a difference to the sequence of events had the stability calculator been in use and the crew received regular training in how to use it to simulate complex damage scenarios. The crew would probably have obtained some assurance of the ship's survivability despite the flooding of more compartments than what the design criteria and carpet plot were based on; see 2.6.9.3. Assurance that the ship would not immediately capsize or sink would probably have made it easier to decide on actions to improve the situation to improve the situation, including where shutdown was most important, where the focus should be on pumping out water, transferring tank volumes and getting the ship pulled off the seabed. From the time the frigates were commissioned, both the Navy and the technical organisation¹³⁴ were aware that the crew felt that the stability calculator did not work in a satisfactory manner. The calculator was meant to serve as an important decision support tool in a damage control situation. The NDMA NSD has nonetheless stated that, during the period from handover to operations
