REPORT

Marine 2021/05

*PART TWO REPORT ON THE COLLISION
BETWEEN THE FRIGATE
HNOMS 'HELGE INGSTAD' AND THE
OIL TANKER SOLA TS OUTSIDE THE
STURE TERMINAL IN THE HJELTEFJORD
IN HORDALAND COUNTY
ON 8 NOVEMBER 2018*

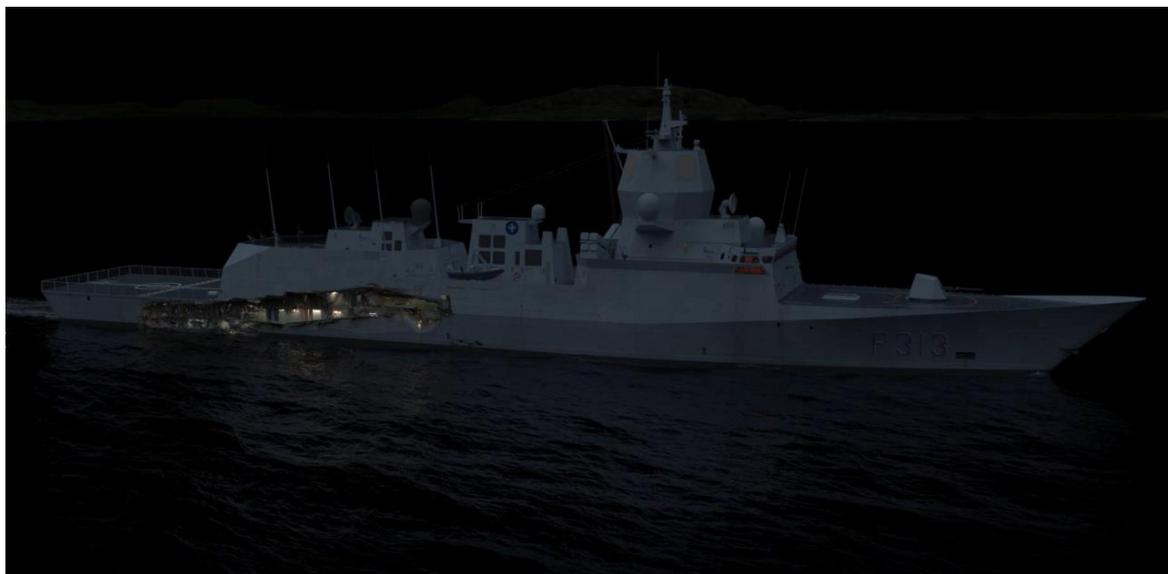
Figure 79: HNoMS 'Helge Ingstad' after the collision. Illustration: NCIS/CIAASS/NSIA
