# Fire on board *Iron Chieftain*

Port Kembla, New South Wales, on 18 June 2018

## **ATSB Transport Safety Report**

MO-2018-011

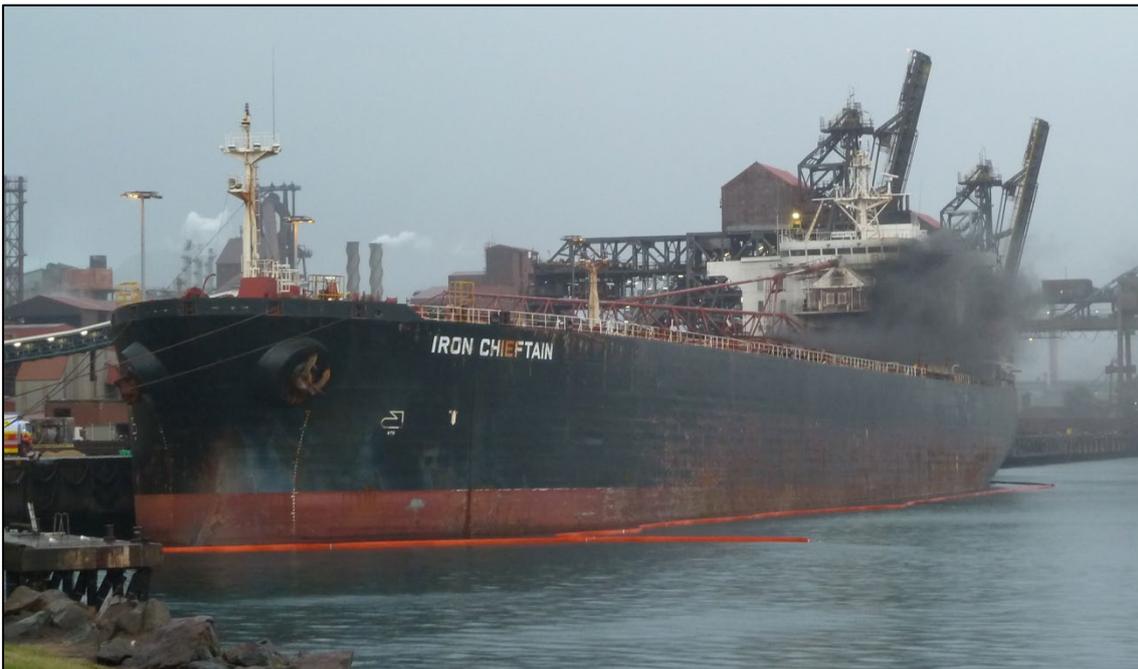
**Figure 1: *Iron Chieftain* on fire at Port Kembla**

At about 0222 Eastern Standard Time<sup>2</sup> on 15 June 2018, *Iron Chieftain* (Figure 1) arrived at the pilot station off Port Kembla, New South Wales, following a voyage from Ardrossan, South Australia. The ship was loaded with about 41,832 tonnes (t) of dolomite.<sup>3</sup> At 0530, a pilot embarked the ship and by 0700, *Iron Chieftain* was safely alongside, (starboard side to) at berth number 113, owned and operated by BlueScope Steel.

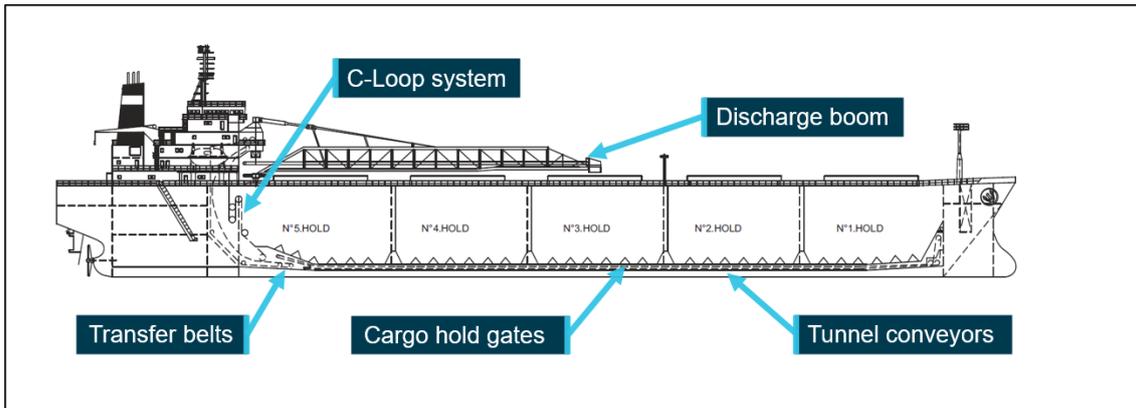
**Figure 2: Iron Chieftain's self-unloading system**

The ship commenced discharging cargo shortly after berthing, at about 0755. The cargo was discharged into trucks through a shore-side hopper using the ship's self-unloading system (Figure 2). The system consisted of a series of hydraulically operated gates under the cargo holds through which cargo was deposited onto conveyor belts running in tunnels under the ship's holds. The cargo was transported to two smaller athwartships transfer conveyor belts, up a vertical conveyor

belt system, known as the C-Loop elevator, and then across the ship's deck to the shore-side hopper and trucks via a discharge boom (see the section titled *The self-unloading system*).

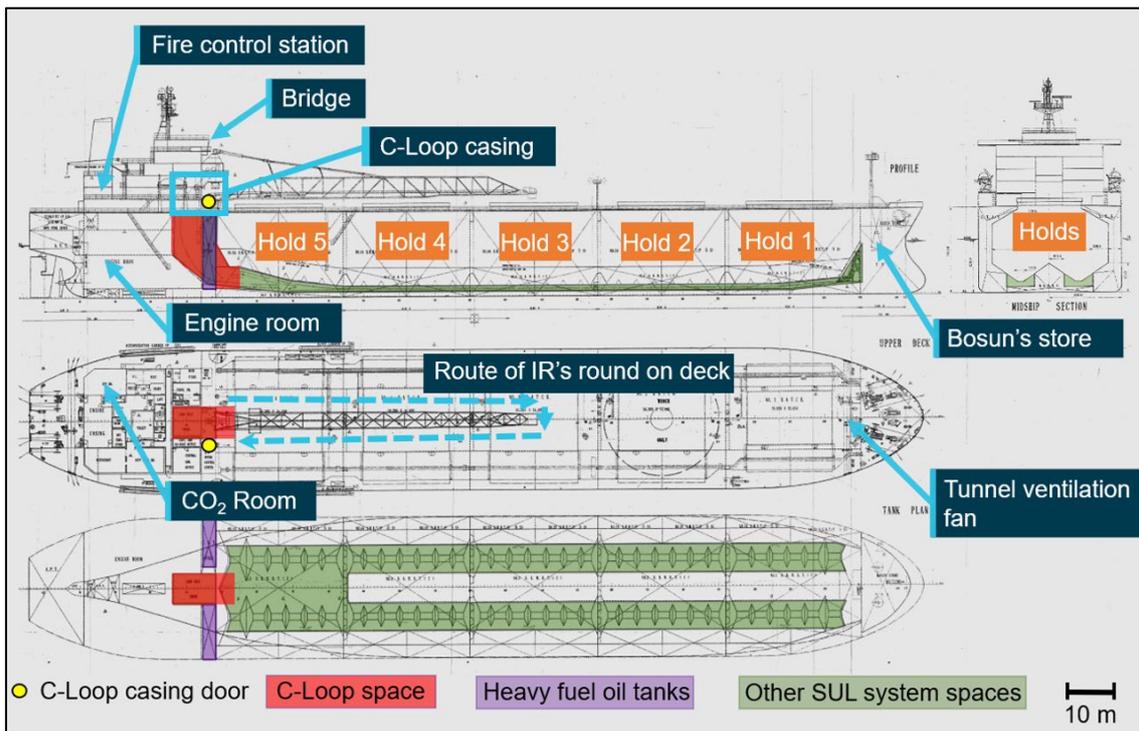
**Figure 3: Iron Chieftain – Ship's plans highlighting relevant spaces and information**

At 0300, the IR radioed the second mate, who was the officer of the watch, and informed him that he was about to start his rounds again. The second mate started the ventilation fan (located on the foc'sle) which provided airflow through the tunnels from forward to aft. By this time, just under 40,000 t of cargo had been discharged from the ship's five cargo holds with about 2,000 t remaining to be discharged from hold number 3 (Figure 3). The hatch covers on hold number 3 were open with those on the four empty cargo holds closed.

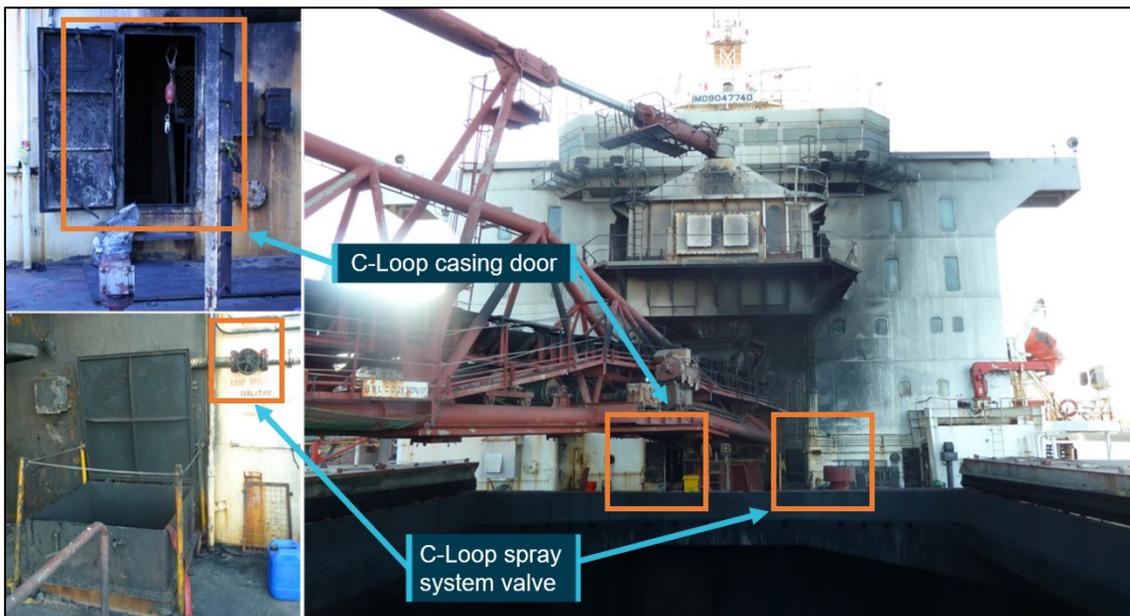
**Figure 4: C-Loop casing door and C-Loop spray system valve**

Shortly after, the chief mate was joined by the deck mechanic. Together they attempted to open the valve for the C-Loop dust suppression spray system, which was in front of the accommodation to port of the C-Loop casing. However, they could not approach it due to the smoke and heat emanating from the C-Loop casing. They decided to go back to the emergency muster station and organise an emergency party to return and open the valve.

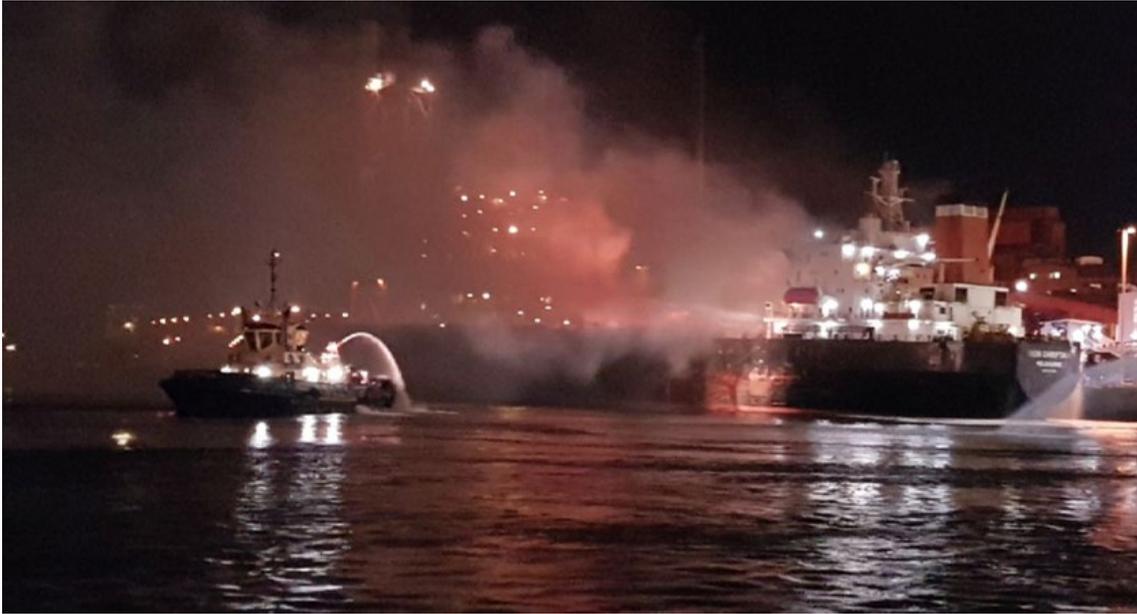
**Figure 6: Port Kembla tugs assisting with firefighting efforts**

By 0606, the IMT was established and included representatives from FRNSW, the ship, police, and the port authority. An anti-pollution boom was also installed around the ship by the port authority and tug support remained in place (Figure 6). Representatives from the ship's owners, Canada Steamship Lines Australia (CSL Australia) also arrived on site later that day.

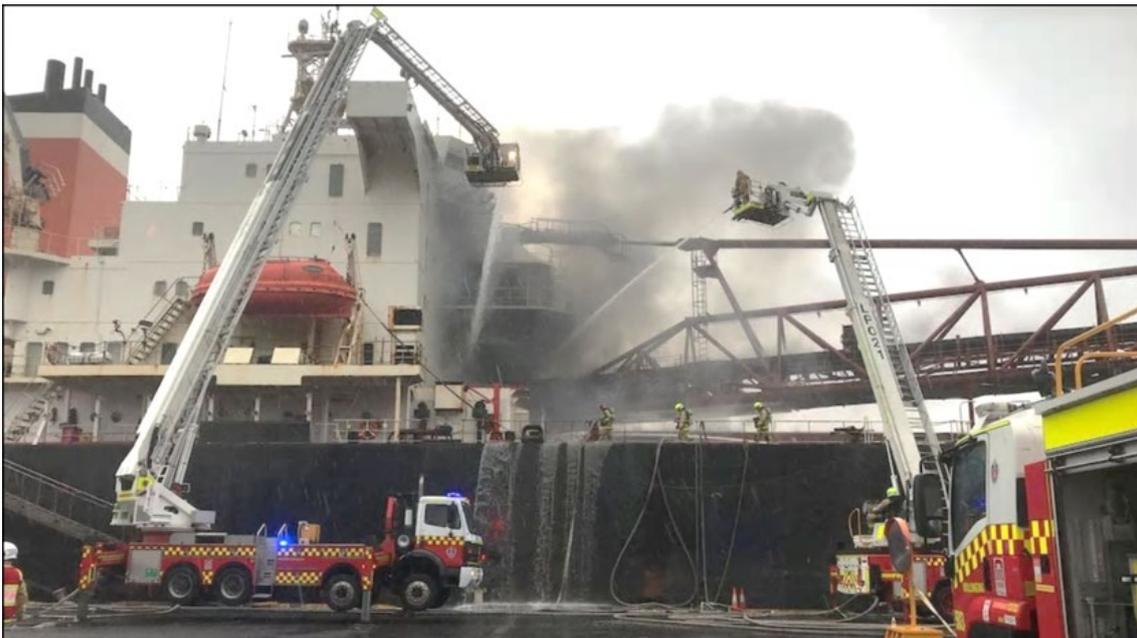
**Figure 7: Firefighting using aerial appliances**

By 0942, the firefighting strategy began to transition from defensive to offensive firefighting using foam. At about 1144, firefighters reported zero visibility at the C-Loop casing door with temperatures between 46-56 °C. Shortly after, the ship's master went aboard to provide assistance with opening the bow access hatch to the forward end of the SUL system tunnel spaces. Meanwhile, firefighting continued using aerial appliances and without the firefighters entering the C-Loop space (Figure 7).

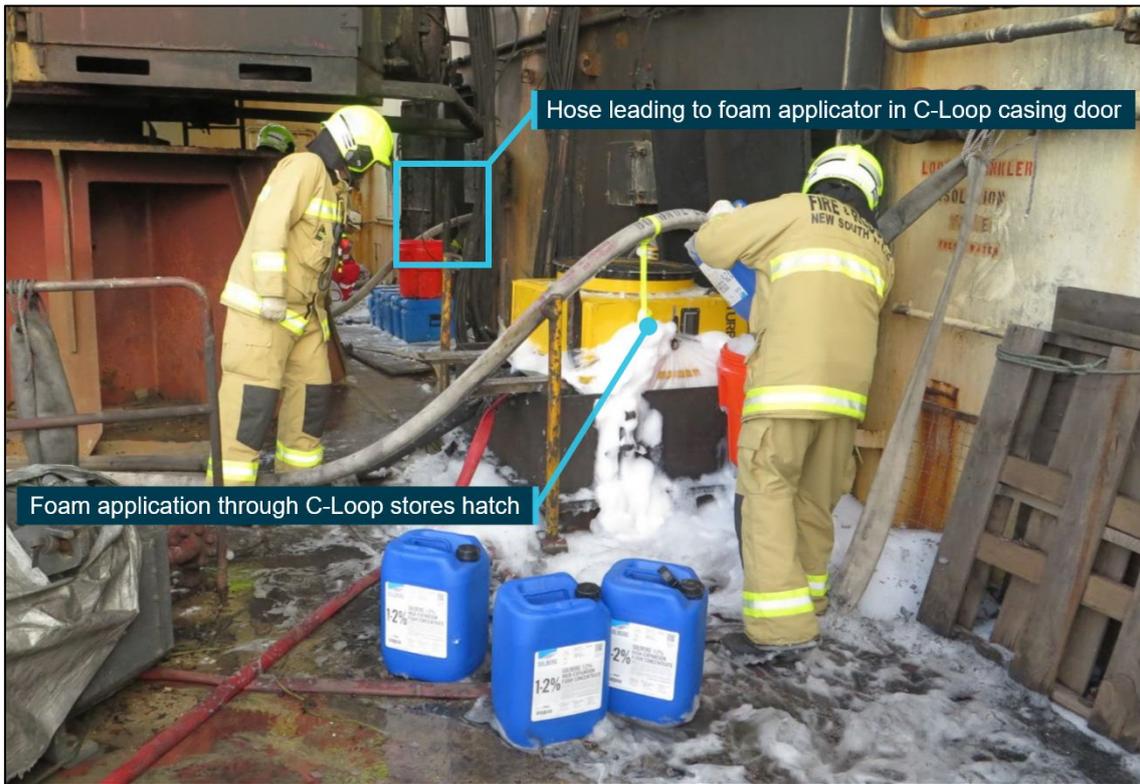
**Figure 9: Foam application to C-Loop space**

Foam being introduced through the C-Loop stores hatch aft of cargo hold number 5. In background, note hose leading to foam applicator in the C-Loop casing door.

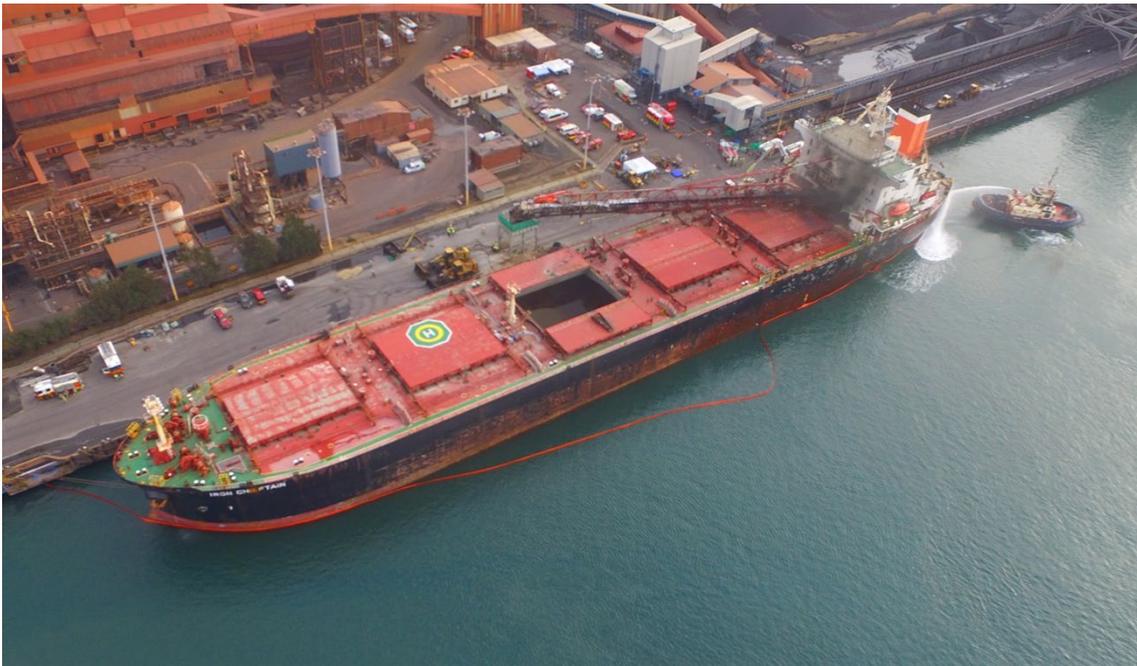
**Figure 10: RPAS footage of *Iron Chieftain* on fire on 20 June**

Shortly after midday, a FRNSW remotely piloted aircraft system (RPAS) was deployed to assist firefighting efforts by providing aerial daylight and thermal imagery (Figure 10).

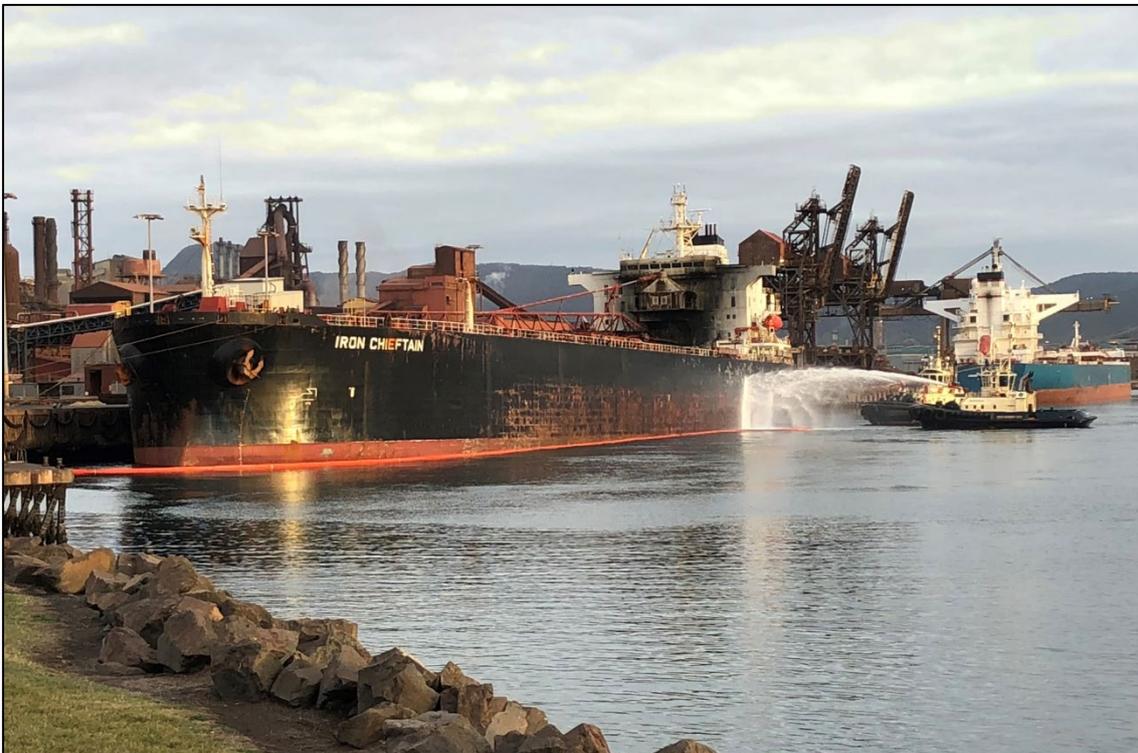
**Figure 11: *Iron Chieftain*, with the fire extinguished**

On 22 June 2018, at 0755, firefighting crews along with ship's engineers completed an assessment of the cargo holds, engine room and superstructure. The low temperature readings and gas monitoring readings obtained indicated that extinguishment had been achieved (Figure 11). The inspections also revealed that HFO, firefighting water or a combination of both had leaked from the tunnels into cargo hold number 3. FRNSW continued to maintain the foam blanket in the C-Loop space while monitoring the situation and beginning preparations to hand over the site.

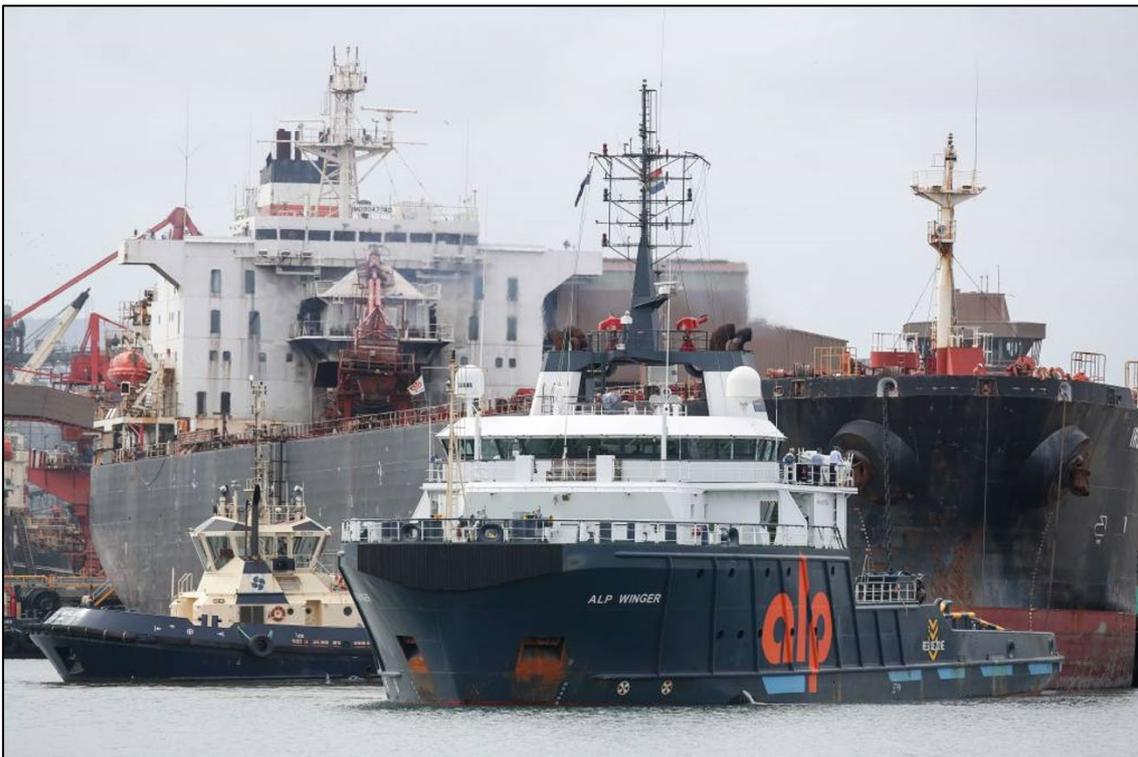
**Figure 12: *Iron Chieftain*, departing Australia under tow**

As a result of the substantial damage sustained due to the fire, *Iron Chieftain* was declared a constructive total loss (CTL). The ship remained at Port Kembla for several months while work continued to remove and dispose of the remaining fuel and contaminated firefighting water on board. On 27 March 2019, the ship departed Port Kembla under tow, for Aliaga, Turkey to be recycled (Figure 12).

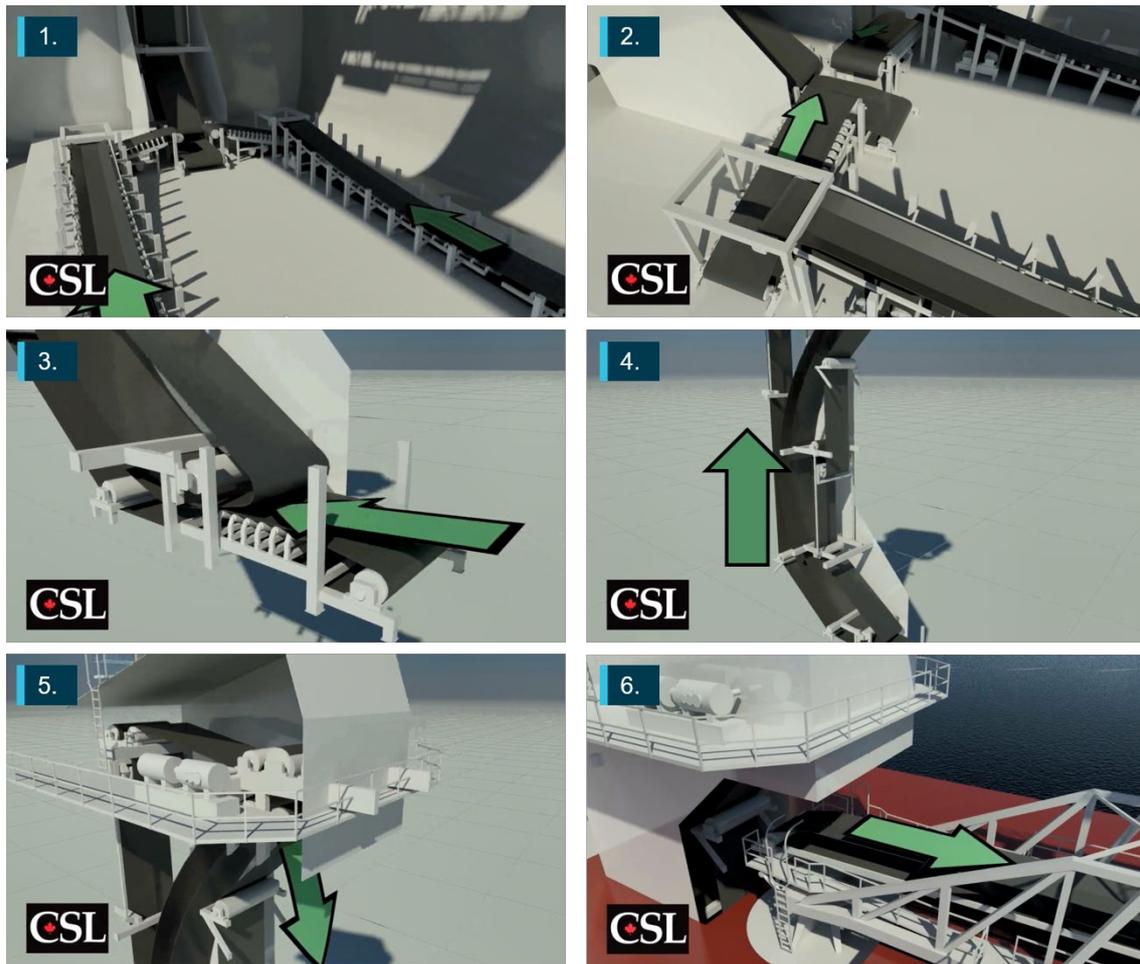
Figure 13: General operation of Iron Chieftain's SUL system

Each tunnel conveyor belt was about 2.1 m wide, 20 mm thick and about 278 m long (in total). The tunnel conveyor belts were arranged in a 'trough' profile supported by idler rollers with the drive pulley<sup>25</sup> at the aft end driven by electric motors. The tunnel conveyor belts were hydraulically tensioned at their forward end. The tunnel conveyors transported cargo from the hold gates and deposited them on the transfer conveyor belts at the base of the C-Loop elevator (Step 1 in Figure 13).

There were two transfer conveyor belts, port and starboard, one each at the aft end of each tunnel conveyor belt. The transfer belts were oriented in the athwartships direction, perpendicular to the tunnel belts. Each transfer conveyor belt was about 2.1 m wide, 26 mm thick and about 19 m long (in total). The transfer conveyors were driven by electric motors and were mechanically tensioned. The transfer conveyors moved the cargo from the tunnel conveyors to a discharge hopper above the horizontal section of the C-Loop outer belt at the bottom of the C-Loop space (Step 2 in Figure 13).

The C-Loop conveyor belts consisted of an outer electric motor-driven conveyor belt loop onto which the cargo was loaded from the transfer belts (Step 3 in Figure 13). The outer belt was paired with a passive (non-motor driven) inner belt which rotated in the opposite direction to the outer belt so as to 'sandwich' the cargo and transport it vertically up the C-Loop elevator tower (Step 4 in Figure 13). The inner and outer belt loops separated at the top where the cargo was discharged into a chute and on to the discharge boom conveyor (Step 5 in Figure 13).

The discharge boom conveyor on deck transported the cargo from the termination of the C-Loop elevator belts, just forward of the accommodation, to receiving facilities ashore or on another vessel (Step 6 in Figure 13). The boom conveyor belt was enclosed within corrugated metal roofing with timber anti-spill liners. The boom was 72 m long giving it a working radius of about 56 m from the ship's side. The boom could be hydraulically slewed up to 90° to either side and luffed up to an angle of 18° from the horizontal. The discharge boom conveyor was driven by electrical motors.

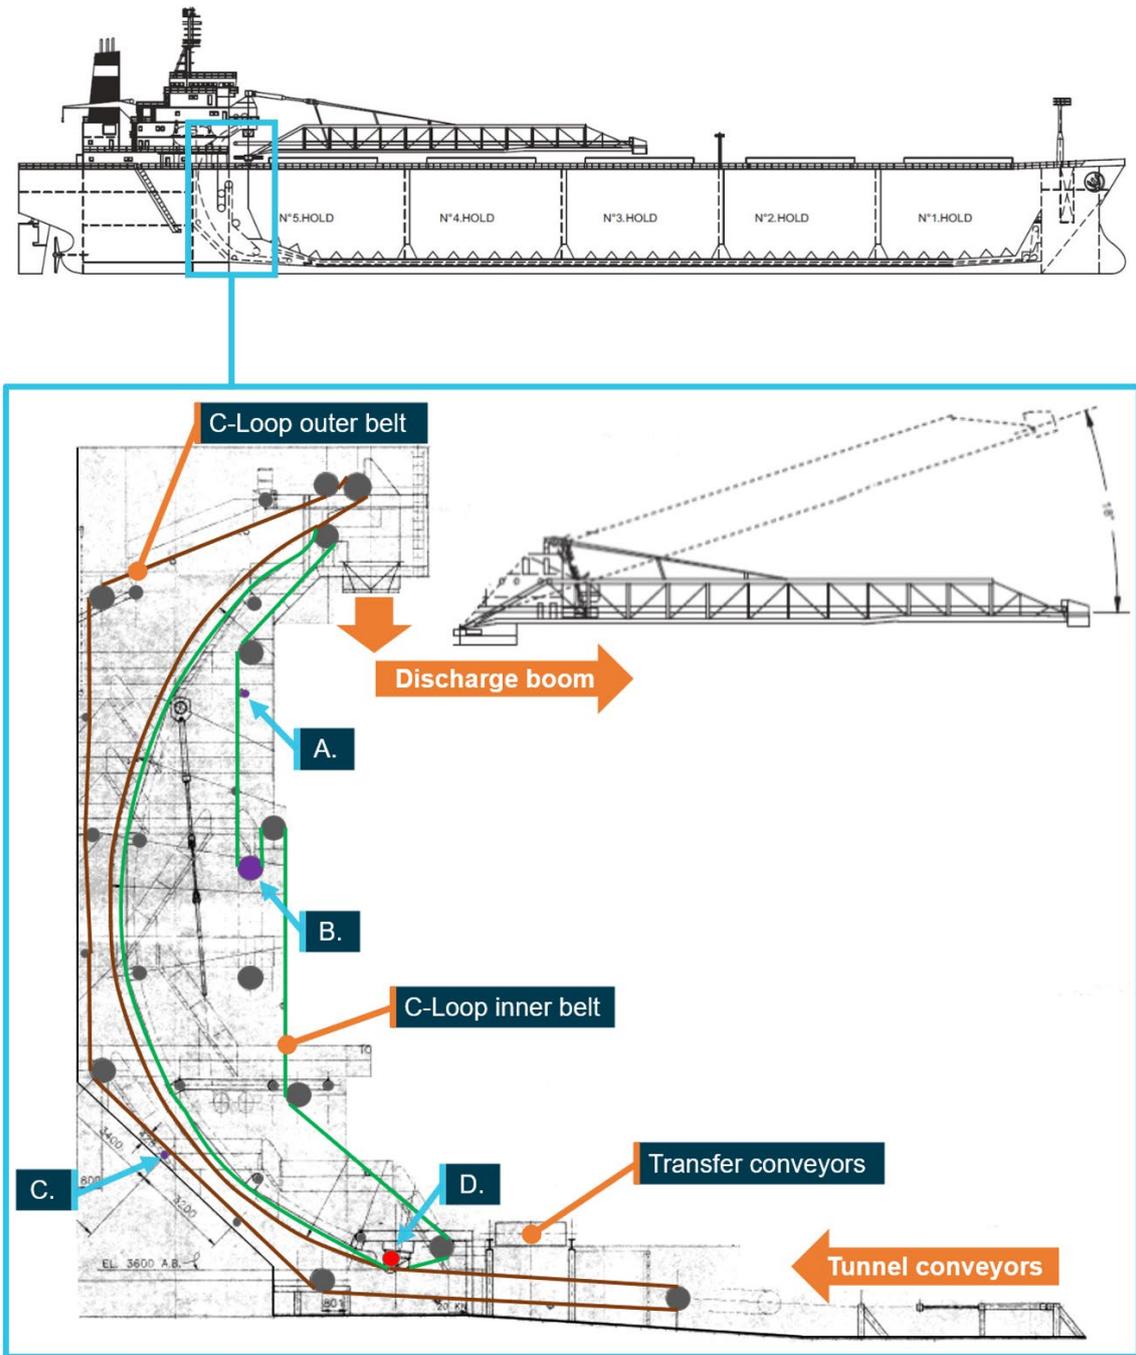
Figure 20: Location of idlers and pulleys of relevance to the fire investigation

The investigation found four specific areas of interest during the examination of the accessible C-Loop idlers and pulleys (Figure 20).

A C-Loop inner belt support idler (Figure 20, Component A) about mid-way up the C-Loop space exhibited signs of impact damage possibly associated with the collapse of the tension pulley or fire damage to the conveyor belt or both. The idler had fallen and impacted ship's structure below. However, it was considered unlikely it interfered with the belt's movement even if it collapsed before the fire began. The damage was assessed as probably a result of the fire rather than causative.

The tensioning pulley for the C-Loop inner belt (Figure 20, Component B) had also collapsed and wedged near the base of the C-Loop. One of its bearings was found to be displaced and showed evidence of heat damage. However, the damage was more consistent with mechanical impact from falling down into the C-Loop space followed by exposure to the fire rather than due to a failure during normal operations.

The cover of the C-Loop outer belt return pulley's (Figure 20, Component C) port side bearing showed signs of being slightly displaced from its original position. However, this was more consistent with a bearing in the early stages of a potential failure rather than a bearing that had already failed.

At the base of the C-Loop was a series of idler rollers and impact idlers<sup>50</sup> collectively known as the lower snub impact assembly (Figure 20, Component D).<sup>51</sup> The lower snub impact idler of the C-Loop inner belt assembly consisted of aft and forward components.

The forward component comprised an impact idler covered with rubber impact discs which remained intact, although fire damaged. The aft component consisted of five idlers and served the inner belt of the C-Loop. The bearings of the port side outboard idler showed no signs of mechanical failure, nor did the central idlers. However, the bearing of the starboard side outboard idler and most of its metal components were destroyed (Figure 21). The degree of damage was considered highly unlikely to have been the result of fire damage and was not observed at any other bearings.
