SAFETY INVESTIGATION REPORT

REPORT NO.: 12/2021

MT MED TUNCER **Electrical fire inside the lifeboat** **in the port of Antwerp, Belgium** **14 May 2020**

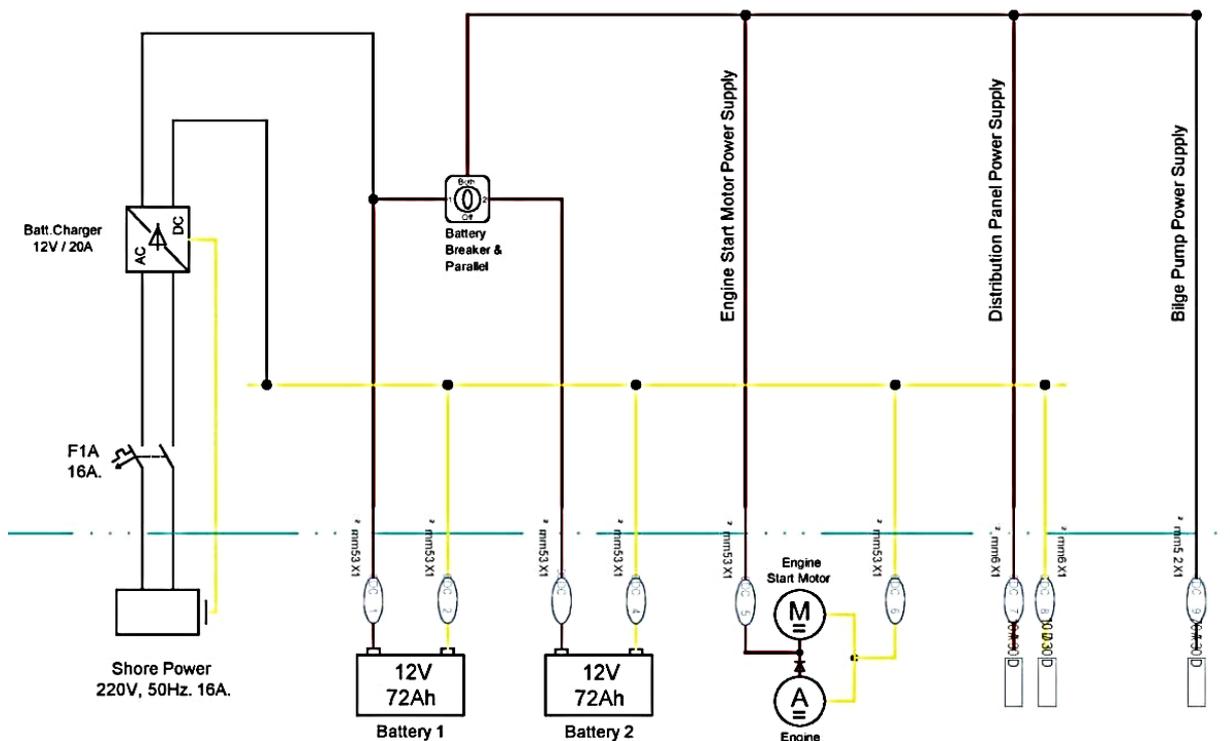
Figure 4: 12 V DC circuit diagram

The battery changeover switch on the control panel had three marked positions: 1, 2 and both (Figure 3). This provided the flexibility to use either battery separately or use them both in parallel. The lifeboat's circuit diagram is shown in Figure 4. The electrical circuit and the ship's power supply to the battery charging system was protected by a 16A fuse and a double pole, 12V DC circuit breaker.
