SAFETY INVESTIGATION REPORT

REPORT NO.: 10/2021

MT MOUNT EVEREST

Serious injury to a crew member, during mooring operations in the port of Marsaxlokk, Malta 08 May 2020

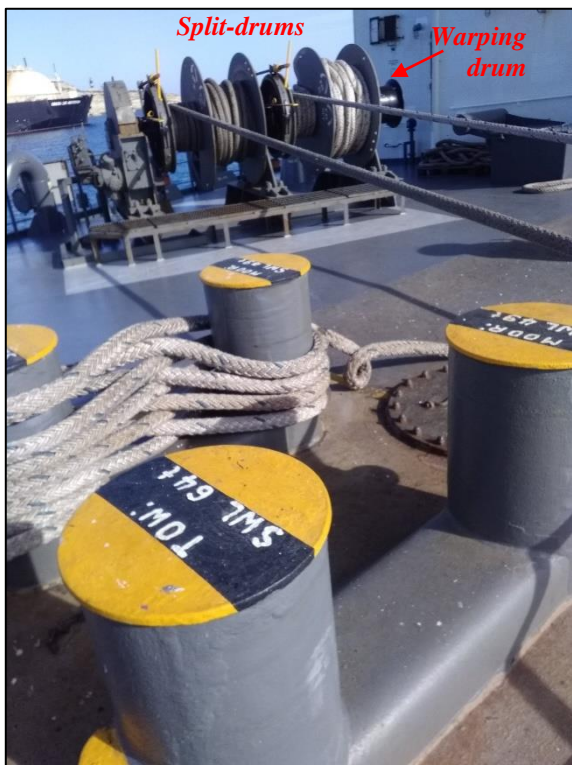
Figure 2: The aft, port side, twin split-drum mooring winch of *Mount Everest*

Each of the split-drums had their own brakes and could be disengaged from the winch, thus allowing for one to be isolated while operating the other. The vessel's records indicated that the brake holding capacity of each split-drum was 40.80 mt.

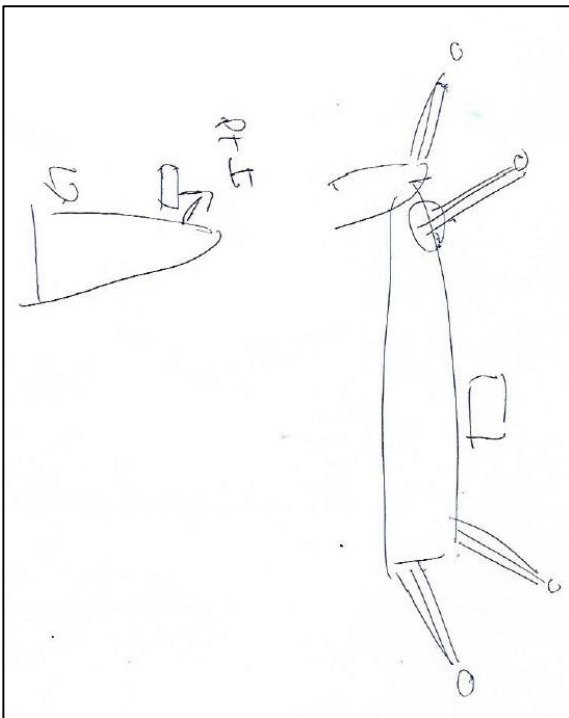
Figure 5: Sketch of the mooring configuration agreed during the master-pilot exchange

The mooring configuration agreed during the master-pilot exchange, necessitated the use of the port anchor, three headlines, three stern lines and three breast lines each, from the forward and aft (Figure 5).

The agreed mooring configuration sketch indicated that three stern lines were meant to be passed from the stern of the vessel (Figure 5). However, the intended mooring configuration (Figure 6), which was reportedly conveyed to the third officer, did not reflect this configuration.

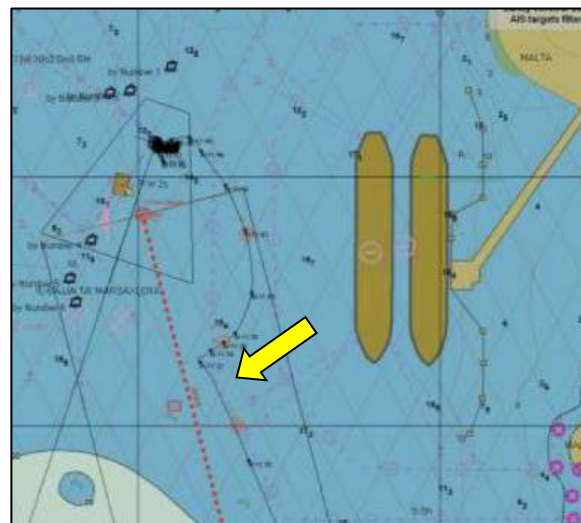
Figure 7: Screenshot of *Mount Everest*'s ECDIS showing the vessel's approach to *Has-Saptan Fuelling Dolphin*

At around 1342, the vessel approached the dolphin (Figure 7), dropped her port anchor to about seven shackles in the water, and the crew members passed the vessel's mooring ropes to be secured to the mooring buoys, beginning with the head and stern lines. At the same time, the vessel's engine was briefly kicked to 'dead slow ahead'.

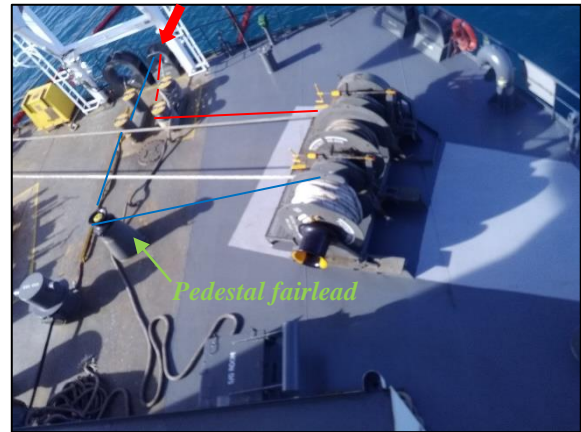
Figure 9: The centre fairlead (red arrow) through which all three stern lines were passed

Two of the three stern lines were passed from the port mooring winch (Figure 8), while the third stern line was a loose mooring rope, which was lightly wound around a mooring bitt (dashed green line in Figure 8), after it was secured on the mooring buoy. All three lines were passed through the centre fairlead on the vessel's poop deck (Figure 9). The master was not aware of the stern lines' configuration since it was neither visible from the bridge, nor was it reported to him by the third officer.

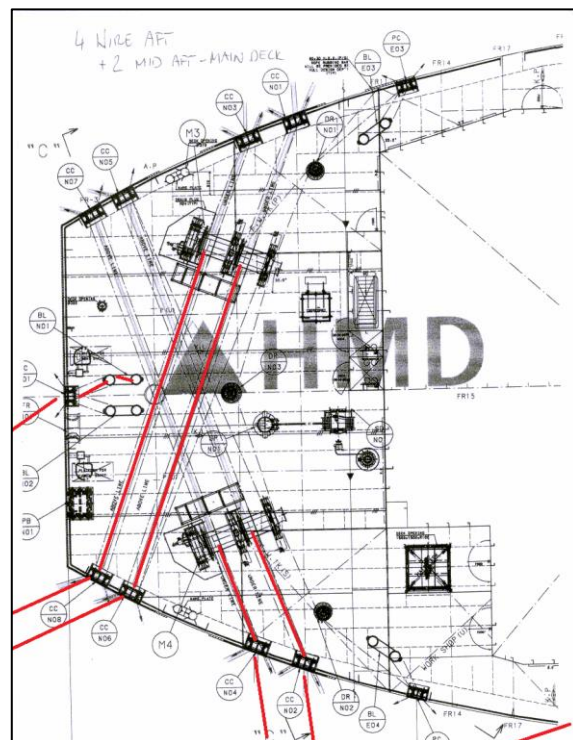
Figure 11: Mooring configuration after the accident

In the meantime, the pilot notified the vessel traffic services (Marsaxlokk VTS) on the accident and requested medical assistance to be organised and deployed. At around 1448, the vessel was moored with a different configuration (Figure 11) and the gangway was finally lowered at about 1518.
