Report on the investigation
into a fatal accident
on board **mv ATLANTIC PROJECT II**

in the port of Antwerp
with the decease of one crew member
on February 8th 2021.

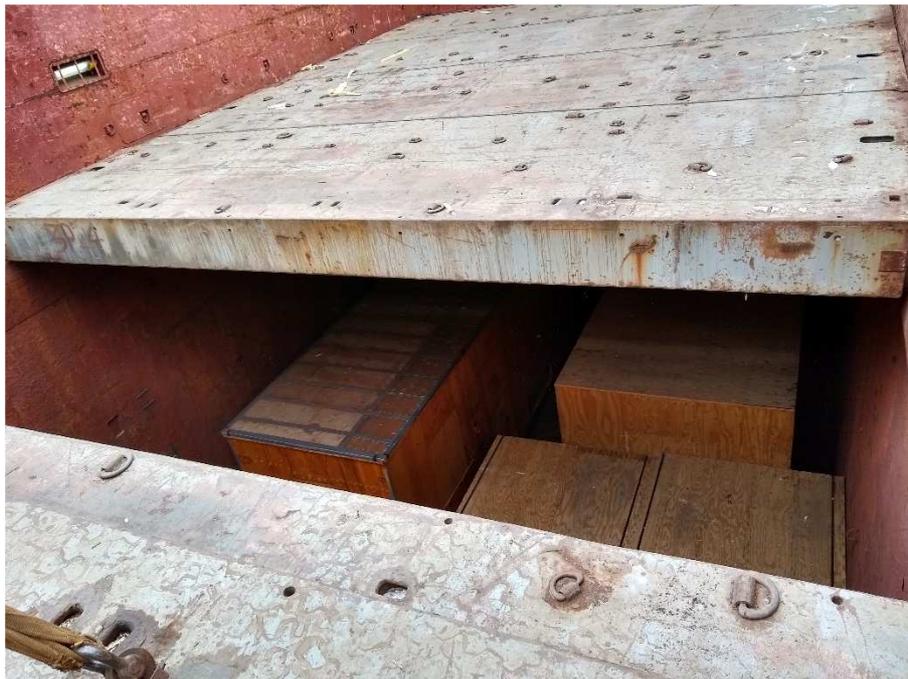
Figure 1 - Cargo below the tween-deck pontoons in cargo hold 3 PS

A part of the cargo to be unloaded was in cargo hold N°3, on top as well as below the tween-deck as seen in Figure 1.

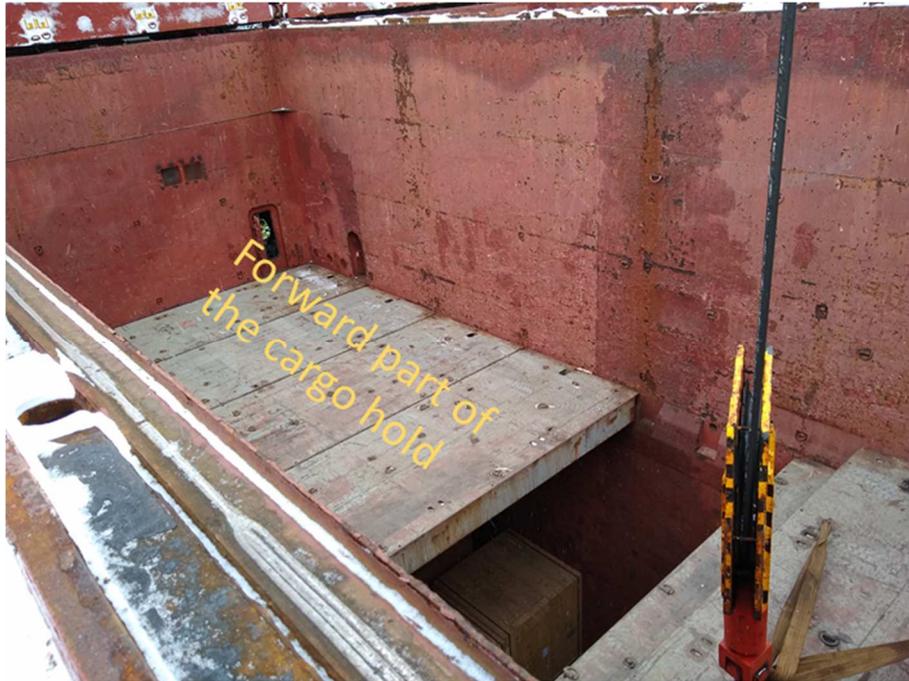
Figure 3 - Location of AB and OS

The AB and the OS were positioned in the forward part of the cargo hold, where they would rig the pontoons, as indicated in Figure 3.

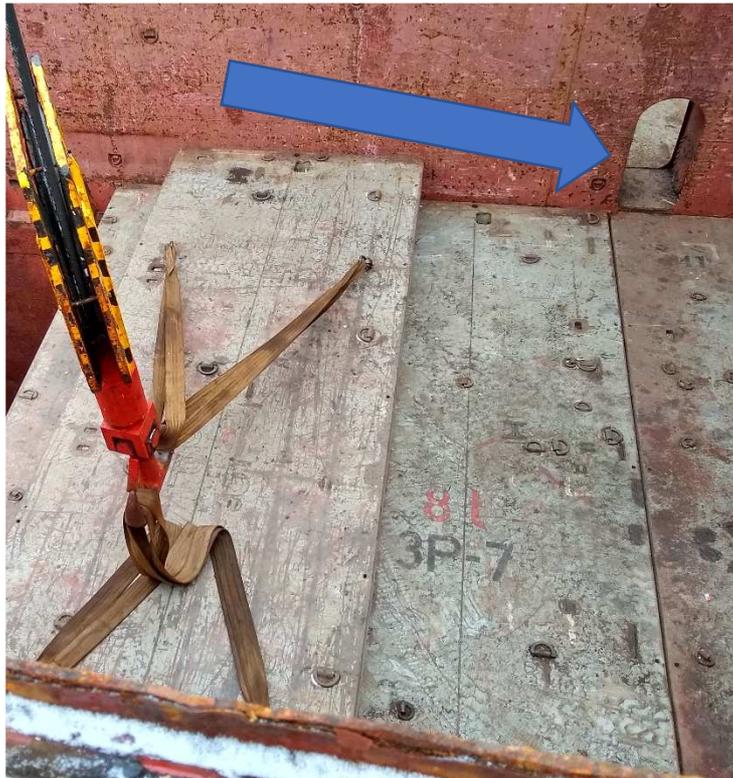
Figure 5 - Manhole between PS and SB cargo hold

This OS had to be stand-by in a safe position until the first pontoon was laid down on deck. The dedicated safe position for a crewmember during the manoeuvring of the pontoons inside the hold was inside or behind a manhole between PS and SB cargo hold, as shown in Figure 5 and Figure 6.

The manhole was the dedicated passage from PS hold to SB hold.

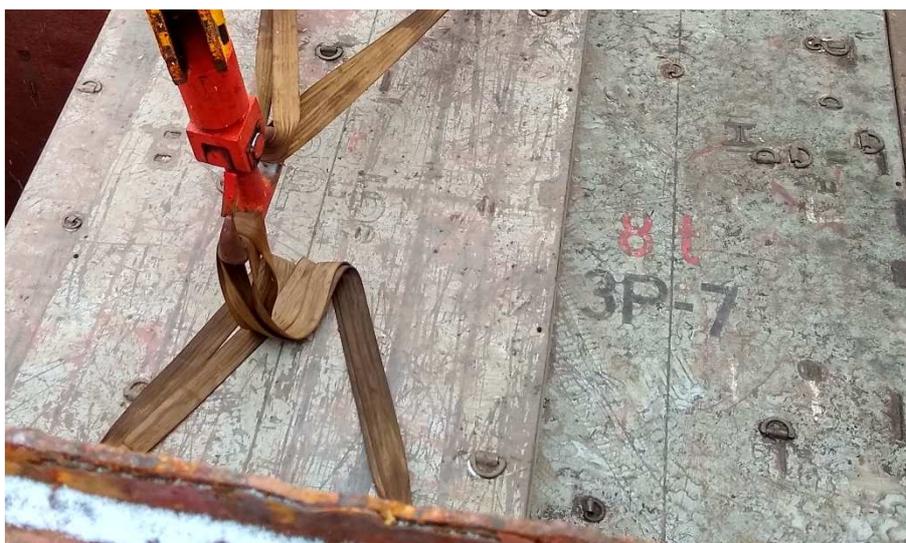
Figure 12 – Numbering of pontoons

In Figure 12, pontoon N°5 is seen to be lifted and placed on top of pontoons N°6 and N°7.

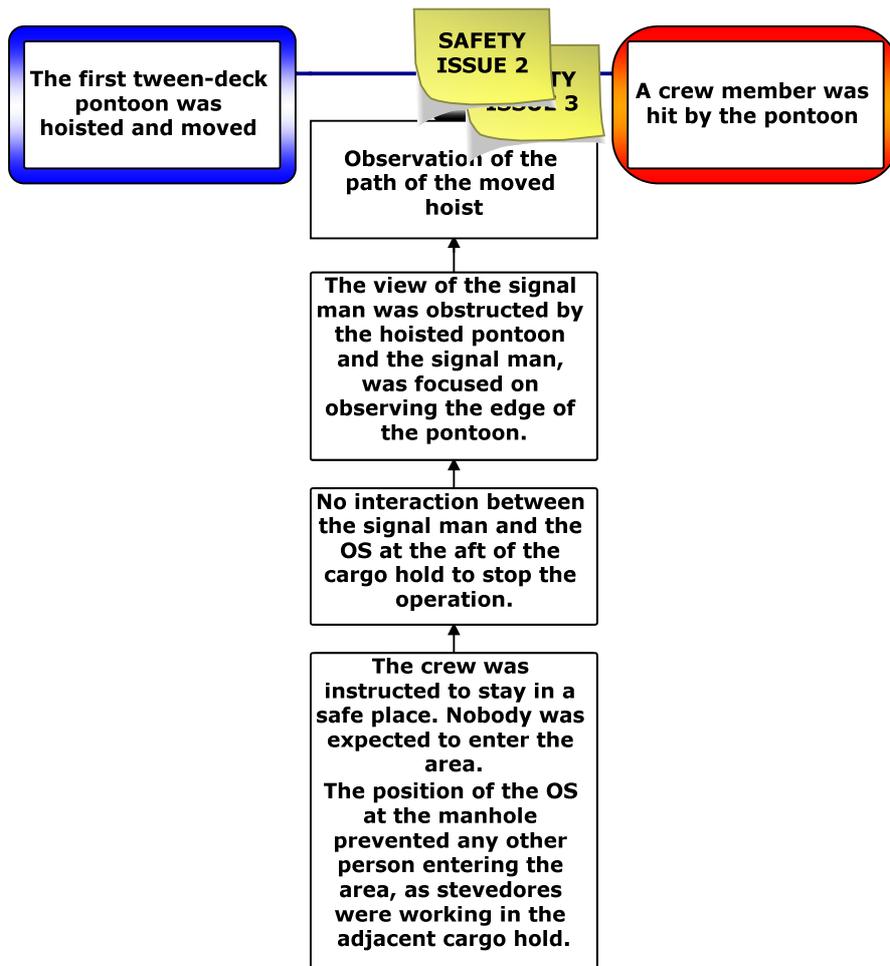
■ *A crew member was hit by the pontoon*

Incident Barrier	Performance	Barrier Challenge	Remarks regarding performance
Failed	BFA Primary Causes	Loss of overview	The view of the signal man was obstructed by the hoisted pontoon and the signal man, was focused on observing the edge of the pontoon.
Observation of path of moving cargo	BFA Secondary Causes	Contingency planning	No interaction between the signal man and the OS at the aft of the cargo hold to stop the operation.
	BFA Tertiary Causes	Operational instructions	The crew was instructed to stay in a safe place. Nobody was expected to enter the area. The position of the OS at the manhole prevented any other person entering the area, as stevedores were working in the adjacent cargo hold.

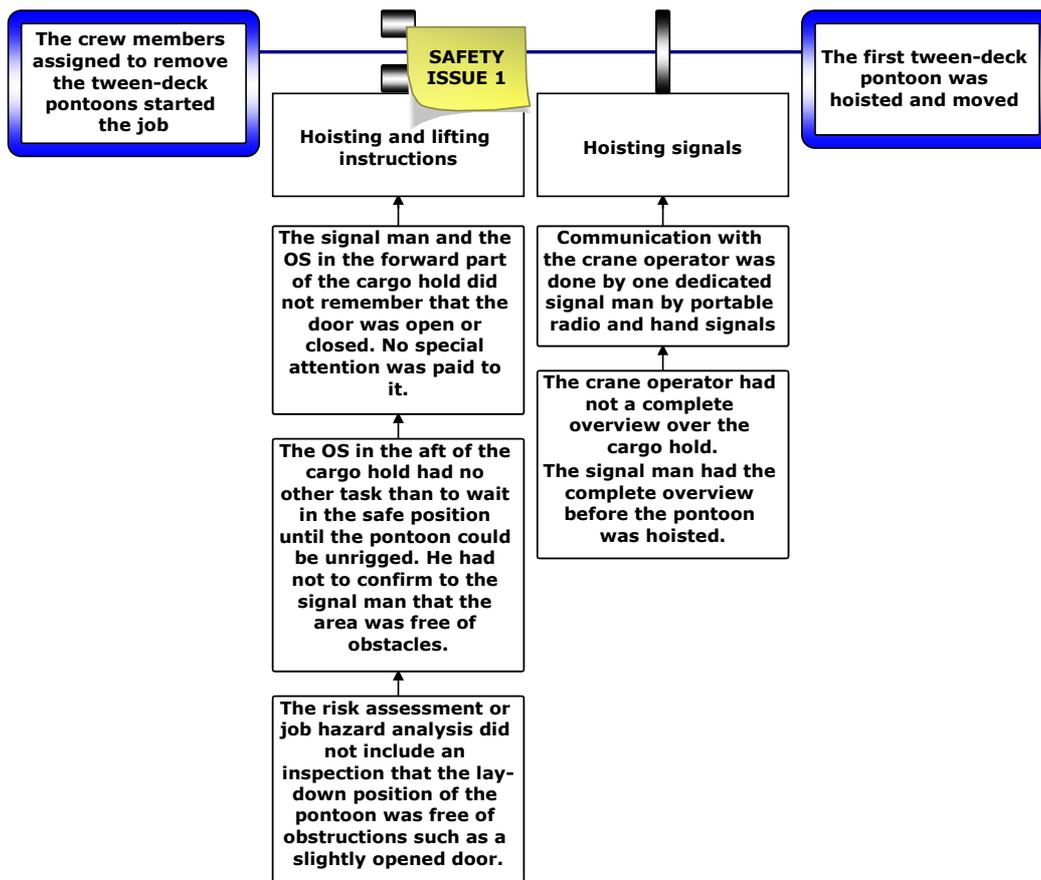
■ *The first tween-deck pontoon was hoisted and moved*

Incident Barrier	<i>Performance</i>	<i>Barrier Challenge</i>	<i>Remarks regarding performance</i>
Effective	BFA Primary Causes	Inspection of lay-down area.	The signal man and the OS in the forward part of the cargo hold did not remember that the door was open or closed. No special attention was paid to it.
Hoisting operation	BFA Secondary Causes	Operational instructions	The OS in the aft of the cargo hold had no other task than to wait in the safe position until the pontoon could be unrigged.
