# National Transportation Safety Board

## Marine Accident Brief

### Barge Breakaway and Contact with Interstate 10 Bridge

<b>Accident type</b>	Contact	<b>No.</b> DCA19FM052
<b>Vessel names</b>	<i>CBC 193, CBC 1403, CBC 1406, IB9123, IB1954, IB1960</i>	
<b>Location</b>	San Jacinto River Fleet, San Jacinto River, Channelview, Texas 29°47.57' N, 95°3.73' W	
<b>Date</b>	September 19, 2019	
<b>Time</b>	2338 central daylight time (coordinated universal time – 5 hours)	
<b>Injuries</b>	None	
<b>Property damage</b>	\$5.46 million est.	
<b>Environmental damage</b>	None reported	
<b>Weather</b>	Scattered clouds, visibility 10 miles, winds from southeast at 7 knots, air temperature 76°F, water temperature 77°F, sunset 1921. Tropical Storm Imelda brought heavy rains and caused flooding in the Houston, Texas, area.	
<b>Waterway information</b>	The Interstate 10 bridge crosses the San Jacinto River about 16 miles east of Houston, Texas. <sup>1</sup> The waterway connects the San Jacinto River to the Houston Ship Channel and is transited by towing vessels, barges, and other small craft.

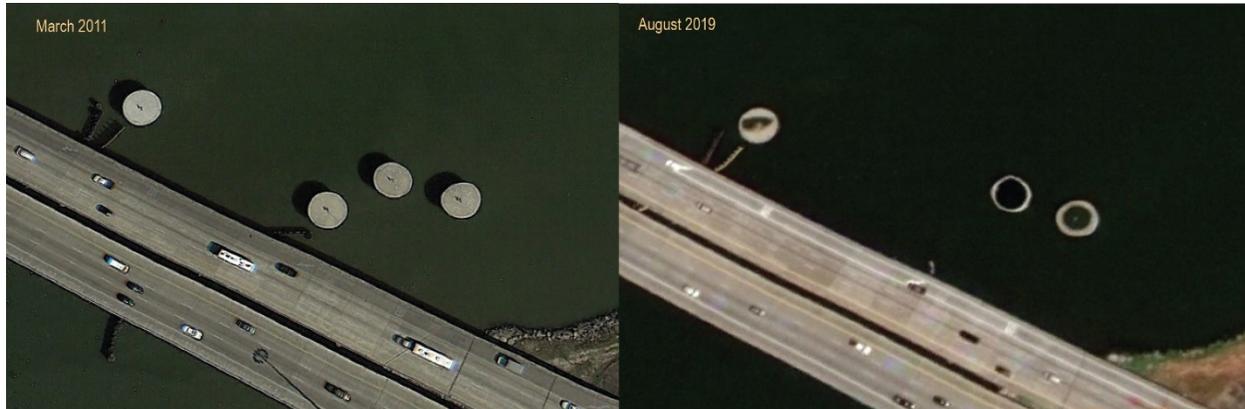
**I-10 Bridge Damage and Repairs.** There were four protective cells on the upstream side of the I-10 bridge (three protecting the columns on the east side of the channel and one protecting the columns on the west side). The pier columns on the west side of the main channel were also protected by a series of wooden horizontal fendering beams and pilings. In 2017, destruction caused by Hurricane Harvey resulted in one damaged and one completely collapsed protective cell on the east side closest to the channel as well as damaged and missing fendering pilings. The wooden fendering systems protecting the piers for the navigable channel were later replaced.

**Satellite images of the San Jacinto River in March 2011 and August 2019 showing the pre-accident condition of the protective cells and fendering systems for the I-10 bridge. (Source: Google Earth)**

Dive surveys and damage assessments determined that only the westbound bridge had been significantly impacted as a result of the September 19, 2019, breakaway barge contact. Bent 26 (a row of pilings) had the three northern columns, a steel stud (from a previous repair), and the cap severely damaged. Bent 28 had the northern column and cap damaged.
