# National Transportation Safety Board

## Marine Accident Brief

### Contact of *Old Glory* Tow with Peter P. Cobb Memorial Bridge

<b>Accident type</b>	Contact	<b>No.</b> DCA20FM025
<b>Vessel names</b>	<i>Old Glory, Cole</i>	
<b>Location</b>	Intracoastal Waterway, Indian River, mile 965, Fort Pierce, Florida <sup>1</sup> 27°27.46' N, 080°19.01' W	
<b>Date</b>	August 19, 2020	
<b>Time</b>	0251 eastern daylight time (coordinated universal time – 4 hours)	
<b>Injuries</b>	None	
<b>Property damage</b>	\$646,000	
<b>Environmental damage</b>	None	
<b>Weather</b>	Visibility 10 miles, clear skies, winds light and variable, air temperature 75°F, water temperature 86°F	
<b>Waterway information</b>	The Intracoastal Waterway is used by commercial light-draft vessels, tows unable to navigate long stretches in the open ocean, and recreational craft. The project depth at the accident site is 10 feet.

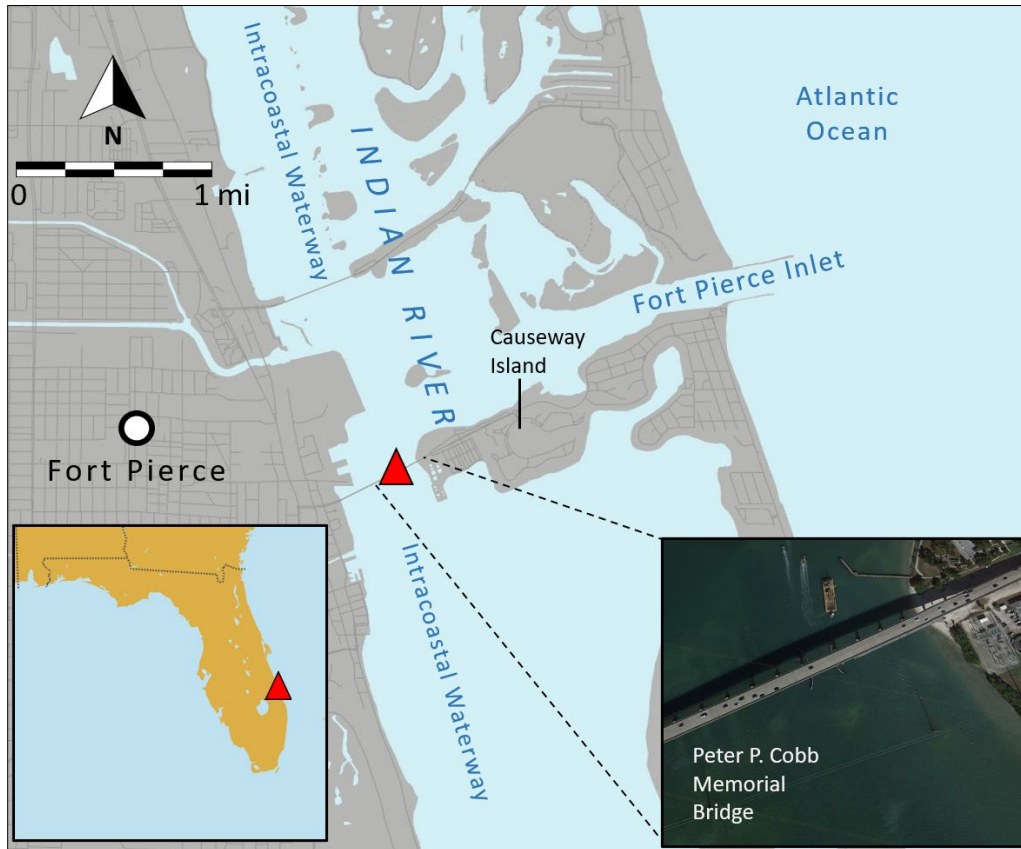
Area of accident where the barge *Cole*, pushed by the towing vessel *Old Glory*, struck the protective fendering of the Peter P. Cobb Memorial Bridge, as indicated by the red triangle. (Background sources: Google Maps and Google Earth)

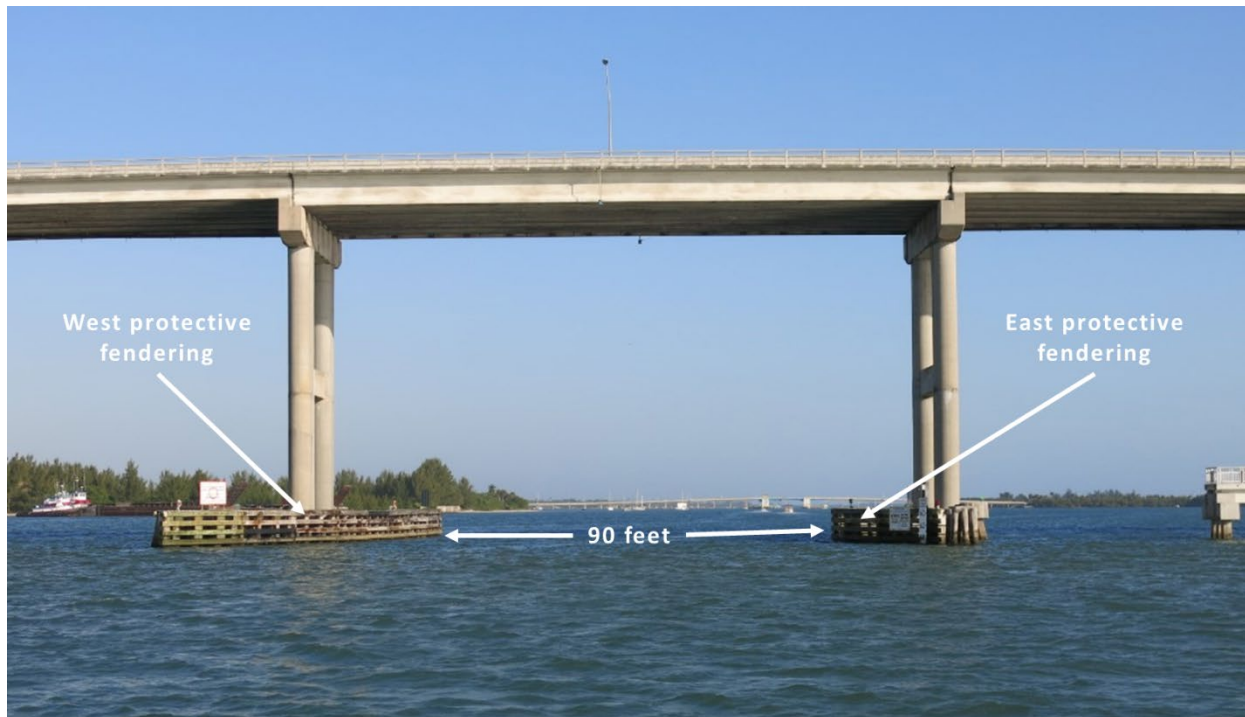
The ICW approach to the Peter P. Cobb Memorial Bridge from the south.
