SAFETY INVESTIGATION REPORT

REPORT NO.: 14/2021

MV ALULA **Serious injury to crew member** **while operating a lathe machine** **in Qingdao anchorage area,** **10 June 2020**

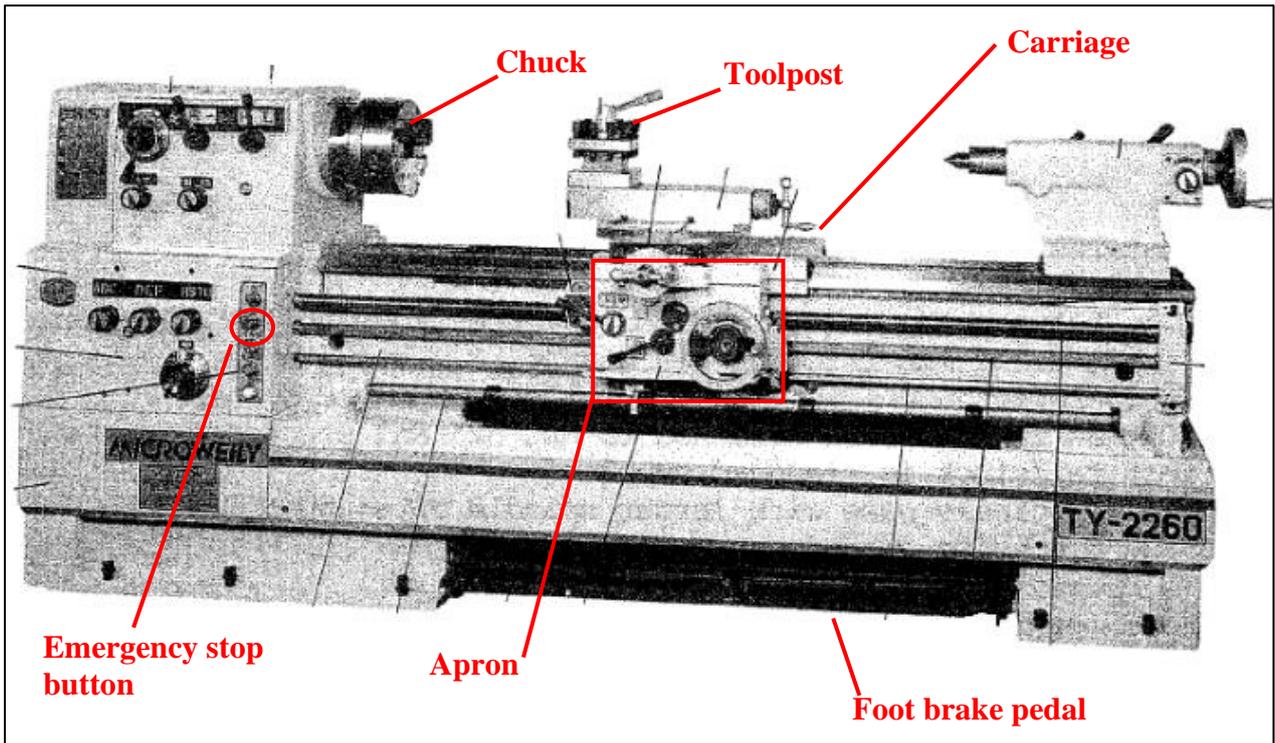
Figure 1: Diagram of the Lathe machine

The lathe machine on board *Alula* (Figures 1 & 2) was fitted at the centre of the engine-room workshop. An Instruction and Parts Manual was provided on board. The Manual included a section on operator safety guidance. The section listed several safety precautions and operation hazards.
