MA2021-6

**MARINE ACCIDENT  
INVESTIGATION REPORT**

<b>Accident type</b>	Fatality of a crew member
<b>Date and time</b>	Around 10:45 on September 9, 2019
<b>Location</b>	Kita Wharf, Maizuru Port, Maizuru City, Kyoto Around 208° true bearing 2.2 nautical miles (M) from Toshima Lighthouse, Maizuru Port. (Approximately 35°27.4' N, 135°19.0' E)
<b>Summary of the Accident</b>	While the cargo vessel FIRST AI was mooring, a boatswain died as his head was trapped in a hatch cover panel when performing hatch cover closing duty.
<b>Process and Progress of the Investigation</b>	An investigator-in-charge and a marine accident investigator were appointed to investigate this accident on September 10, 2019. September 10 and 11, 2019 On-site investigation and interviews; November 1, 2019, May 13, 2020, and June 12, 2020 Collection of questionnaires Opinions on the draft report were invited from parties relevant to the cause of the accident. Comments on the draft report were invited from the flag state of FIRST AI.

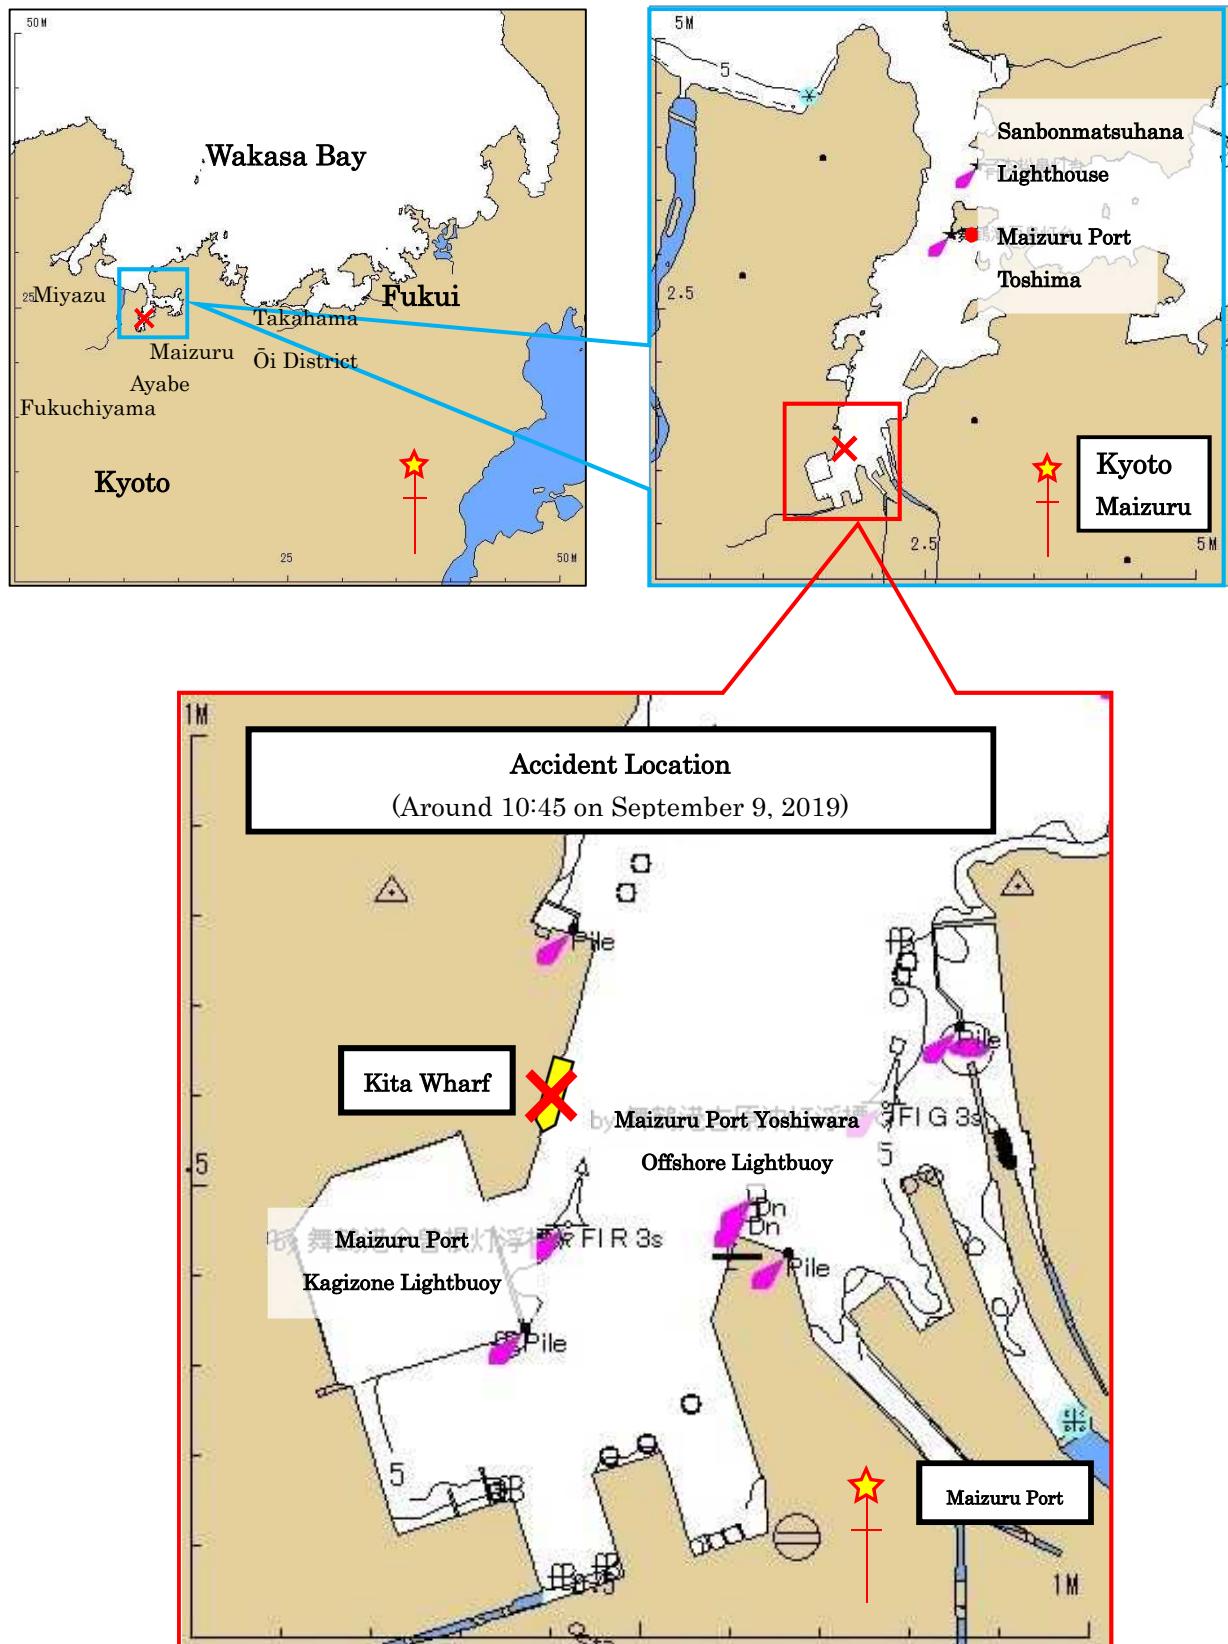
Attached Figure 1: Overview of the Accident Location

<p>Officer A was checking the condition of the rubber packing after the hatch cover stopped moving. Then, the Arm Pin fell off and hit his right hip, so he turned to where the Arm Pin was inserted. At where the arm pin had fallen off, he noticed that the boatswain's head was caught between panel No. 11 (about 2.5 tons), which had fallen, and panel No. 7 which is already stored in the drum (See Attached Figure 2). He called out loudly for other crew members to come, and asked the stevedore who came to the scene to call an ambulance.</p> <p>The helmsman was in his room when he heard Officer A shouting and rushed to the scene of the accident. He confirmed that the head of the boatswain was caught between two hatch cover panels, reported the accident to the second officer in the chart room, and called the chief cook and the ordinary seaman.</p> <p>The second officer reported that the boatswain was injured to the master and immediately went to the scene of the accident.</p> <p>The helmsman and the chief cook transported the boatswain to the nearby corridor of the living quarter.</p> <p>As the boatswain was in cardiac arrest, he received chest compressions and artificial respiration from the rescue squad that arrived near the scene at around 11:02.</p> <p>At around 11:08, the rescue squad called for a medical helicopter to be dispatched.</p> <p>The boatswain was transported to a hospital in Toyooka City, Hyogo, at around 12:24 by a medical helicopter that arrived near the scene of the accident at around 11:31.</p> <p>(See Attached Figure 1 Overview of the Accident Location, Attached Figure 2 Overview of the Accident Situation)</p>
