SAFETY INVESTIGATION REPORT

REPORT NO.: 16/2021

MT KEY FIGHTER **Grounding** **in position 67° 29.15' N 012° 04.02' E** **01 July 2020**

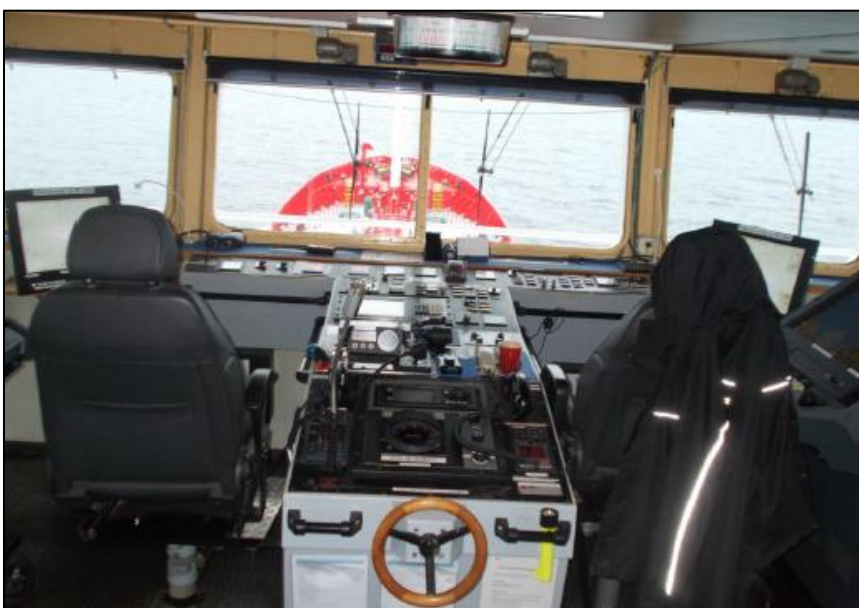
Figure 1: Navigation main console

The navigational main console (Figure 1), installed on the centreline of the wheelhouse, was fitted with the steering wheel, navigational equipment, and controls for the main engine and bow thruster. The vessel's steering could also be controlled via a joystick lever, located on the main console. The navigational equipment consisted of a magnetic and gyro compass, autopilot, X and S band radars, an AIS, a GPS receiver, and an ECDIS.

On 03 July, following the grounding, a service technician inspected the steering control system. The technician reported that the spring to prevent activation of micro switches in the wheel assembly unit, on starboard side was defective (Figure 5), "resulting in activation of micro switches on SB side by accident or by itself as there is nothing to stop it." The technician explained that when activated, the vessel would turn to starboard and at the same time, disabling the joystick, autopilot and one steering gear pump.

He further noted that the design of the steering gear system was such that the activation of the steering wheel would disable the autopilot and joystick function. In Esbjerg Shipyard, the steering system was further examined by service engineers, the defective spring was replaced. Tests on the rudder movement indicated that they were within the prescribed limits.

Thus, taking account of the technical reports, the vessel management's subsequent findings⁷ and given the proximity of navigational controls relative to the operator console position, it appeared probable to the MSIU that the unintended port rudder movement may have been caused by an inadvertent physical contact with the wheel⁸; overriding the joystick control function and invalidating the master's starboard helm command. This would have initiated an uncontrolled course alteration to port towards the shallow water, as evidenced by the ROTI data. The steering wheel had no protective or locking features to prevent unintended or accidental movement of the wheel.

- the steering gear system, including electronics and hydraulics were inspected by service engineers and the worn-out parts were replaced;

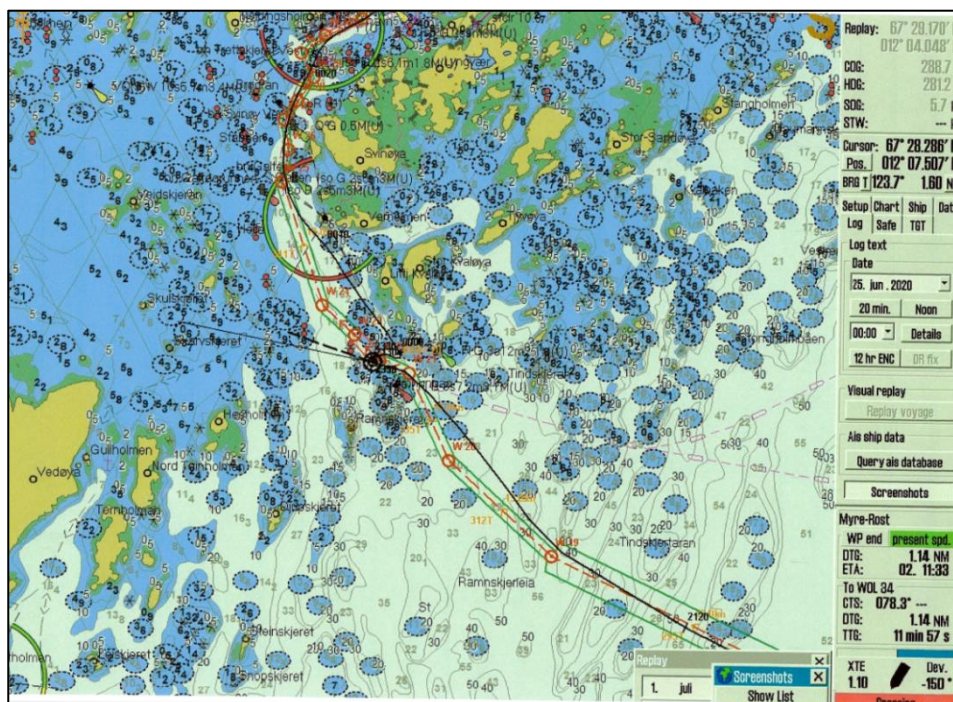
Figure 2: ECDIS image showing navigation route in the approaches to Røst.

During the evening, *Key Fighter* satisfactorily completed her pre-arrival navigational checks. Two steering gear motors were switched on. No steering system faults were detected². The bow thruster was ready, and the X and S band radars were set on three and six nautical mile ranges, respectively. In the approaches to Røst, courses were displayed on the ECDIS (Figure 2). The vessel was steering 260° on autopilot.

From the information provided by the vessel, it is apparent that in proximity to waypoint 22, the master executed a starboard helm on the joystick, tracing the course displayed on the ECDIS. Following a sluggish alteration to starboard, the vessel veered to port. The sVDR captured a rate of turn of $30^{\circ} \text{ min}^{-1}$ (to port) before dropping to $10^{\circ} \text{ min}^{-1}$. The precise cause of the vessel turning to port, contrary to the master's joystick command, could not be established. It is unlikely that the turn to port side was the result of a defective spring, activating the micro switches in the steering wheel unit⁶.
