MONTHLY SAFETY SCENARIO

SEPTEMBER 2021

Broken davit wire on rescue boat

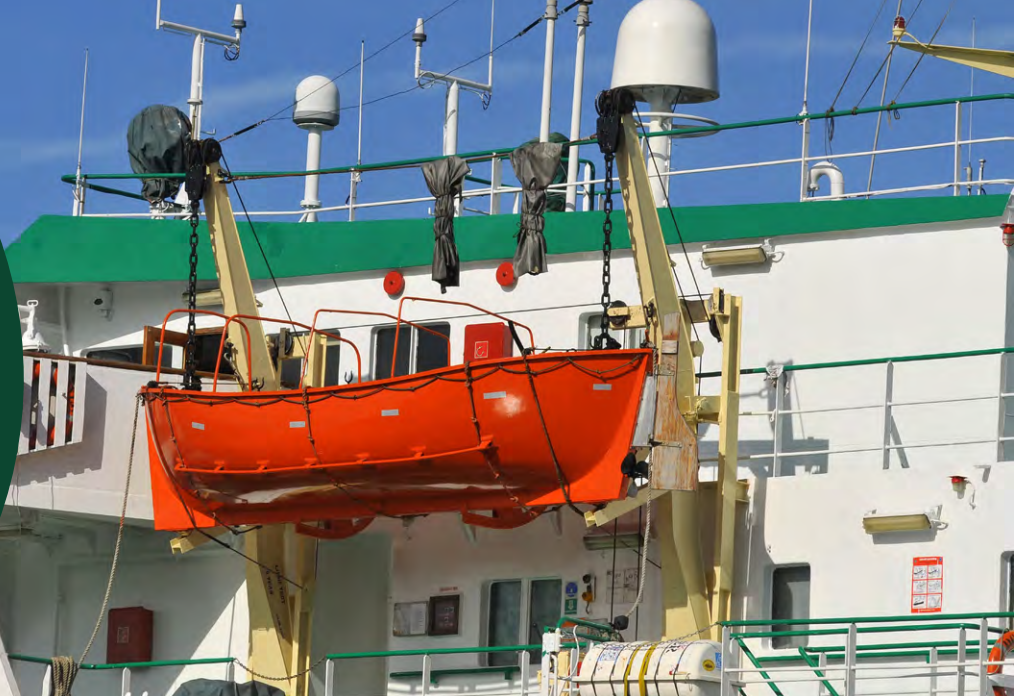
This sudden increase in power caused the wire to break and the boat to fall more than 20 metres into the water, taking the crew members with it.

1. The Chief Officer was unaware that the davit winch motor was too strong for the replacement davit wire.
2. While in dry dock an electrician had replaced the fuse in the circuit board of the davit winch motor. He had replaced the original fuse with a much higher amperage fuse.
3. It was also the case that the electronic proximity switch was not working. When the rescue boat had been washed down with the high-pressure hose, moisture had entered the system through the cover of the proximity switch, causing a short circuit.

The proximity switch is intended to cut power to the winch motor when the boat is close to being in the stowed position. This is an emergency device to ensure that the winch motor does not put too much stress on the davit wire. It is essential for preventing possible catastrophic failure. The davit had only one proximity switch so there was no back-up.

7. It is very important to monitor sensitive electronic equipment on deck and ensure that it is not washed down or painted over. Is this addressed on board our vessel?
