Collision between *Accolade II* and *Sandgroper*

Off Port Adelaide, South Australia, on 29 February 2020

ATSB Transport Safety Report

MO-2020-001

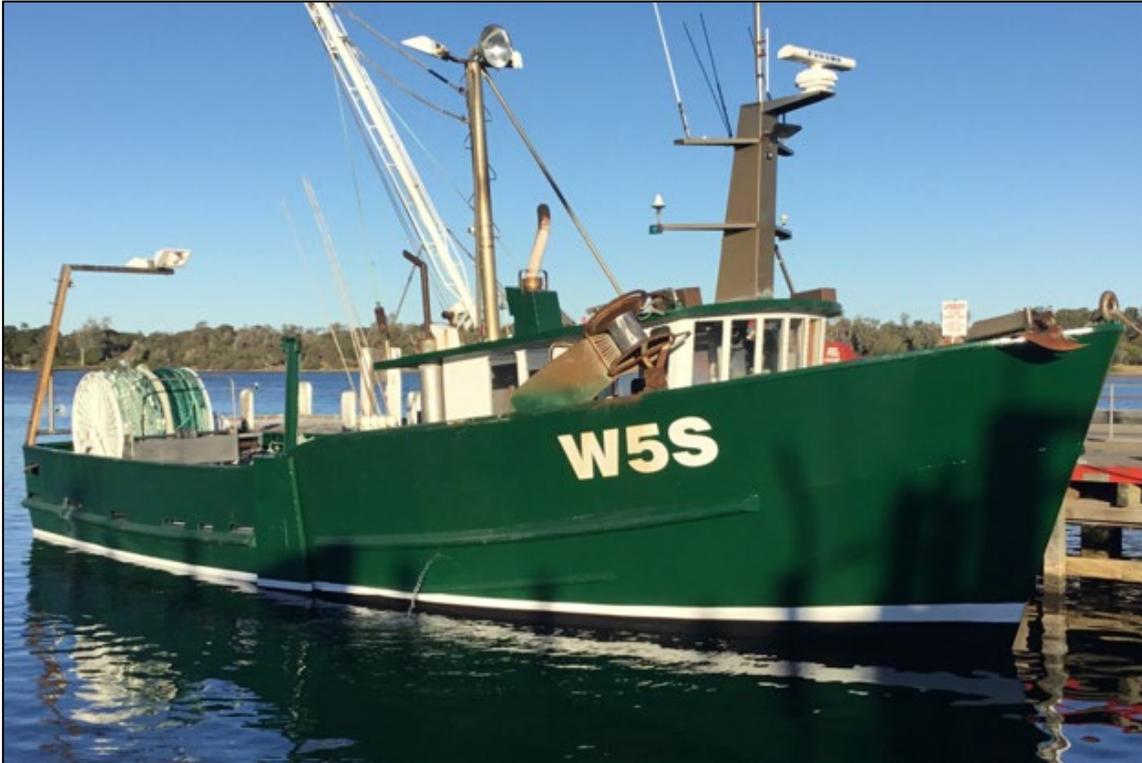
Figure 1: *Sandgroper*

At about 1100 Central Daylight-saving Time¹ on 28 February, *Sandgroper* (Figure 1) departed its fishing grounds off Kangaroo Island, South Australia and began making its way back to North Arm Marina in Port Adelaide. The vessel was crewed by a skipper and two uncertificated crew (deckhands). The crew had been fishing at sea for the previous week when a hydraulic equipment malfunction resulted in the decision to return to port.

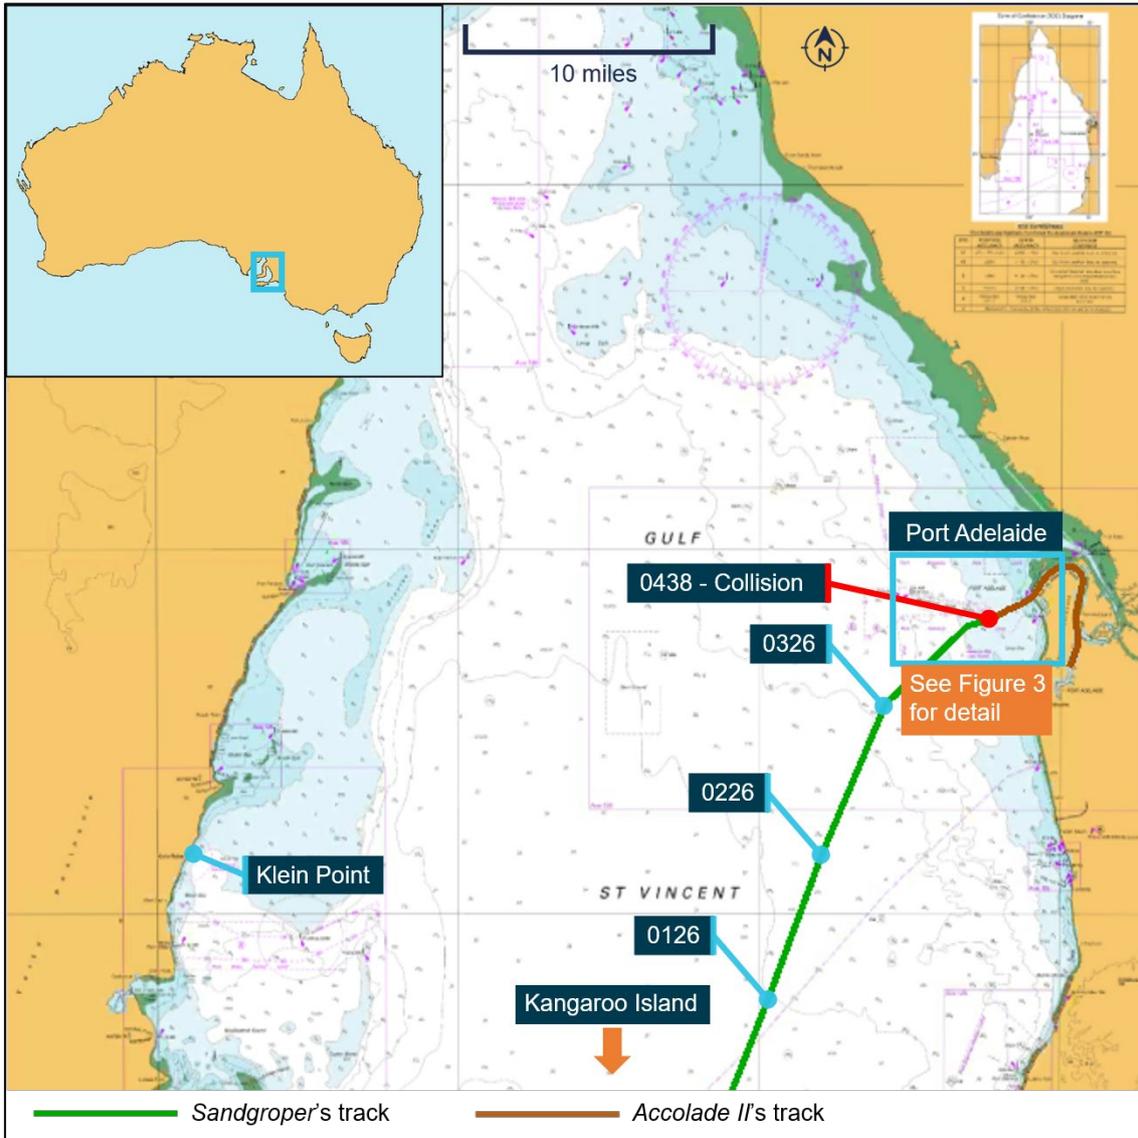
Figure 2: Section of chart Aus 781 showing key locations and vessel tracks

At 0226 on the morning of 29 February, *Sandgroper* was about 13 nautical miles (miles)² south-west of Port Adelaide's southern breakwater (Figure 2), on a heading³ of about 020°, with steering in autopilot mode and a speed of about 5-6 knots. The skipper was on watch in the wheelhouse with the deckhands resting. At about 0300, the skipper handed over the watch to one of the deckhands in order to get some rest. The skipper instructed the deckhand to follow the course plotted on the chart plotter and to wake them if there were any concerns or when arriving at a nominated point marked on the chart plotter near Port Adelaide's port limits. The skipper then lay down to rest on the wheelhouse bunk, aft of the conning position. Both the vessel's very high frequency (VHF) radio units were set to maintain a listening watch on VHF channel 16.⁴
