Issued November 1, 2021

MAB-21/22

Contact of *Trent Joseph* Tow with Barataria Bridge

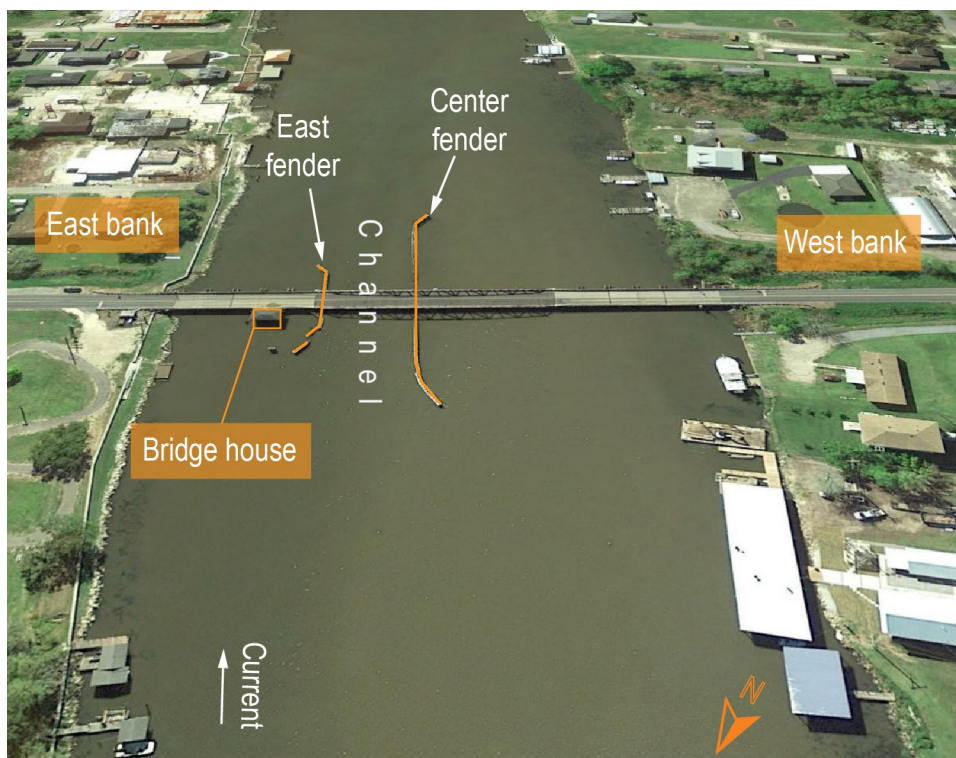
Figure 4. Southern-facing view of the Barataria Bridge channel and fendering. (Background source: Google Earth)

The permanent navigable channel through the bridge was 77 feet wide and ran between a long fender wall in the center of the waterway (center fender) and a shorter fender wall on the east bank (east fender). When in the fully open position, the bridge was protected by the center fender wall, which was constructed of timber.

Each of the fenders had red lighting marking the ends and middle. According to the bridge tender, at the time of the accident, the red lights on the east fender had been removed to be repaired. No temporary lighting was fitted to replace the lights that had been removed. On the northern side of the swing span of the bridge (east-facing when open) were three navigation lights (each light showed alternating red and green colors) marking each end and the top center of the swing span. For an approaching vessel, when the bridge was in the closed position, the swing span's lights would show red, and
