Investigation Report 23/20

Less Serious Marine Casualty

**Cargo-related accident
(loss of two mobile cranes)
on the
JUMBO VISION
at berth in the port of Rostock
on 31 January 2020**

21 December 2021

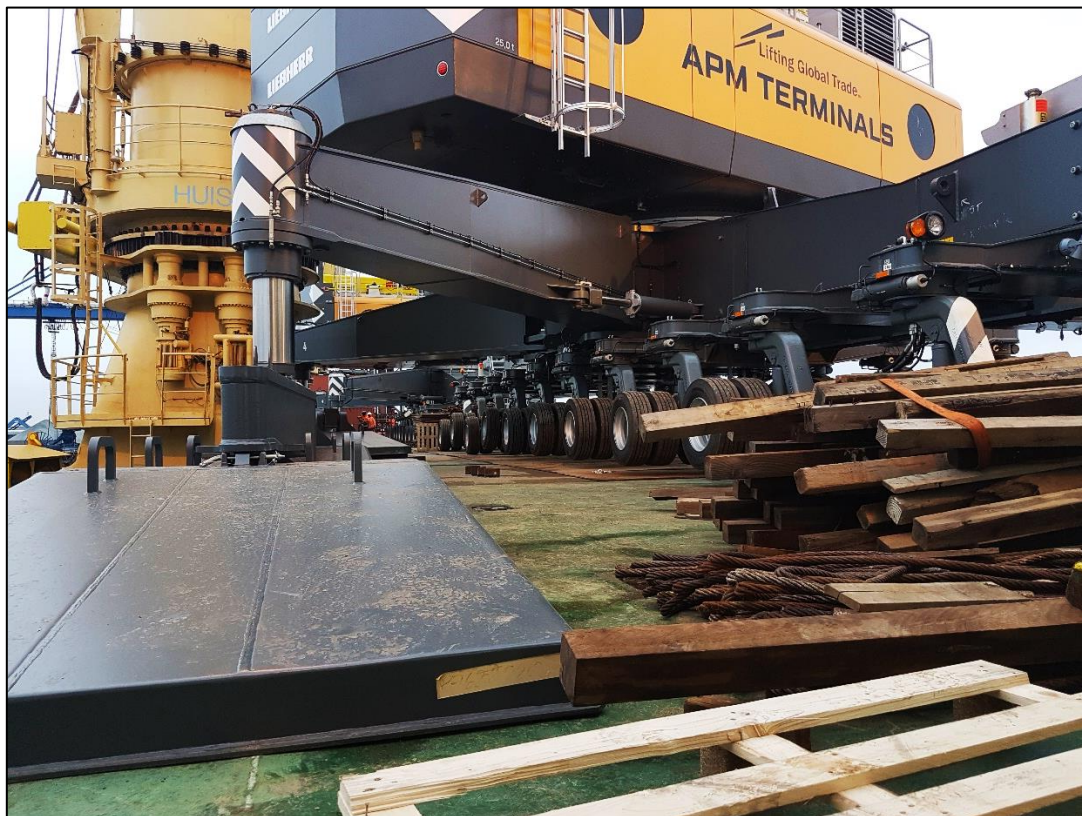
The crew began preparatory work for securing the deck cargo at about 2000. At about 2045, the ship's cargo-handling gear was secured, which entailed moving crane 2 slightly aft.

Figure 8: View from the deck looking towards the stern after the two cranes were loaded

Crane 2 had just been moved a short distance aft and was now standing amidships with its support cylinders raised (see Figure 8 and Figure 9).

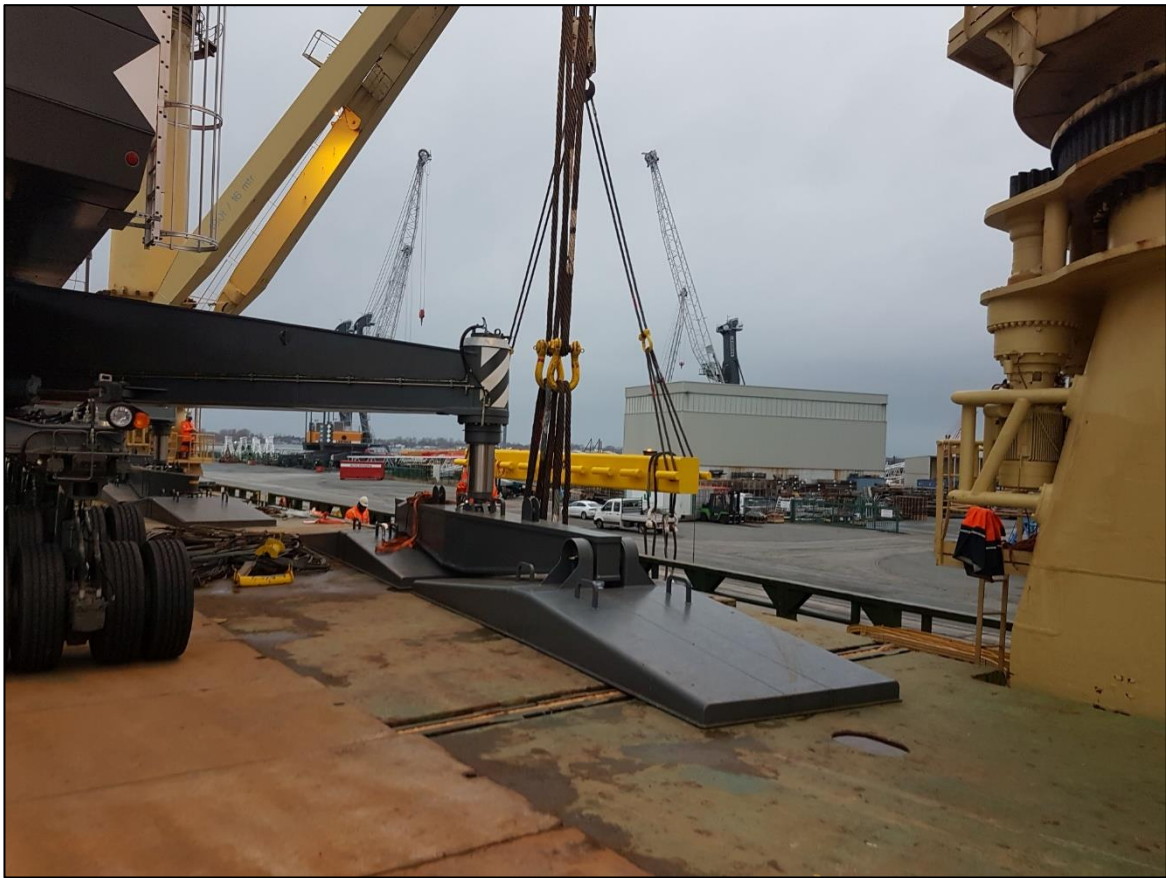
One of the two cranes (crane 2, which subsequently went overboard first) had a tower superstructure that was 4.8 m higher and made it about 12 t heavier than the other one.

Figure 18: Crane 2 with double supporting pad
(photograph taken after loading)

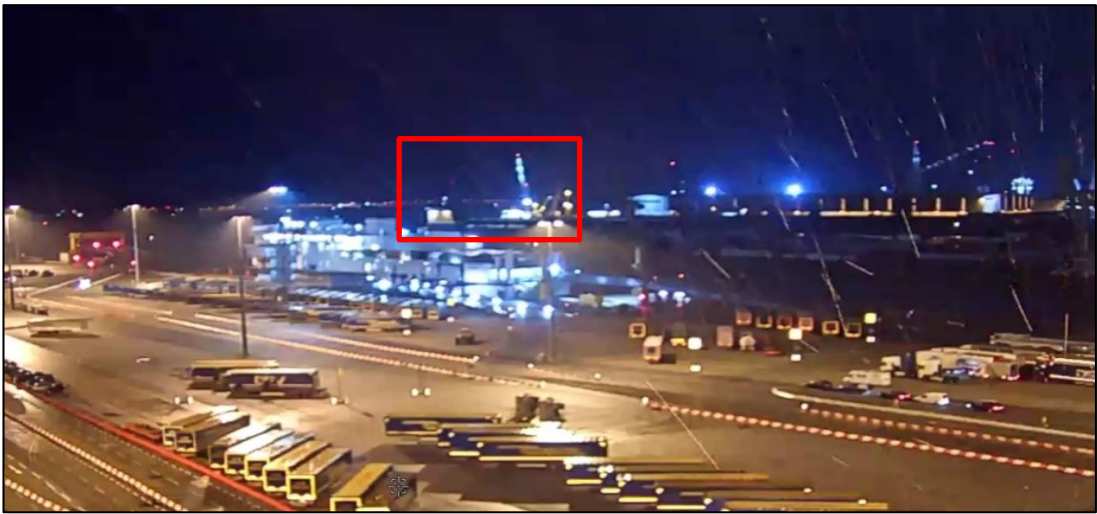
Figure 27: Screenshot: second surveillance camera before accident
 (view from the side)
