Collision between fishing vessel *Achieve* (HL257) and general cargo ship *Talis*, resulting in the sinking of *Achieve* off Tynemouth, England on 8 November 2020

SUMMARY

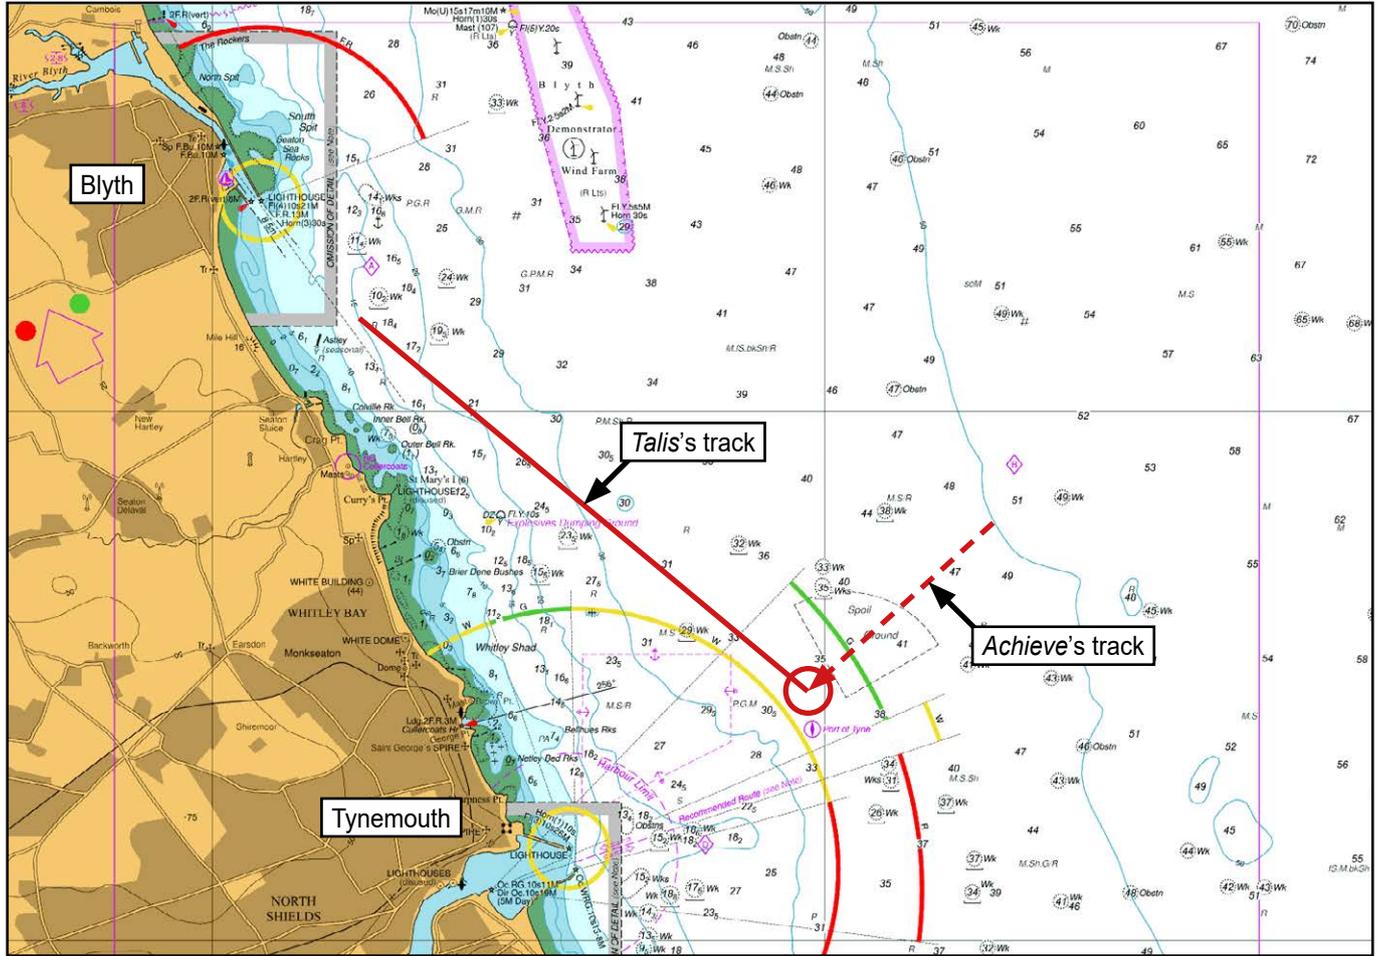
Figure 1: Extract from Admiralty Chart 156, showing tracks of *Talis* and *Achieve*

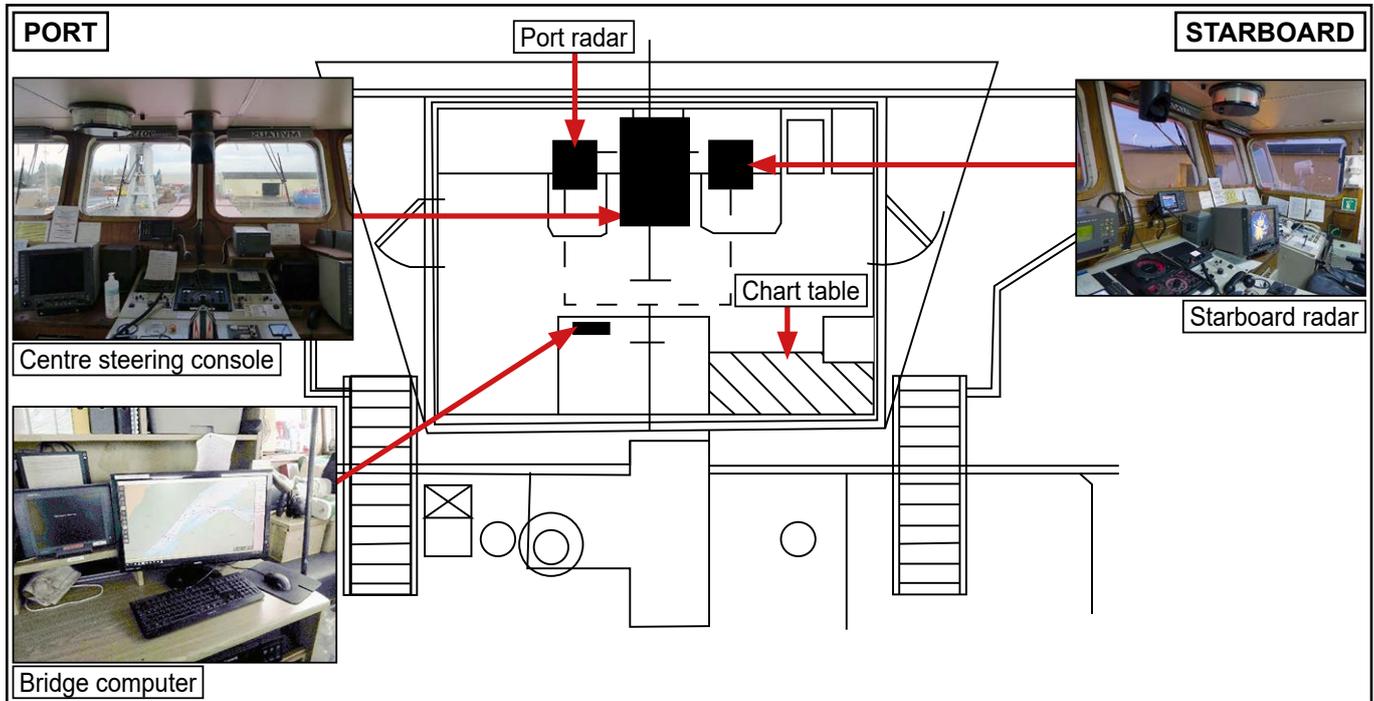
Talis's C/O carried out administrative navigation duties at the chart table and the bridge computer (**Figure 2**). The AB was on the port side between the closed bridge wing door and the centre steering console. The starboard radar was set to the 6 nautical mile (nm) range scale, head-up display, with 1.5-minute trails active. The port radar was in standby mode.

Figure 2: Plan of *Talis's* wheelhouse
