IIMS 2021 Safety & Loss Prevention Briefings Compendium

A 100-PAGE COLLECTION OF WORLDWIDE MARINE
INCIDENT AND ACCIDENT REPORTS, LOSS PREVENTION
BRIEFINGS AND CASE STUDIES PUBLISHED IN 2021

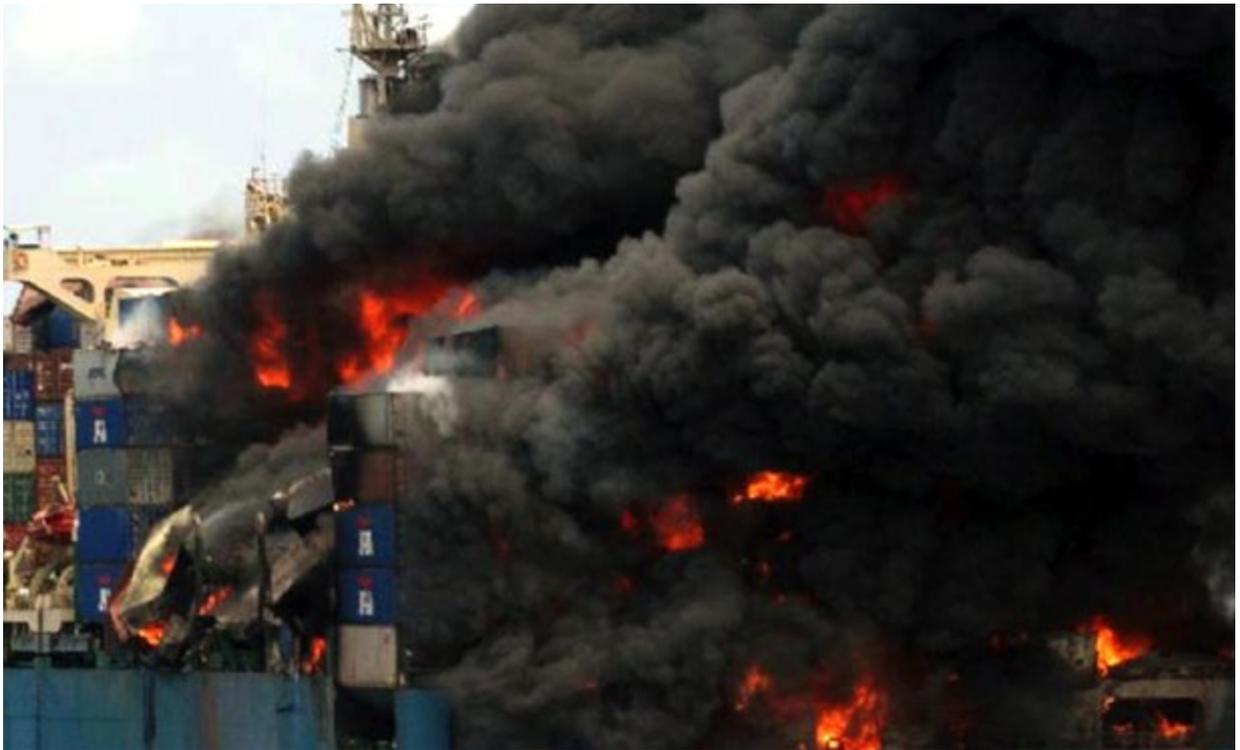
WRONGLY STOWED CONTAINER LED TO FIRE

The Swedish Club has reported an incident where a wrongly stowed container led to a fire.

During early morning hours, the Master was at the bridge of the vessel when they observed a large cloud of smoke issuing from the forward part of the vessel. At the same time the fire detection system for cargo hold 3 sounded on the bridge. According to the Master, the smoke was first white and then greyish. Yet, the Chief Officer, however, described the smoke as being "dark grey, almost black".

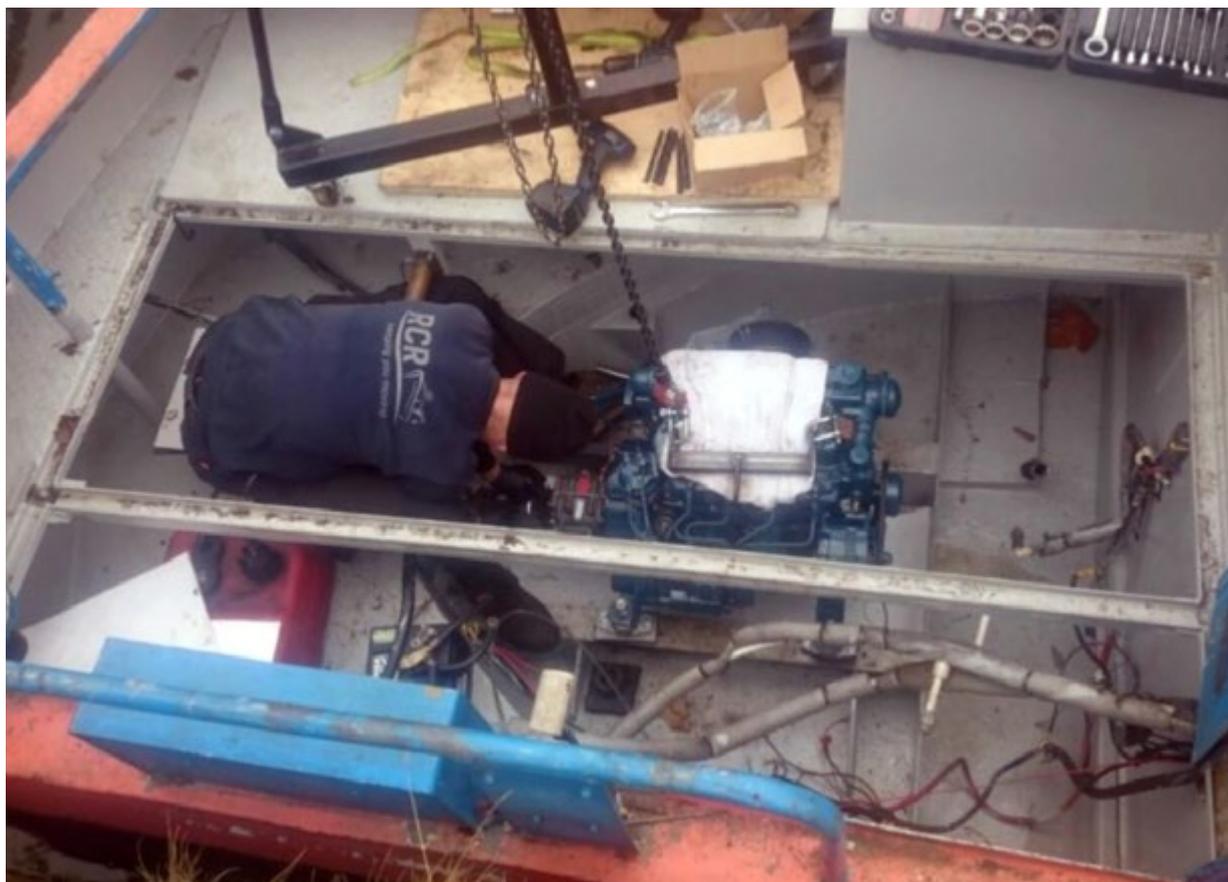
RIVER CANAL RESCUE CALLS FOR 'STICKY FUEL' SAMPLES

The situation came to light when River Canal Rescue had two identical jobs. Fuel injectors were diagnosed as needing an overhaul, yet their replacements stopped working within a week. The injection pumps were found to have failed even though the diesel was clear and bright.

Upon further investigation, RCR engineers found in both cases the injector pump racks had seized solid and the nozzles were blocked, and when replacing the plunger filter head, they found the fuel had a sticky, syrup-like substance. Alongside stuck injection pump racks, injectors and filter head plunger failures, RCR is also seeing cases of fuel filters blocking with wax inside them.

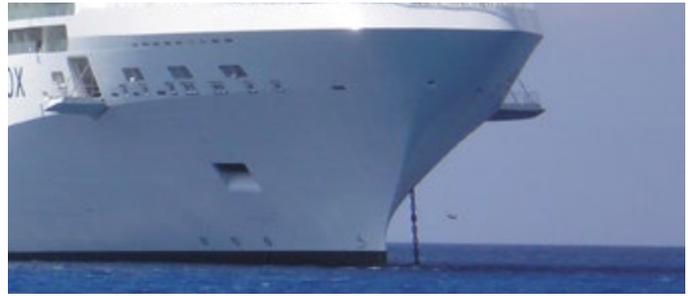
SAFETY WARNING ABOUT MULTIPLE CRUISE SHIP ANCHOR FAILURES

In early 2020 the COVID-19 pandemic forced the international cruise industry into an unprecedented operational pause, resulting in many cruise ships anchoring off the UK south coast for long periods of time. The MAIB has been made aware of several marine incidents of anchor failures since October 2020 where cruise ship anchors or anchor cables have failed, often while trying to ride out named winter storms. One cruise ship lost both its anchors within a week.

- As the restrictions on the cruise industry ease, it must be remembered that this period of prolonged anchoring may have decreased the life span of the anchoring equipment. A full assessment of the future suitability of the anchoring equipment should be undertaken at the earliest opportunity or the next dry-docking period.

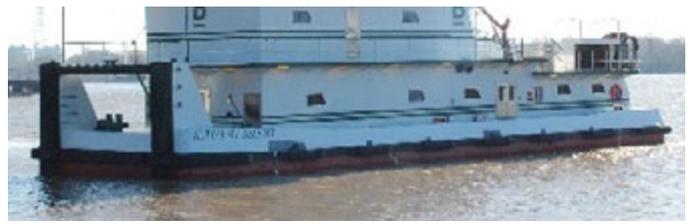
FLOODING OF TOWING VESSEL CAUSED BY A LACK OF MONITORING

The National Transportation Safety Board (NTSB) has published an investigation report on the flooding of the towing vessel 'Alton St Amant' while moored in the Harvey Canal in New Orleans. The incident resulted in an oil discharge into the water. The investigation identified lack of pre-inspection and monitoring procedures for water transfer as a key cause of the incident.

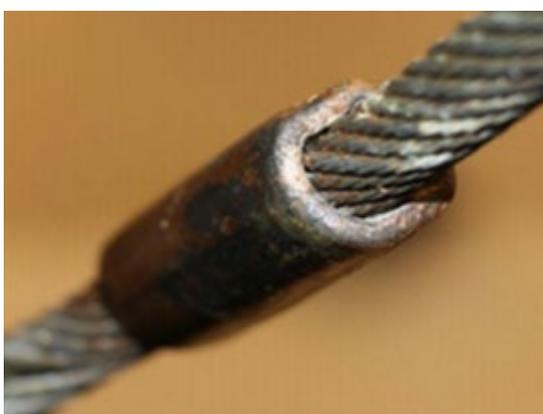
Figure 2: Completed fitting is not "round" nor within manufacturer specifications.

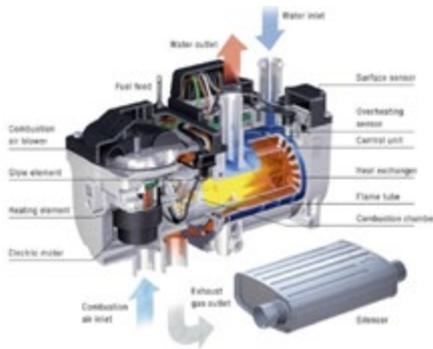
Surveyors beware some diesel heater installations

Recent contact with someone has brought to attention a problem regarding a fault causing potentially life-threatening fumes from his boat's diesel heater. The heater in question is an Eberspacher for which cheap imported spares are available on the internet. The part in question was a replacement fuel pump which he bought online. The part was manufactured in China and on the face of it appears to be very much the genuine article, but there was no CE marking identifiable. The product description stated, "Good replacement – Based on the original factory specifications, a direct replacement for the old or broken one."

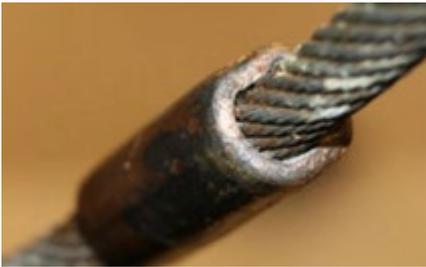
Incorrect wire rope terminations can lead to catastrophic failure

The USCG Coast Guard has published a Marine Safety Alert to notify interested parties of a potentially dangerous situation involving incorrect wire rope terminations, which can lead to catastrophic failure. The Alert addresses the importance of verifying the condition, manufacturing, and physical specifications of wire rope that was purchased directly from Southwest Wire Rope (SWWR) or fabricated by SWWR and sold through other vendors.

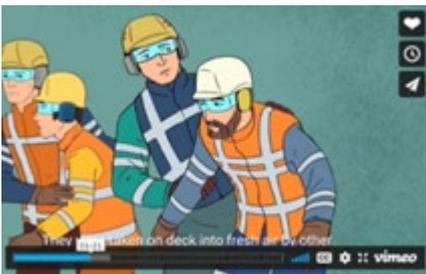
Improper maintenance procedures can cost lives

At the commencement of the test, the surveyor asked to observe the pump being started locally and operating before proceeding on deck to check the hoses rigged fore and aft. Shortly after descending into the fire pump well, the chief engineer urgently ordered the surveyor to get out and by the time both men reached the steering compartment deck, they were experiencing symptoms of dizziness, with the chief engineer in a state of near collapse.

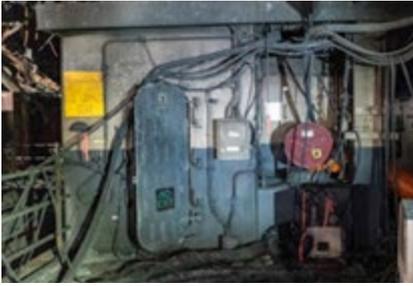
A catalogue of failures left navy personnel unprepared to fight USS Bonhomme Richard fire reveals investigation report

A scathing report extending to more than 400 pages by the US Navy into the fire that destroyed the USS Bonhomme Richard in 2020 has concluded that the loss of the ship was “completely preventable” and that there were major failures within the military chain of command that allowed the fire to destroy the warship.

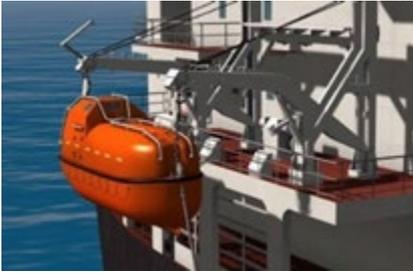
Lessons learned from defect of lifeboat on-load cable release unit

During an annual lifeboat safety inspection, it was discovered that the on-load cable release could not easily be moved, and the release lever required extreme force to operate. The forward hook cable release also did not operate properly. A replacement cable release arrangement was procured locally, and repeated tests were conducted to confirm that it was once again fully operational. The post-event investigation noted that the company's shipboard safety operations manual required the lifeboats to be inspected on a weekly and monthly basis.

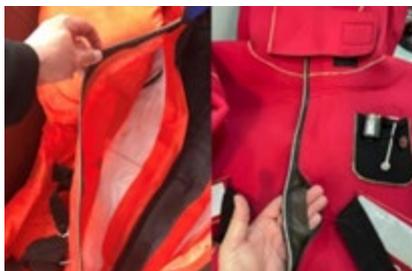
RMI recommends all immersion suits to be checked rather than spot checks following a number of defective items

The Republic of the Marshall Islands (RMI) has published a Marine Safety Advisory notice. In it RMI stresses the importance of properly inspecting and maintaining all immersion suits, following a number of recent cases of defective equipment found onboard RMI flagged vessels. Since 2019, when RMI shared a marine safety advisory focusing on the importance of following the manufacturer's instructions for maintaining immersion suits, there have been multiple additional instances of defective or improperly maintained suits on RMI-flagged vessels, one of which resulted in a PSC detention by the US Coast Guard. In that case, "29 of 32 immersion suits were unserviceable due to unsealed seams," and these suits were only five years old.

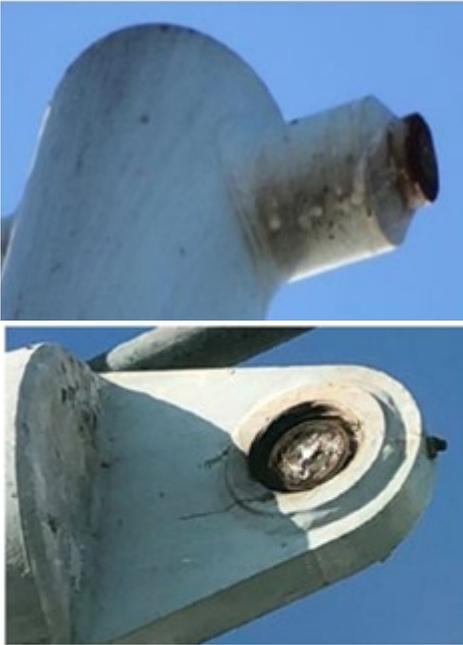
Catastrophic failure of marine loading arm

The MLA failed as it was being manoeuvred towards a ship manifold for connection. A section of the MLA fell backwards onto a jetty handrail narrowly avoiding live plant and pipework. This hydraulically operated MLA had been in service for 11 years and had been regularly maintained by various recognised industry contractors. It had a rigid link pantograph balancing system with independent primary and secondary counterweights linked to the inboard and outboard arms.

Investigation found that a failed pantograph pivot pin led to the resulting collapse of the arm.

The immediate cause of the failure was from corrosion of the bearing that led to a complete fracture, emanating from the circumference. The underlying causes were inadequate inspection and maintenance practices which had led to the corrosion. The failure to properly inspect and maintain an MLA could result in a serious risk of a joint failing, allowing the pantograph arm to fall – with the potential of causing death, serious injury or damage to process pipework. There was no convenient means of accessing the pivot pin for inspection and maintenance. As a result, it had not been lubricated during servicing by several different contractors.

This safety alert is aimed at users and companies that service MLAs to ensure they carry out suitable and sufficient inspection and maintenance to help avoid similar incidents. It has wider applicability to all lifting equipment

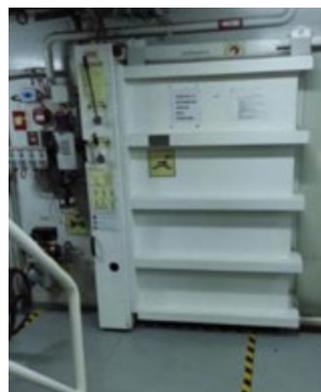
2: Watertight door left open at sea

A vessel watertight door was found left open when the vessel was at sea. Watertight doors are there to prevent the ingress of water from one compartment to other during flooding or other accidents and act as a safety barrier. It is a requirement of SOLAS (section B4, regulation 22) that watertight doors shall be kept closed during navigation, except under certain conditions not met here. This company has its own requirement also, that all watertight doors, scuttles, and fittings below the main deck shall remain

closed at all times except when actually in use. A further check revealed no justification for keeping the door open.

The IMCA member found that persons nearby were not aware of SOLAS or company management requirements.

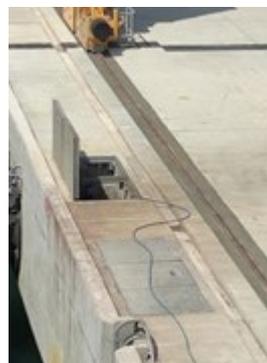
3: Hatch left open on the quay – a successful intervention prevents a potential accident

Two open hatches on the wharf in close vicinity to the vessel were observed and reported by vessel crew members. There were no barricades or safety signs installed, despite the potential fall hazard inside from 2m height. Following this intervention, the hatches were closed and locked by wharf service personnel.

The crew challenged an unsafe condition, although it was not directly related to the vessel. This is an excellent example of proactive application of the principle of "Stop the job". Remember that everyone has the authority – and the duty – to STOP THE JOB if work is taking place that is clearly unsafe.

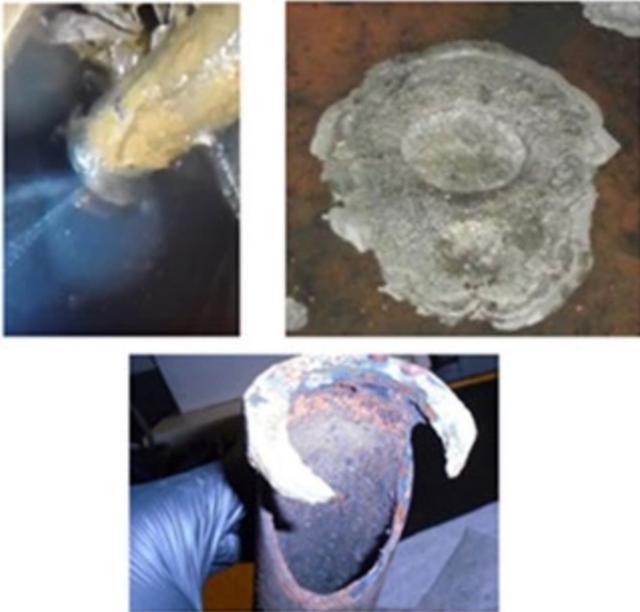
Tank corrosion

During daily tank sounding routines in the engine room on a vessel, there was an unexpected rise in liquid level in the tank. A close check was made which confirmed this finding, and it was decided to open the tank for investigation. A pinhole leak was discovered in the structure beneath the sounding pipe. This allowed salt water to enter the space from outside the tank. The vessel was sent for repairs.

Initial investigation by the ship's engineers concluded that the striking plate at the bottom of the sounding pipe was missing. This allowed the brass weight to repeatedly strike the steelwork, damaging the paint coating and exposing the steelwork to corrosion.

The brass weight of the sounding tape had damaged the paint coating on the striking plate and steelwork below. A corrosive chemical had been incorrectly disposed of and introduced to the tank, accelerating the corrosion process. The acid may have become trapped under bubbles of damaged paint, allowing concentrated corrosion over the short time. The combination of exposed steelwork and caustic solution destroyed the striking plate and steelwork below.

Effective repairs were carried out onboard in collaboration with third party welders and divers.

Caustic or otherwise dangerous chemicals, and their containers, should be disposed of to an authorized hazardous or special waste collection point in accordance with any local regulation.

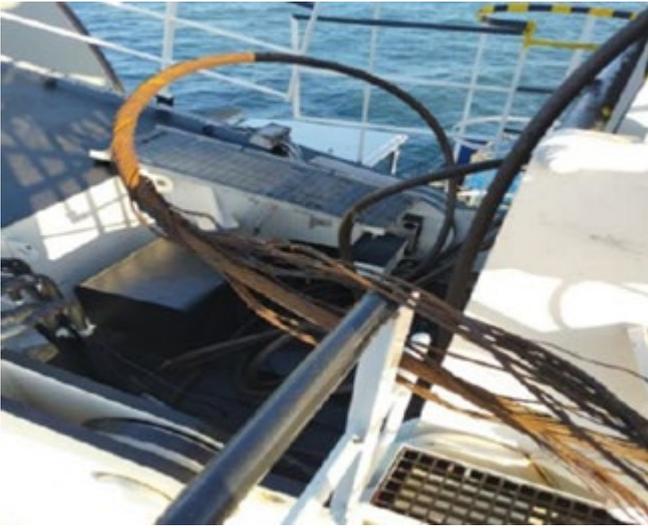
Crane wire parted during offshore operations

A concrete mattress was being deployed as part of the construction of a pipeline crossing. As the load was swung outboard and before it entered the water, the crane wire parted causing the load to fall to the seabed. The vessel was in a safe handling zone more than 5m from subsea assets. The mattress was overboarded when the crane was 17m from the nearest subsea asset.

During the lift, the load was swung outboard and before it entered the water, the crane wire parted causing the load to fall to the seabed. The mattress and lifting frame were found 6m away from the buried gas pipeline.

The vessel main crane was in use during the period following the Magnetic Rope Testing (MRT) when the results were still being evaluated. The test results stated a clear recommendation to cut back the wire. The operational limit was set on using 30% of the crane capacity. There was a misunderstanding that the Safe Working Load (SWL) of the crane wire was 60Te.

There was no process within the company's Wire Rope Integrity Management Procedure that provided an option for application of an operational limit to deteriorating wires.

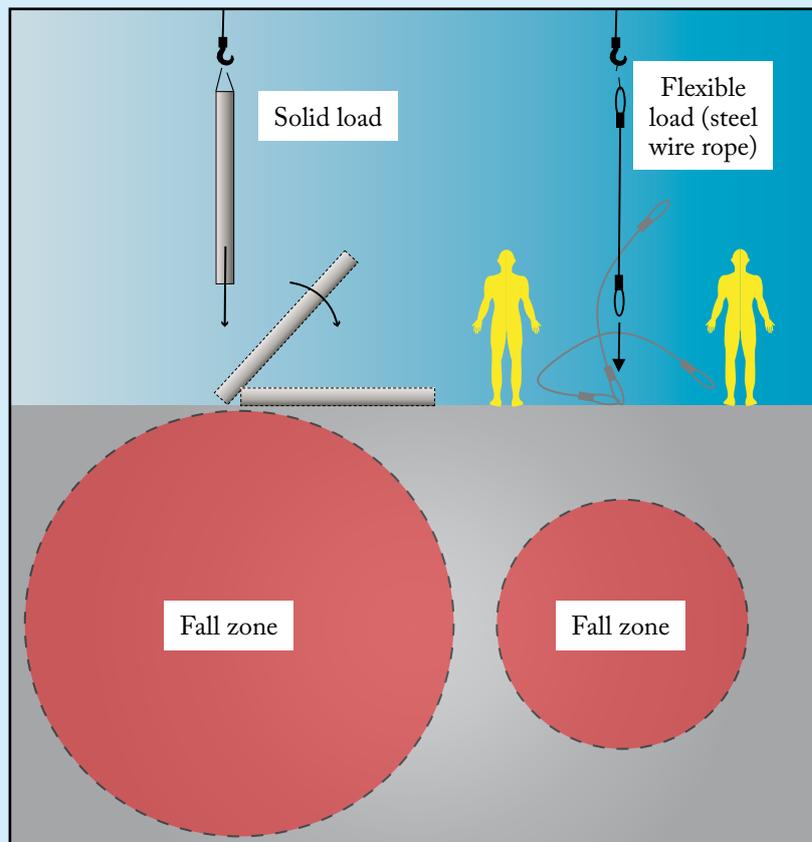
Figure 1: Illustration of the danger zone under a suspended load

1. During lifting operations, it is vital that crew avoid the hazardous fall zone under the suspended load. This is not just the area directly under the suspended load; it extends to the entire area where it is reasonably foreseeable that a load could fall (Figure 1).
2. All lifting operations should have a safe plan, ideally a task specific risk assessment and method statement. In this accident, the ABs were struck because they were standing in the fall zone, which had not been assessed as a dangerous area. At safety briefs or toolbox

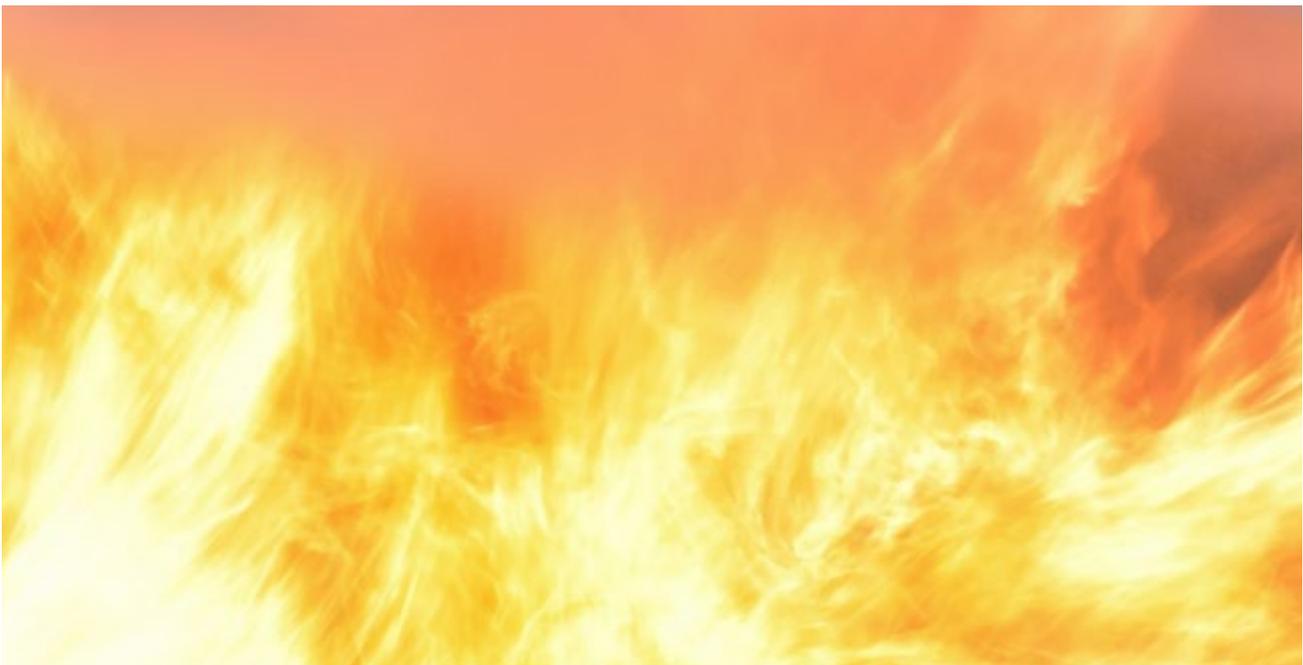
Shortly afterwards, the fire alarm activated in the aft engine room and small flames were seen coming off the lagging (Figure 1). This was rapidly extinguished using an aqueous fire-fighting foam (AFFF) extinguisher, and the bridge team were asked for approval to stop the main engine.

The company investigation later identified that during maintenance work on the main engine cooling system a pipe had been removed to allow a leak to be repaired by replacing a seal. This was not a planned task, and no risk assessment or method statement had been produced. When the pipe was removed, around 5 litres of water had drained from the top of the crank case breather box, and some oil residue inadvertently washed into the lagging. Main engine runs conducted alongside after the repair had not produced sufficient heat to ignite the oils. However, when the main engine was run under load at sea, the increased temperature produced was enough to cause a fire.

Figure: Location of lagging that ignited indicated

restart the engine and monitor the situation carefully. The fire reignited after a few minutes' running and was once again extinguished. Again, the engine was stopped, and this time the lagging was removed; the engine restarted with no further issues. The lagging pad was subsequently replaced.

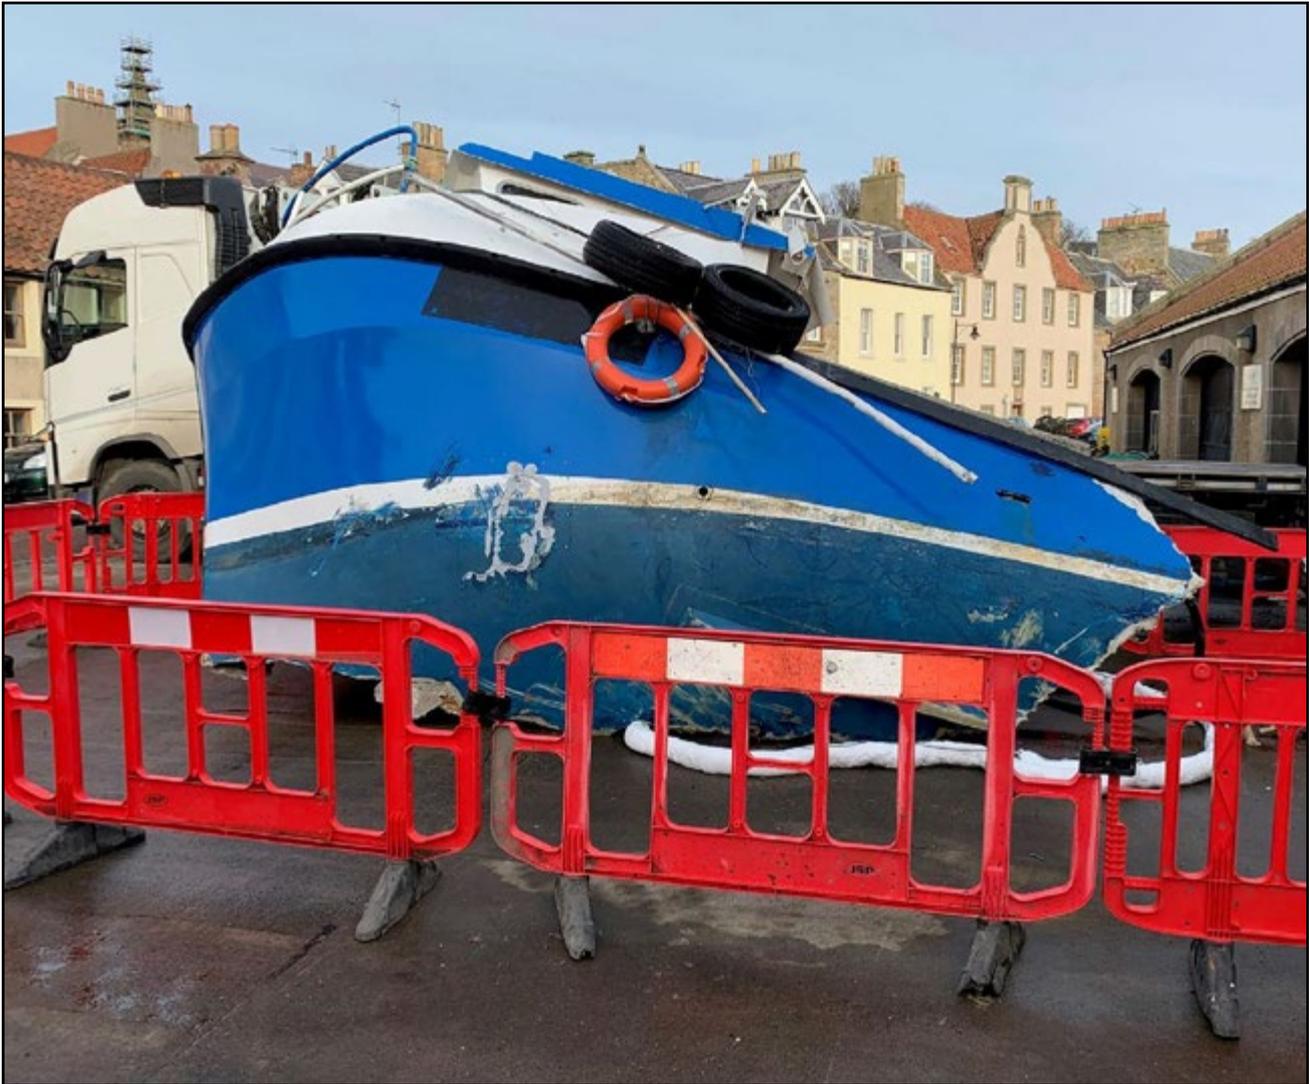
At low water, the skipper and the lifeboat crews tried to patch the hole in the hull, but by that time the damage was too great and the attempt to recover the vessel had to be abandoned as the tide rose again. The vessel was totally engulfed, and with an onshore swell still running it broke up on the rocks (Figures 1 and 2), with its fuel causing some minor pollution.

Figure 2: Bow section ashore

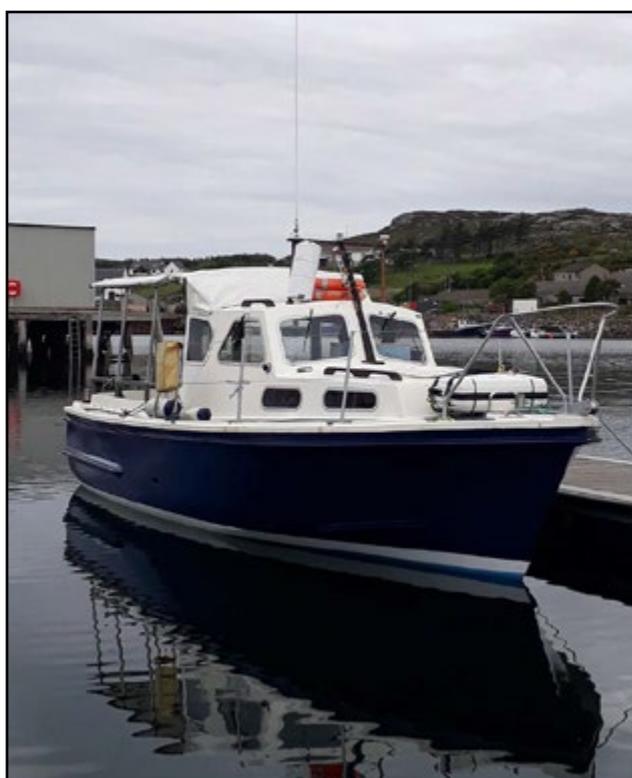
Figure: The fishing vessel before the accident, showing the liferaft on the foredeck – on the day of the accident, the liferaft was stowed inside

5. The liferaft that failed to inflate was not recovered, so the reason it did not work will remain a mystery. Nevertheless, this accident serves as a reminder to keep all safety equipment regularly serviced and in good working order.

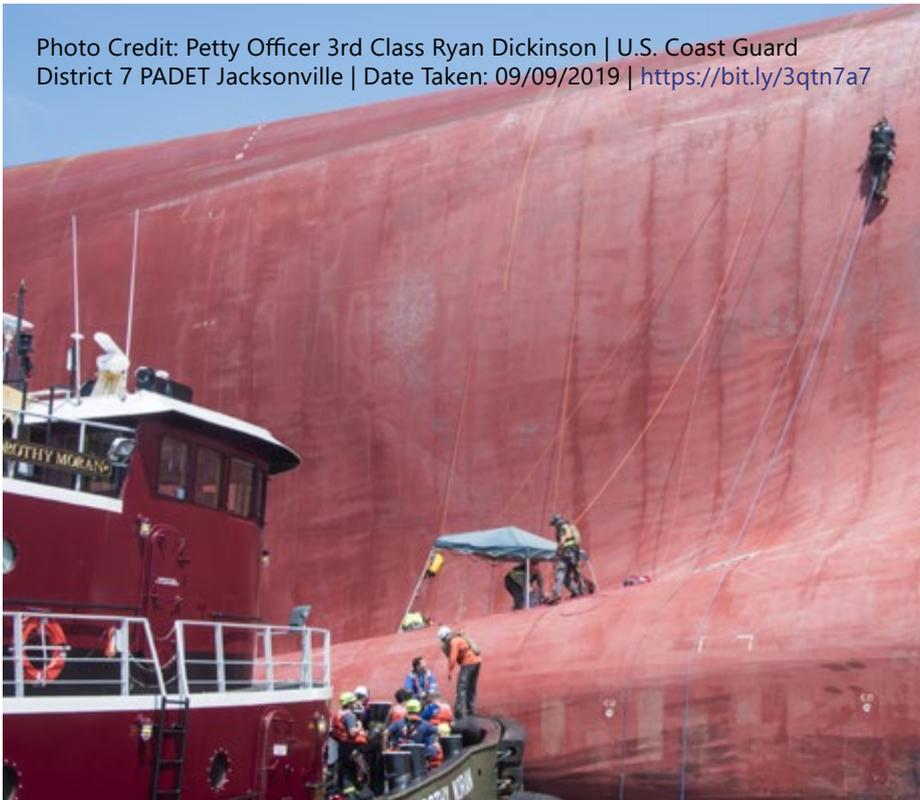
- The probable cause of the capsizing of the Golden Ray was the chief officer's error entering ballast quantities into the stability calculation program, which led to his incorrect determination of the vessel's stability and resulted in the Golden Ray having an insufficient righting arm to counteract the forces developed during a turn while transiting outbound.

vessel in the final turn toward the open sea as the vessel sped up, it resulted in the centers of gravity and buoyancy rolling the vessel when she heeled past 8 degrees.
