The missing question from the NTSB Report on MV Golden Ray:

By *Salvatore R. Mercogliano, Ph.D.*

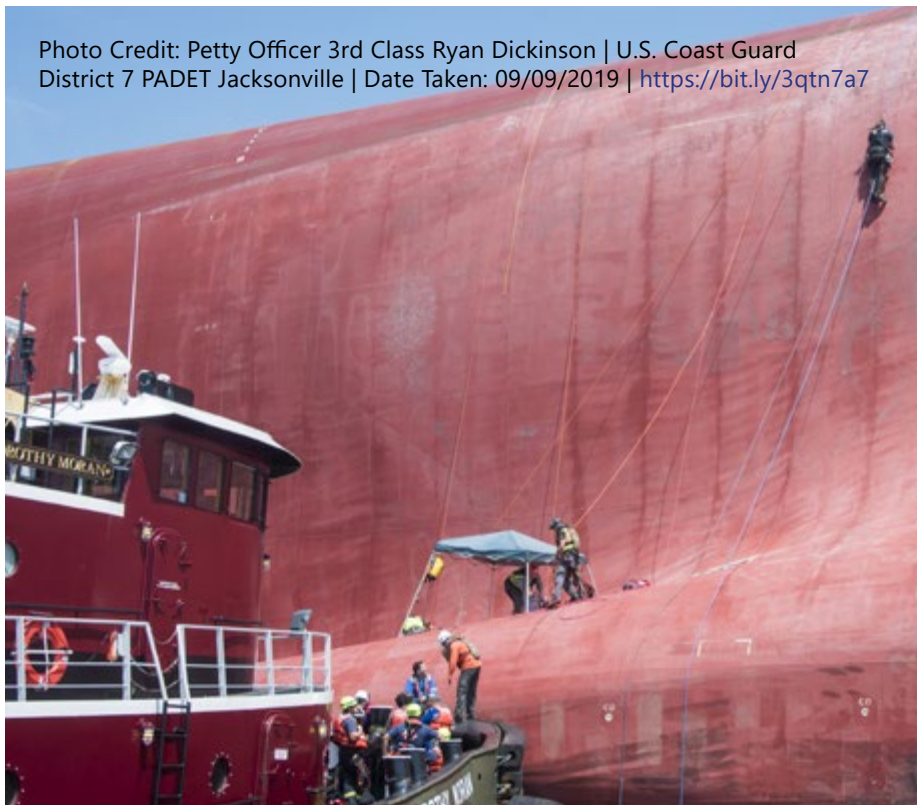
Photo Credit: Petty Officer 3rd Class Ryan Dickinson | U.S. Coast Guard District 7 PADET Jacksonville | Date Taken: 09/09/2019 | <https://bit.ly/3qtn7a7>
