Issued February 15, 2022

MIR-22/03

Grounding of Fishing Tender Barge *SM-3*

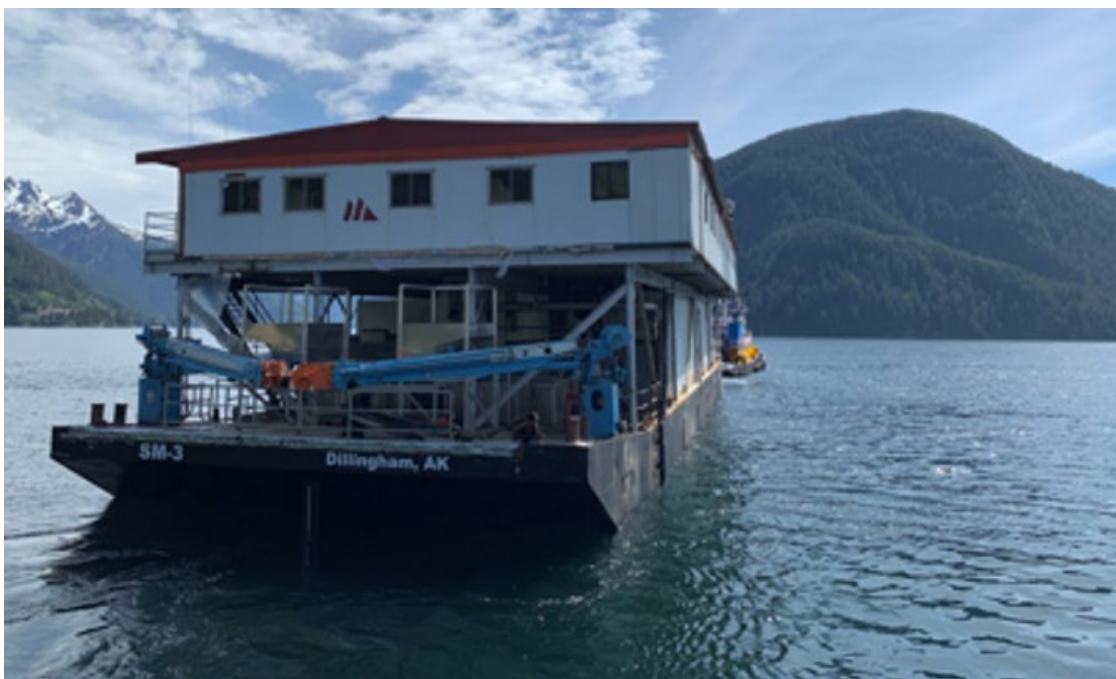
Figure 1. *SM-3* under tow before the grounding. (Source: Northline Seafoods)

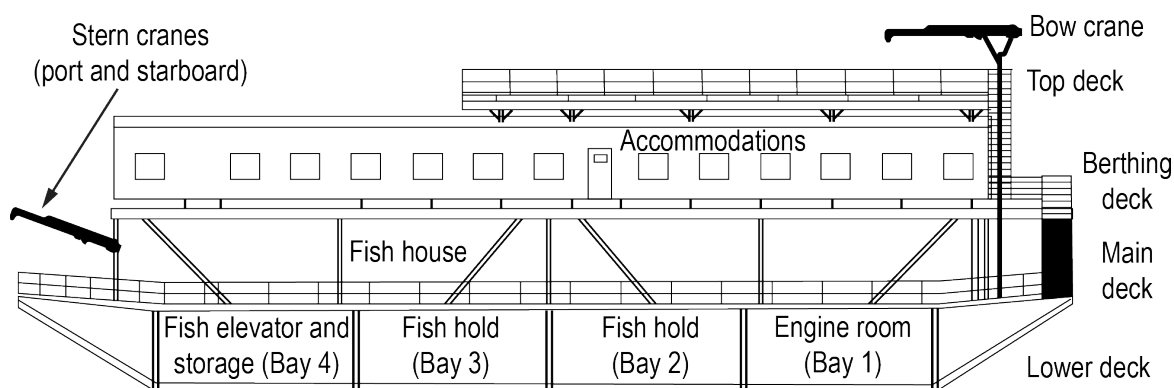
The *SM-3* had four decks. Within the barge hull was the lower deck, consisting of four compartments: an engine room (Bay 1), two fish tank holds (Bays 2 and 3), and a pump, maintenance, and storage room, which also contained a fish elevator (Bay 4). The four compartments were separated by watertight bulkheads, each fitted with a watertight door. The main deck had an enclosed fish house, used for processing fish, and three deck cranes (one on the bow and two on the stern). Above the main deck was the berthing deck, which housed crew accommodations. Above the accommodations forward on the vessel was the former helipad, also referred to as the top deck, which was used for storage.

Figure 3. *SM-3* profile. (Background source: Northline Seafoods)
