Investigation Report 282/20

Serious Marine Casualty

**Grounding of the RUBINA
after steering gear failure
on the River Weser
on 27 August 2020**

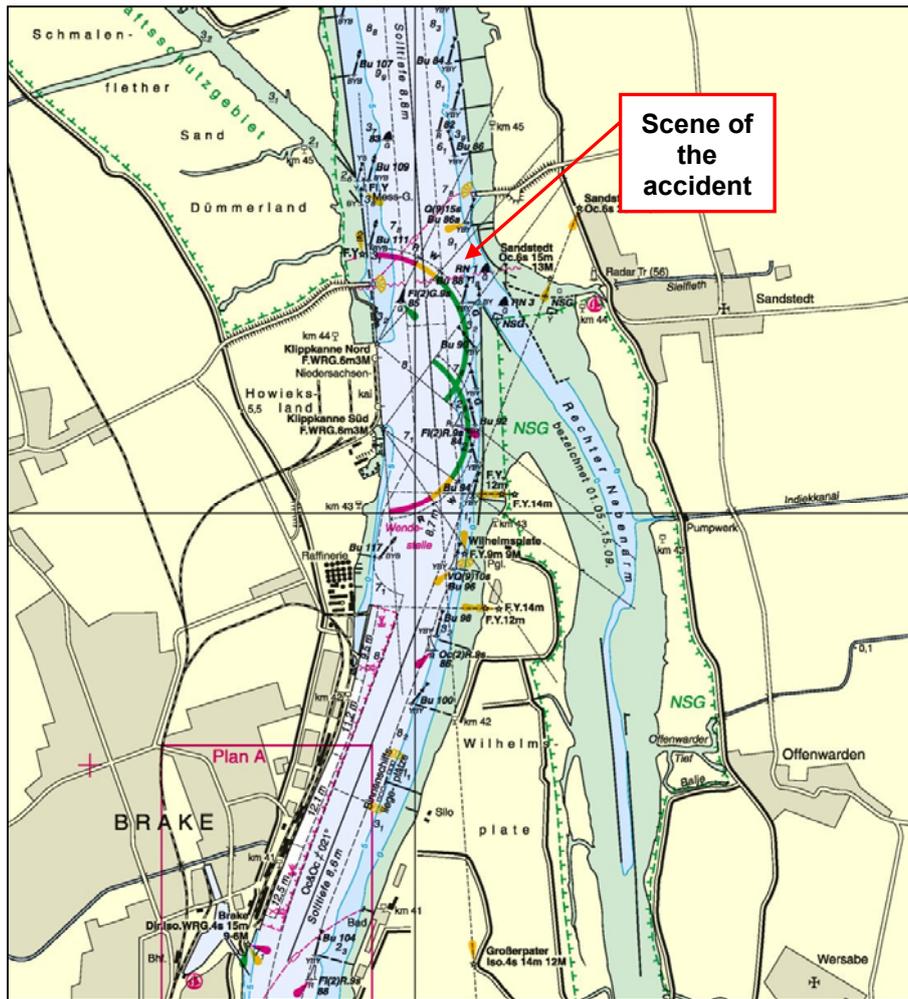
Figure 2: Scene of the accident⁴

The RUBINA's prow ran aground outside the fairway before any of these immediately initiated measures could have any effect (at about 2157). Rudder control was regained almost at the same time. Luckily, the grounding occurred in a relatively 'harmless' position on the river: at the mouth of a Weser tributary (the so-called 'Rechter Nebenarm') and outside the fairway, roughly level with Sandstedt (see Figure 2, Figure 4 and Figure 13). About two and a half minutes had passed since the rudder had jammed.

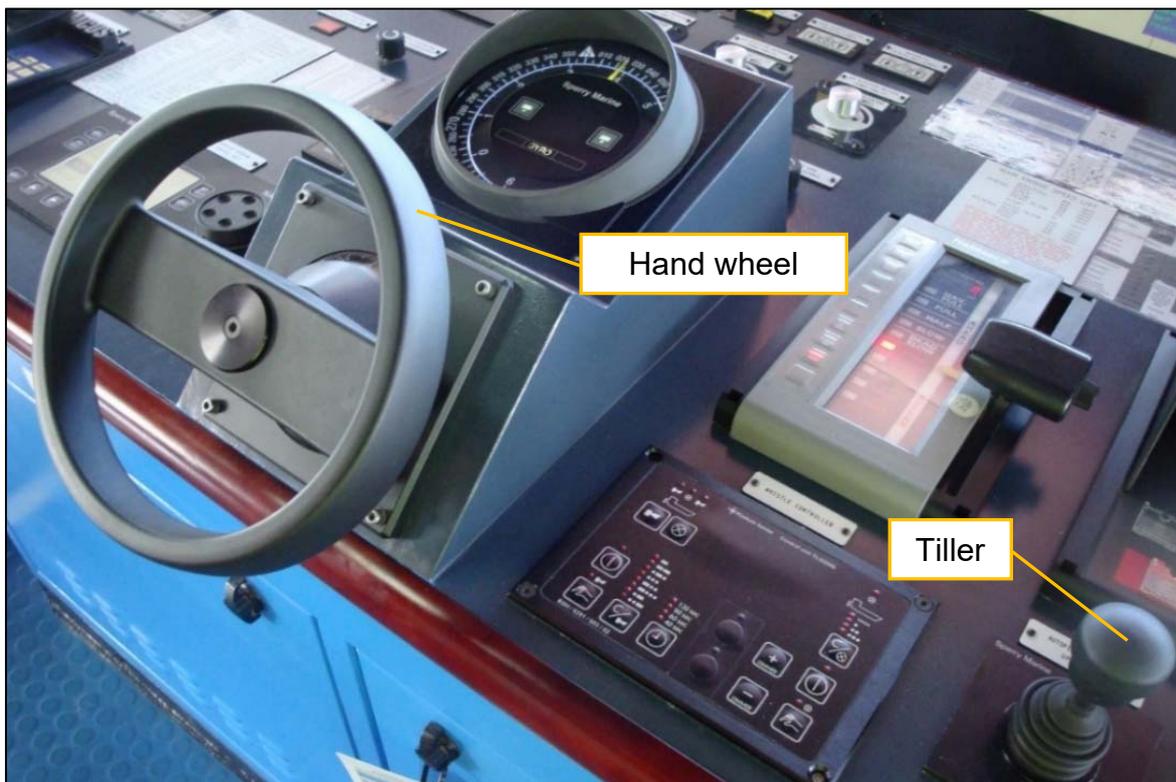
Figure 3: Hand wheel and tiller⁶ on the RUBINA

At around 2154, the helmsman tried to return the rudder to midships from a rudder angle of about 15° starboard. Initially, nothing happened, despite a correct had steering wheel position; the rudder remained at 15°. The helmsman immediately reported the problem to the pilot and the ship's command. After about three seconds, the steering control system automatically switched into so-called "override"⁵, accompanied by a clearly audible alarm.

⁶ Tiller: Input device for rudder orders on a ship. Varies in design – can be a rotary wheel with scale, for example. On most ships (including the RUBINA) the tiller looks like a joystick, see Figure 3. See section 0 for a more detailed explanation.

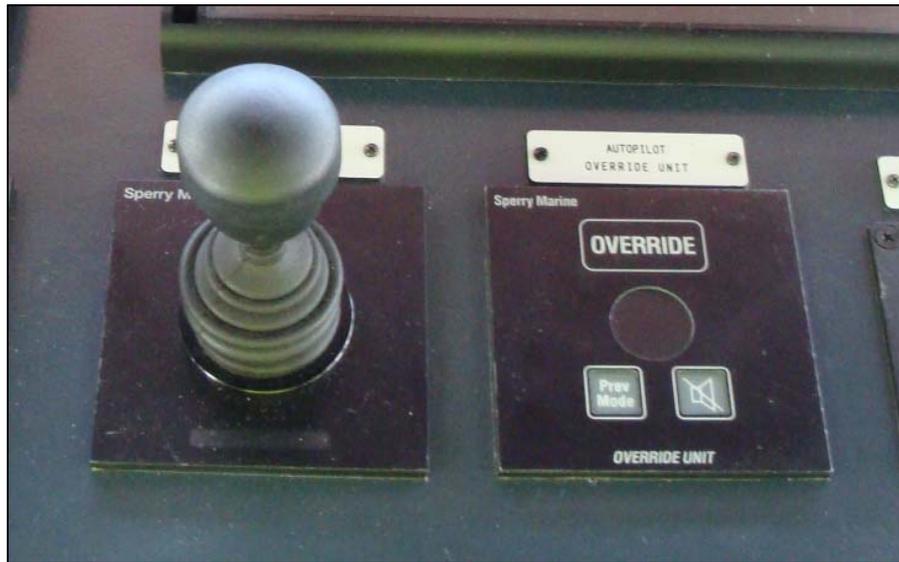
Figure 11: Tiller and Steering Override Unit SOU

This *intended and manual activation of the override* is indicated by an alarm on the so-called 'Steering Override Unit' (SOU) located next to the tiller. The 'Prev[ious] Mode' button (see Figure 11) can then be used to deactivate the override and return to FU mode.

However, after a Steering Failure Alarm (i.e. after an *unintended and automatic activation of the override* due to a problem with the rudder angle, i.e. a 'steering failure'), a reset is not possible this way. In such cases, a reset must be carried out by switching to NFU mode and back to FU. Of course, the override can then be expected to reengage after another three seconds if the underlying problem has not been solved in the meantime.

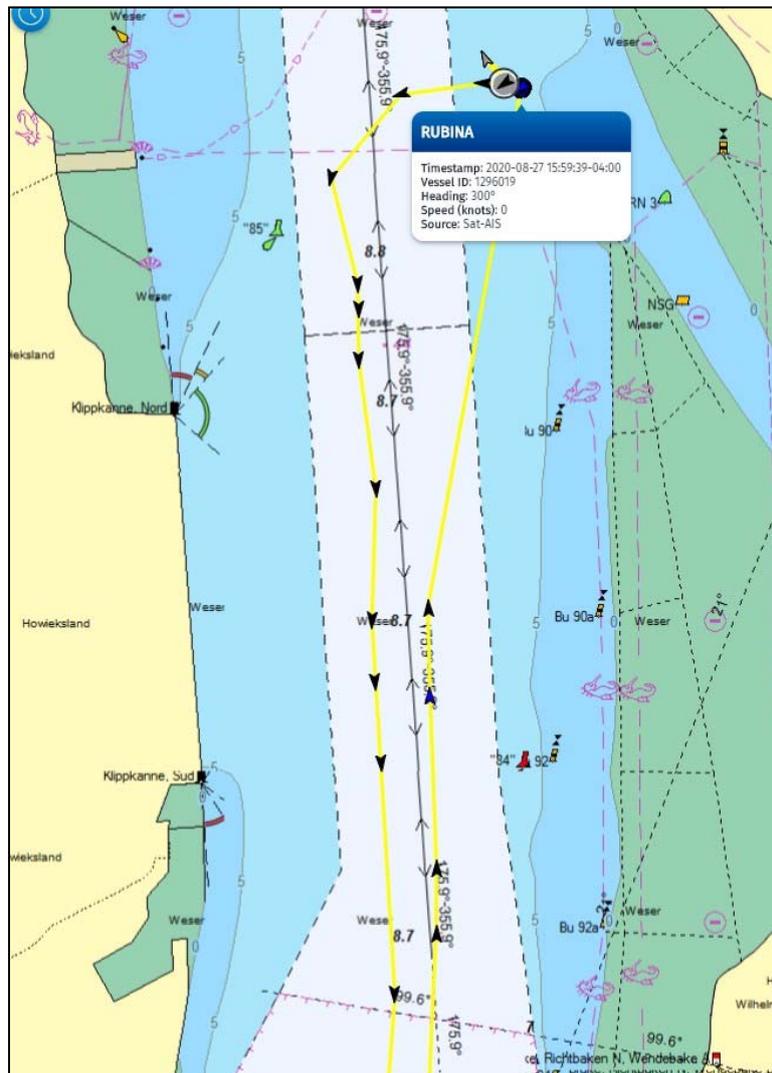
Figure 13: Past track of the accident (external recording)²⁷

The RUBINA's track could be retraced using various ship tracking and information platforms. However, since the data used there originate from the ship's AIS signal²⁵ (ultimately the GPS device²⁶), it is consistent with the track found on board (see Figure 4) and has no standalone meaning.

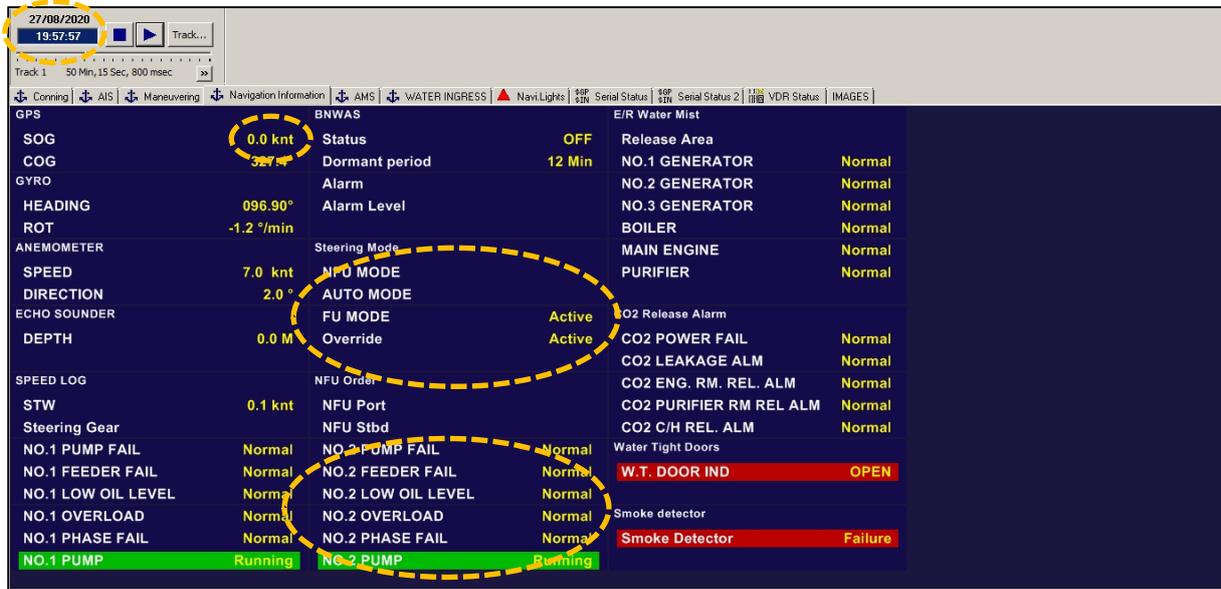
Figure 21: VDR: Time of grounding (speed: 0.0 kts³⁰).

(215757 local time)
