SAFETY INVESTIGATION REPORT

REPORT NO.: 05/2022

MT SEASCOUT Explosion leading to equipment and structural damages in position 21° 07.1' N 059° 31.9' E 18 March 2021

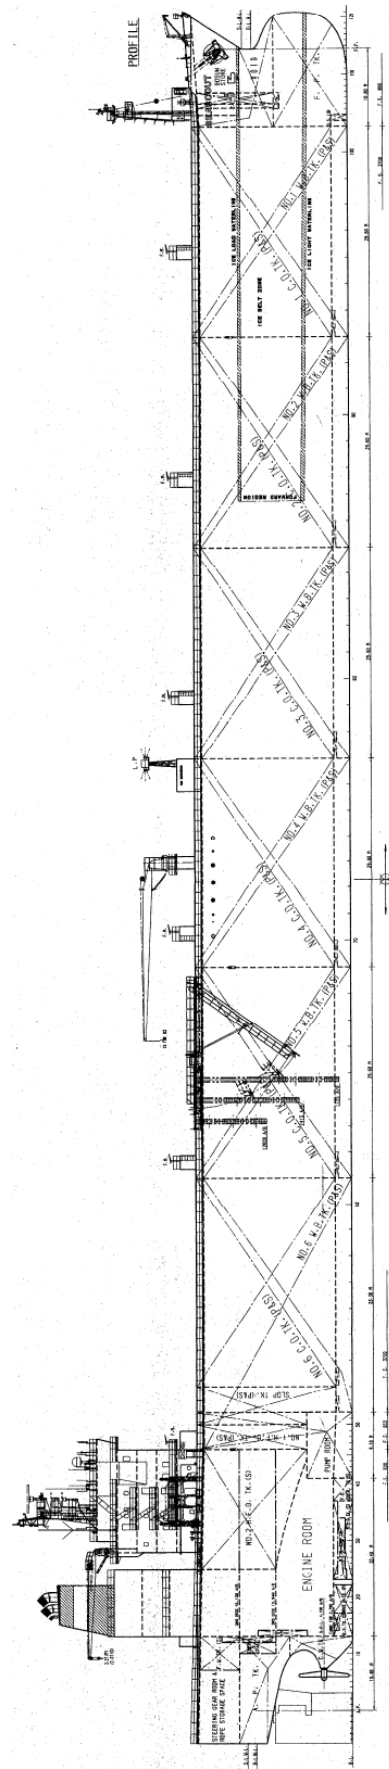
Figure 1: An extract from the vessel's general arrangement plan

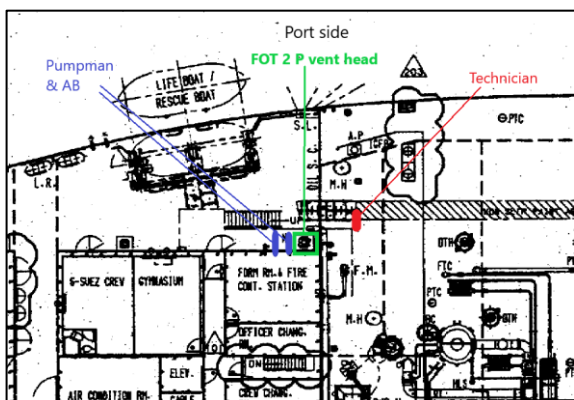
The pumpman and the AB, who were close-by on deck (Figure 2), were installing a new isolation valve on the fire line, when they heard the angle grinder running.

Figure 2: Extract from the General Arrangement plan indicating the location of the crew members and the technician prior to occurrence
