Collision involving the bulk carrier *Goliath* and tugs *York Cove* and *Campbell Cove*

Devonport, Tasmania on 28 January 2022

ATSB Transport Safety Report

MO-2022-002

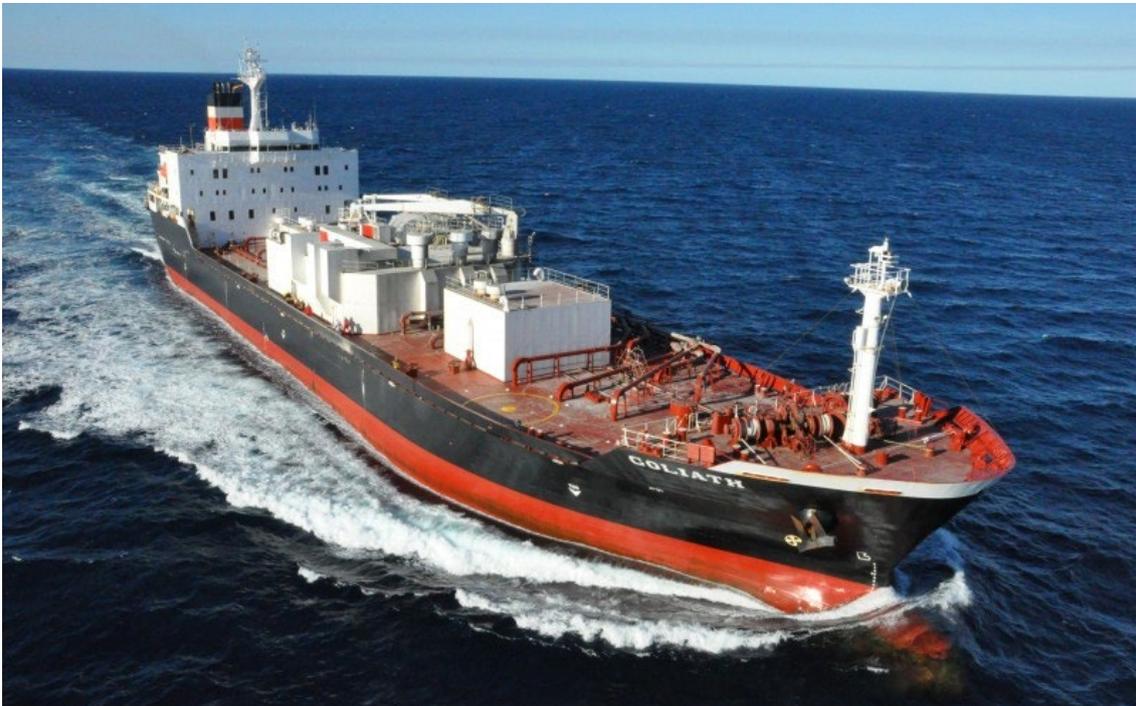
Figure 1: *Goliath*

On the morning of 28 January 2022, the 143 m Australian-registered, bulk cement carrier *Goliath* (Figure 1) was on passage from Melbourne, Victoria to Devonport, Tasmania. The ship had departed Melbourne the previous evening and was bound for the bulk cement facility at Devonport's berth number One West, where it usually berthed port side alongside.

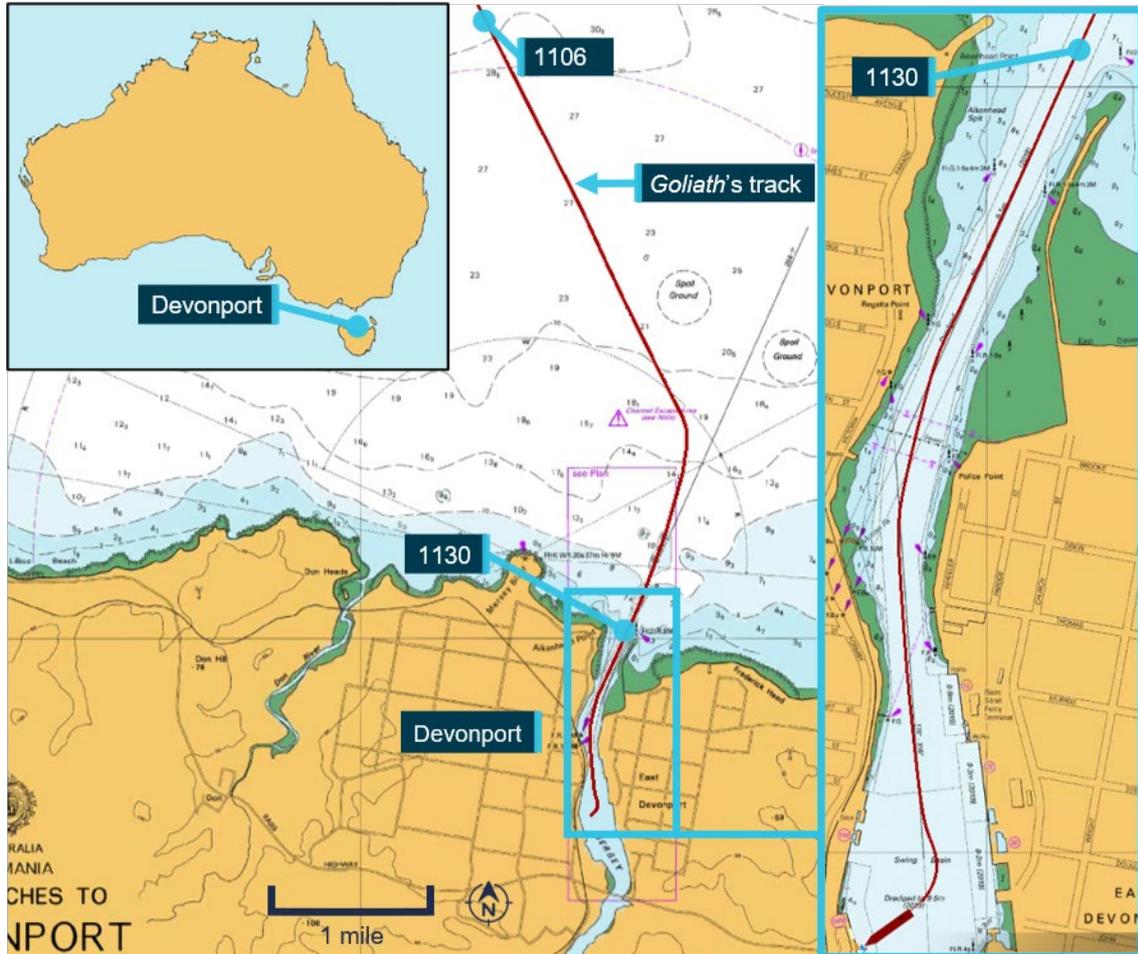
Figure 2: Section of chart Aus 164 showing *Goliath's* track

At about 1106, as the ship approached Devonport port limits (Figure 2), the third mate tested the ship's bow thruster and had the main engine put on stand-by for manoeuvring. Shortly after, the master called Devonport vessel traffic service (VTS) on the port's VHF radio working channel (VHF channel 14). The master reported the ship's draught and pilotage exemption details to the

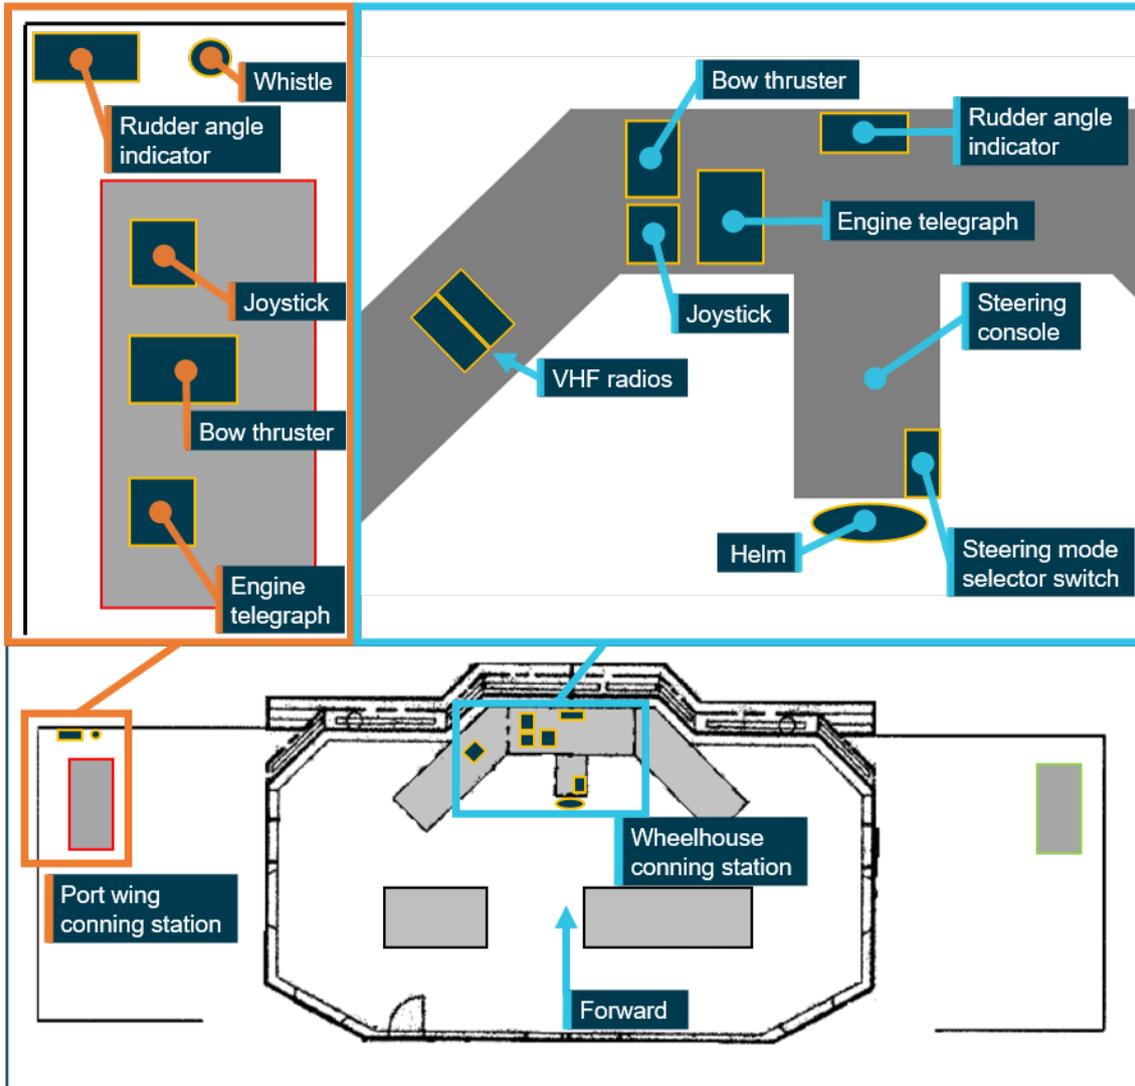
Figure 3: *Goliath's* bridge layout showing the location of controls for various equipment

At about 1140, the second mate came to the bridge with the intention of relieving the chief mate. The second mate and chief mate, situated to starboard of the steering console, began to discuss the state of the various ship's machinery, personnel, and bridge equipment. The helmsman was steering and the master was stationed to port of the steering console where the main engine telegraph, bow thruster controls and VecTwin steering control joystick were located (Figure 3).

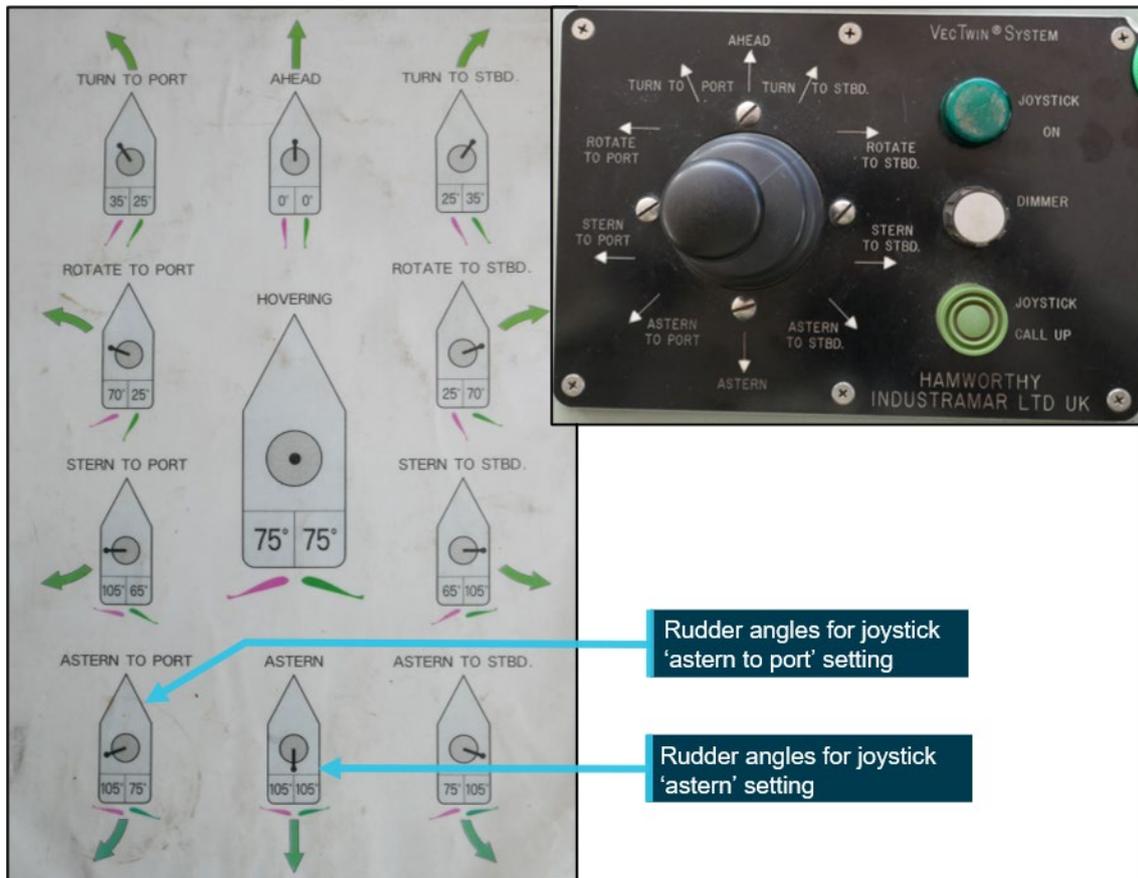
Figure 9: VecTwin steering joystick showing settings and corresponding rudder angles

When using the VecTwin steering mode, ahead inputs on the ship's main engine could be used to generate astern thrust, transverse thrust or even to 'hover', all with the propeller kept rotating in the ahead direction. For example, with the 'astern' joystick setting selected, each rudder was set to 105° outboard, with ahead inputs on the main engine generating astern thrust to slow/stop the ship or move the ship in the astern direction (Figure 9). This meant that the ship could be slowed, stopped or moved astern without the need to stop the engine and engage astern propulsion, as is usually required during conventional ship manoeuvring.
