# Investigation report

Report	
Report title Investigation of undesirable incident on Troll C on 24 October 2021 – revised	Activity number 001085030

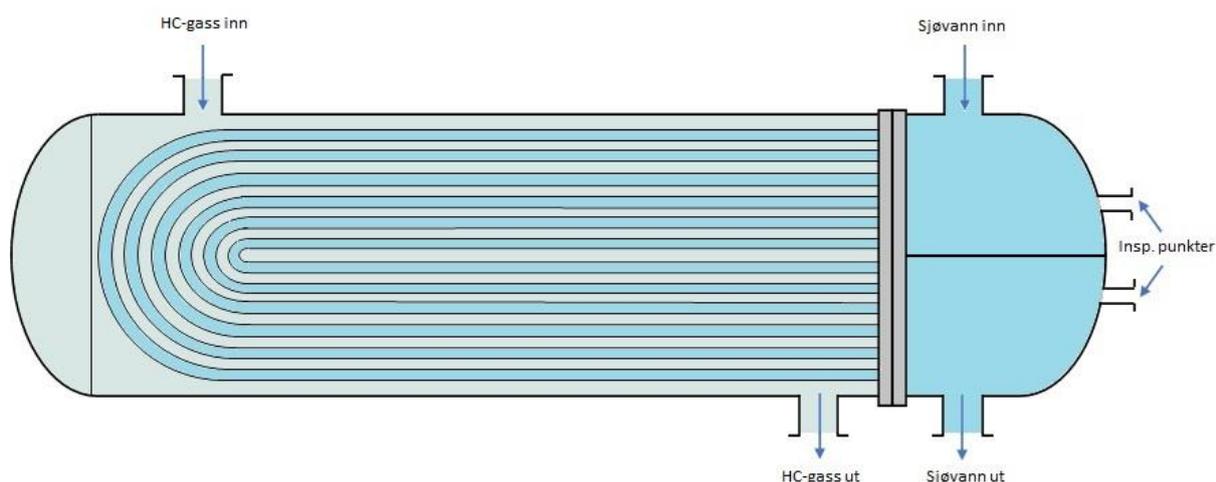
Gas from the first-stage export compressors (KA-23-00011A/B) is routed to the second-stage export compressor coolers (HA-23-0012A/B). It enters these coolers with a pressure of about 60 barg and a temperature of roughly 148°C. The gas is cooled down to some 25°C before continuing via the gas dewatering system to the second-stage export compressors (KA-23-0012A/B).

Figure 6 Simplified diagram of the gas coolers.

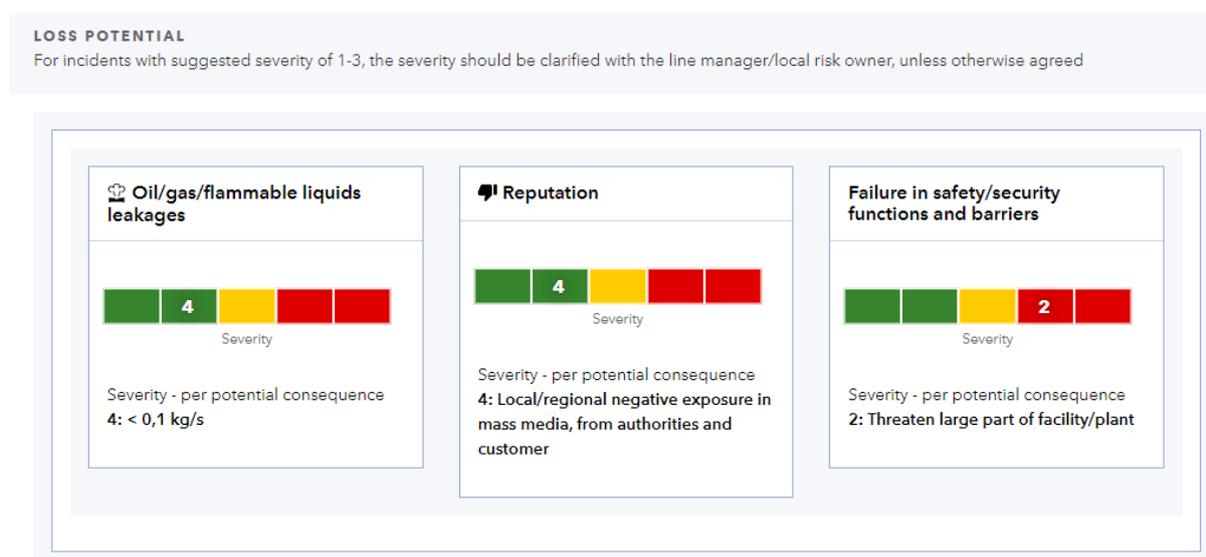
Figure 11: Classification of the incident according to Synergi case 1746821 at 8 November 2021.

At this point, both gas coolers were shut down. Interviewees have reported that the classification of "failure in safety/security functions and barriers" has been Red 2 since 2 November. This calls for a level-2 COA ACC investigation pursuant to the requirements in the supplement to WR9592 – register safety and security incidents (EPN). The task force considered seeking an exemption from this. At a meeting between the PSA and Equinor on 5 November, the PSA inquired whether Equinor intended to investigate, and if so at what level. The PSA reported that it had not yet decided whether to conduct an investigation. Equinor resolved on 8 November to initiate its own investigation at COA level 2.
