Published September 2022

REPORT MARINE 2022/10

***Fall overboard from the cargo ship
'MV Titran' east of Stigen in Lurøy
municipality on 6 March 2022***

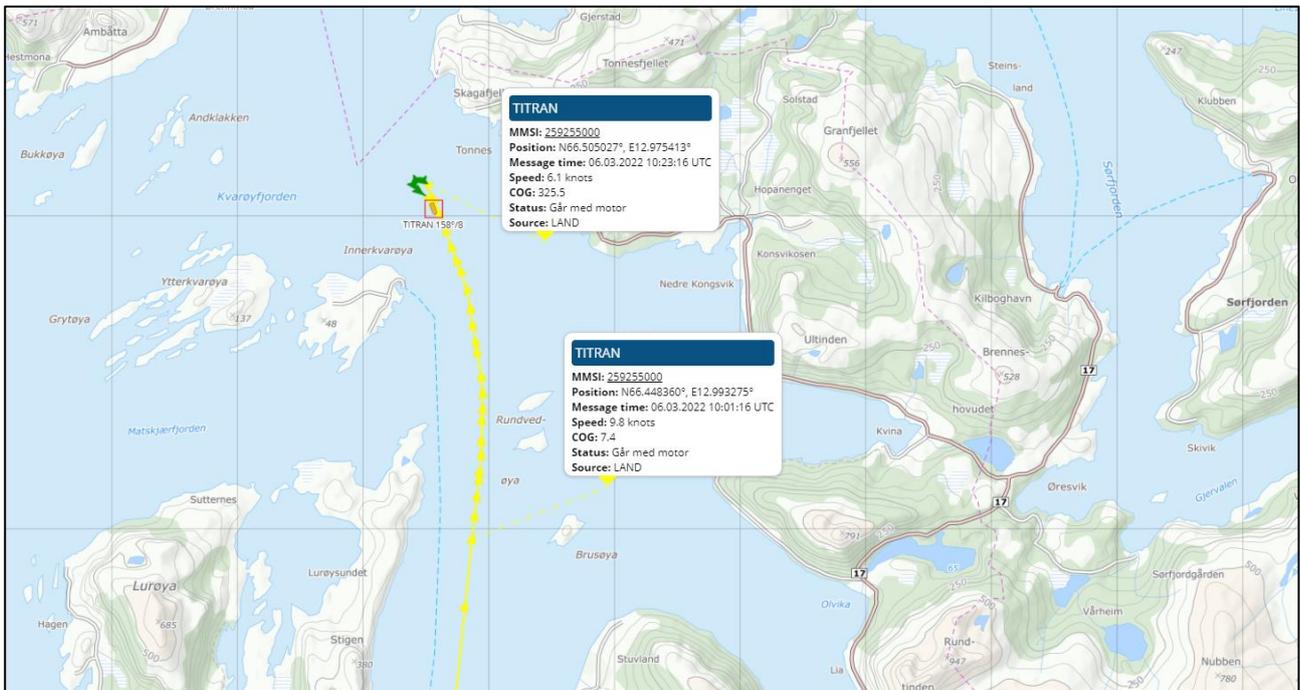
Figure 6: The ship's position when the missing person fell overboard at approximately 11:00 and when the ship turned at 11:23. Map: The Norwegian Coastal Administration

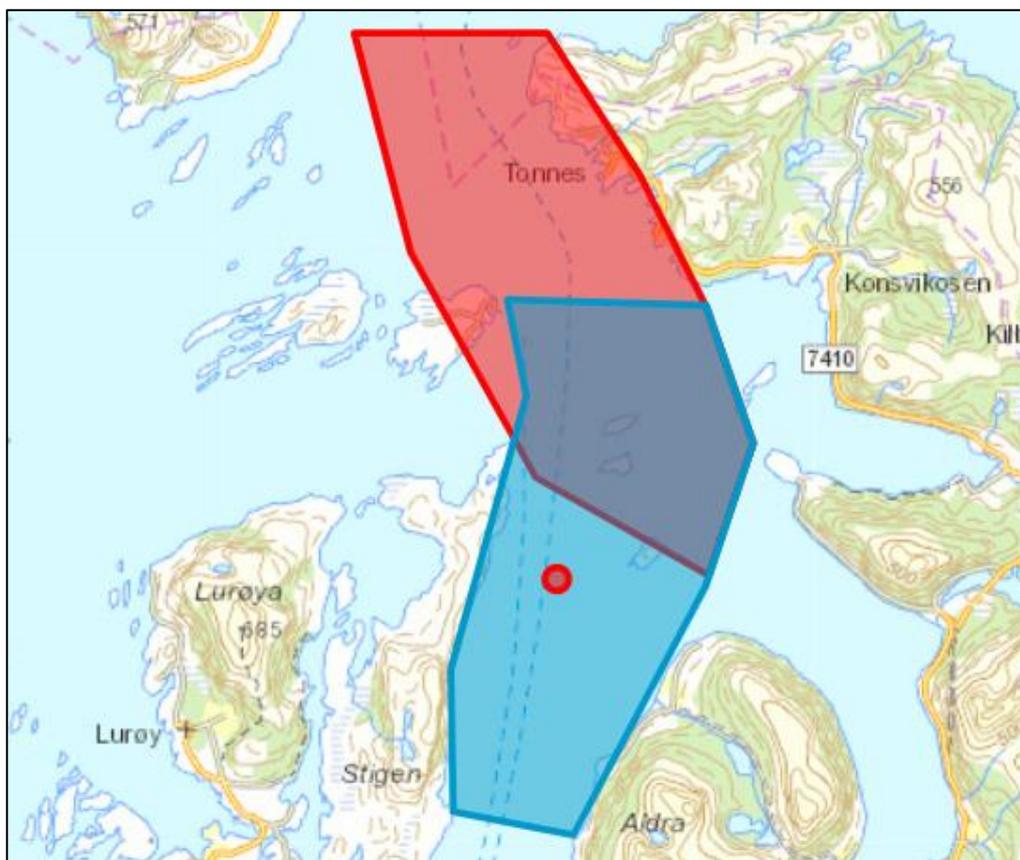
Nearby vessels started searching for the cadet at around 11:40. They were searching an area based on the vessel's position when the crew believed the cadet had fallen overboard. It later

emerged that the cadet had fallen overboard further south, and the vessels changed their search area at approximately 13:15; see Figure 7.

Figure 7: The search started in the area marked in red and was later moved to the area marked in blue based on new information about where the accident occurred. The red dot shows where the cadet fell overboard. Map: NCA/NSIA

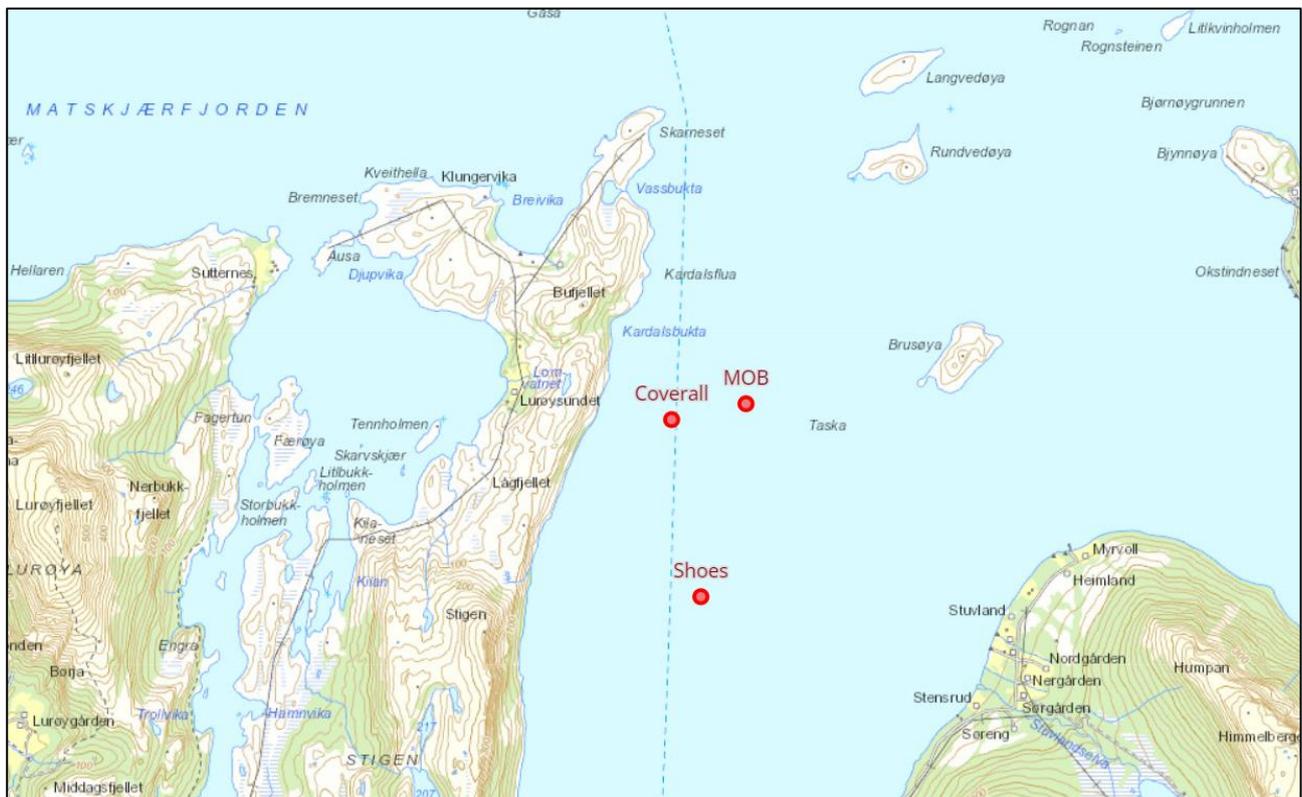
Figure 8: MOB position and position in which the missing person's coverall and shoe were found. Map: Norwegian Coastal Administration/NSIA

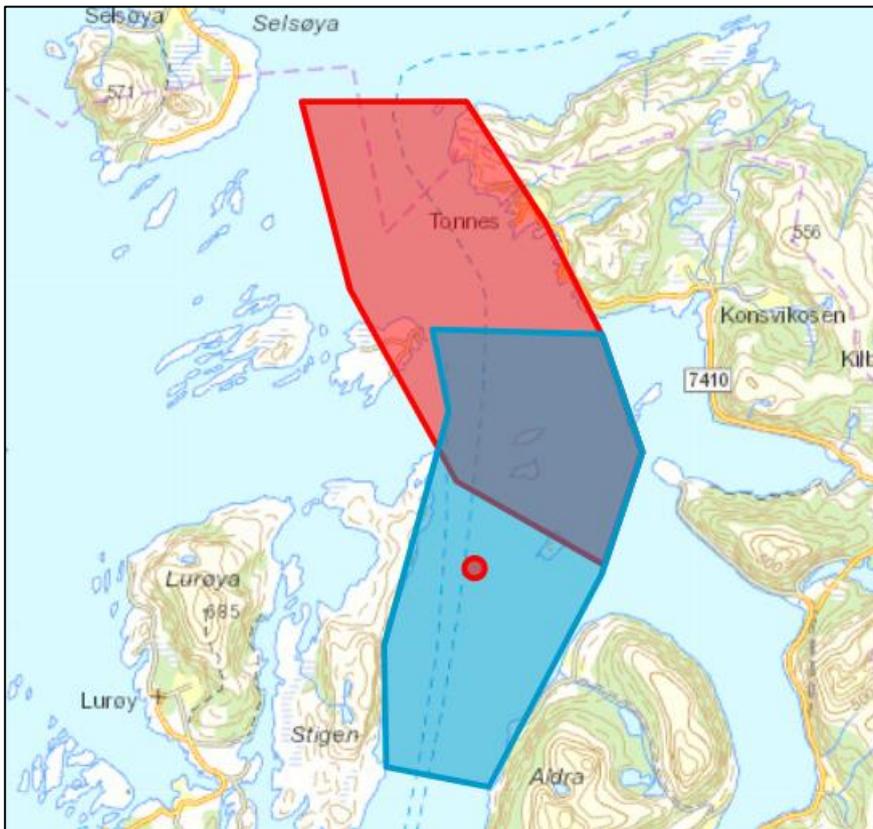
The crew did not witness the missing person fall overboard. This led to difficulties pinpointing the exact time when the cadet had fallen overboard, and the initial information provided to the JRCC about the time and place of the accident was therefore incorrect; see Figure 16.

Figure 16: The search started in the area marked in red and was later moved to the area marked in blue based on new information about where the accident occurred. The red dot shows where the cadet fell overboard. Map: NCA/NSIA

Even though the estimated time when the crew last saw the cadet was uncertain, the information was communicated to the JRCC and KRN as a certain indication several times until the captain received information from the shipping company that CCTV footage showed the missing person falling overboard 20 minutes earlier than initially assumed. This information was an important factor when the JRCC defined the search area. It meant that the vessels searched too far north for 1.5 hours before they received new information from the shipping company, which had confirmed the time and MOB position based on the CCTV footage. The rescue helicopter searched a larger area, including the place where the cadet fell overboard, but it did not initiate the search until 1 hour and 15 minutes after the incident. The NSIA believes it is essential for the crew of a vessel to clearly communicate any uncertainty about when a person fell overboard to the rescue services, so that the search area can be defined accordingly. In addition, the JRCC must consider the reliability of the information received from the vessel in such situations.
